**POST-CLOSING INSPECTION NO. 4  
ETHAN GARDENS APARTMENTS  
NEW HAVEN, CT**

**INSPECTION DATE: 11/10/10  
FHA CASE NO.: 017-55025**

REF: ETHAN GARDENS APARTMENTS  
POST-CLOSING INSPECTION NO. 4  
NEW HAVEN, CT  
FHA CASE NO.: 017-55025

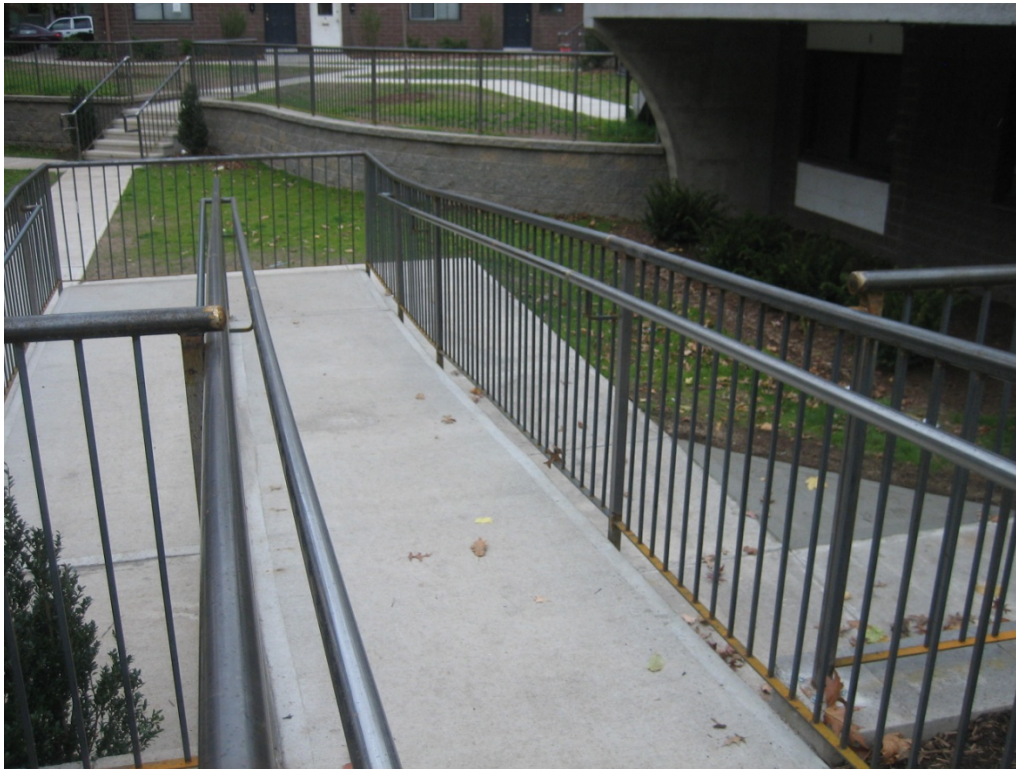
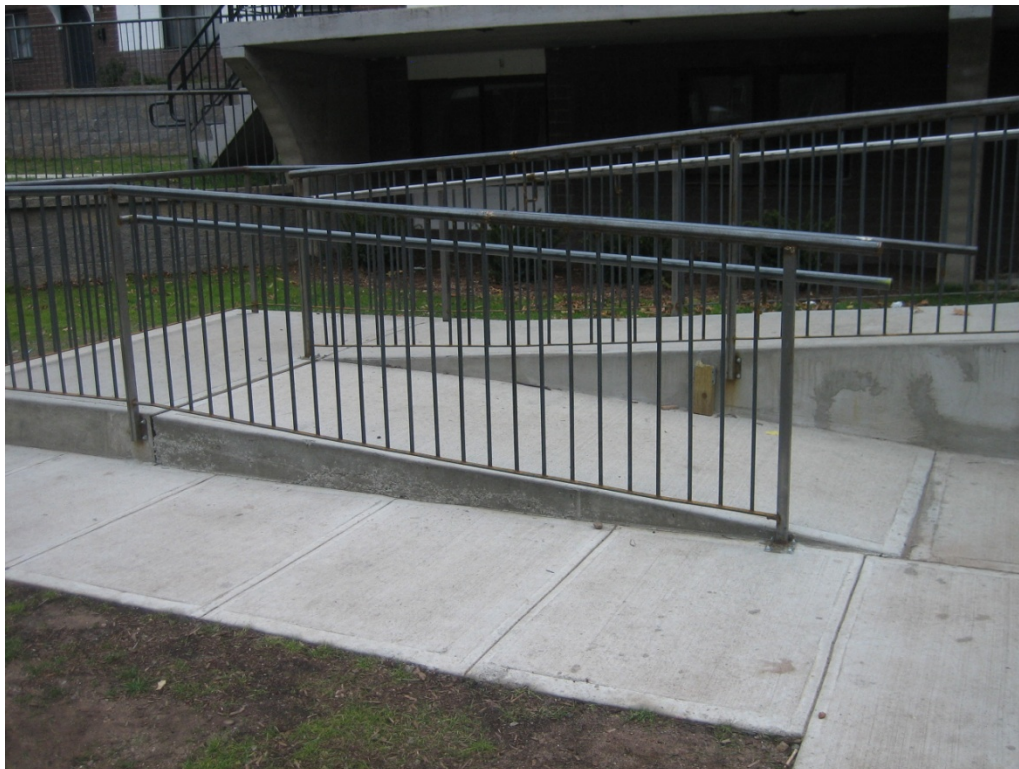
A new handicap ramp was constructed to provide an accessible route to the apartments designated for those with physical disabilities.

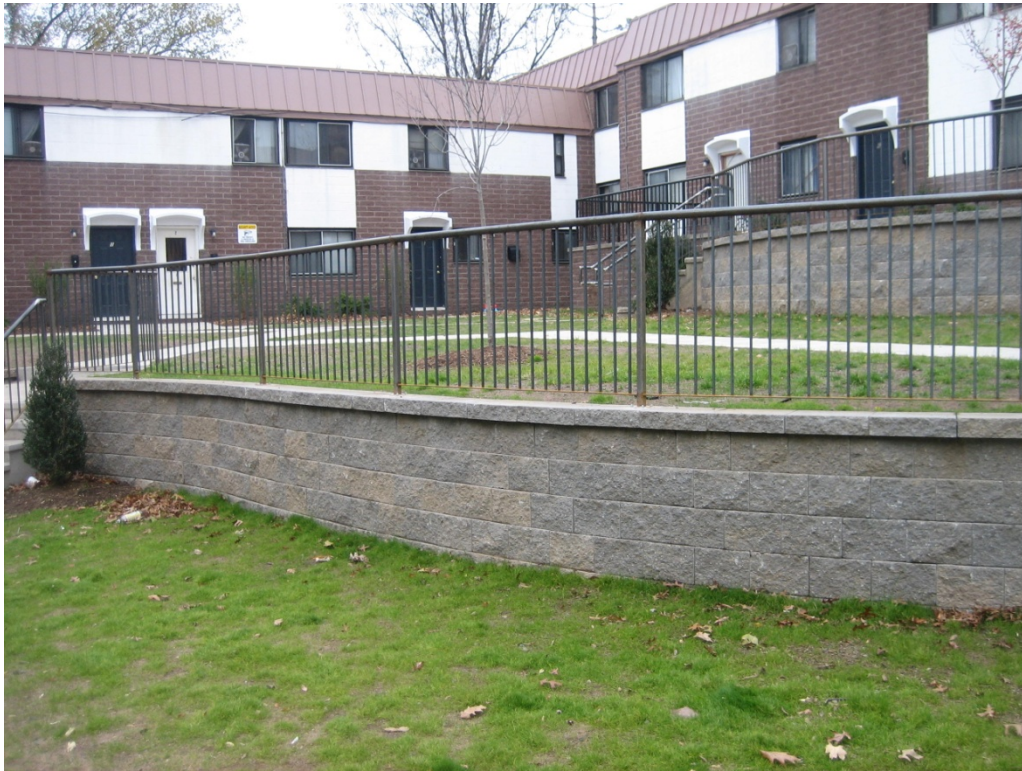
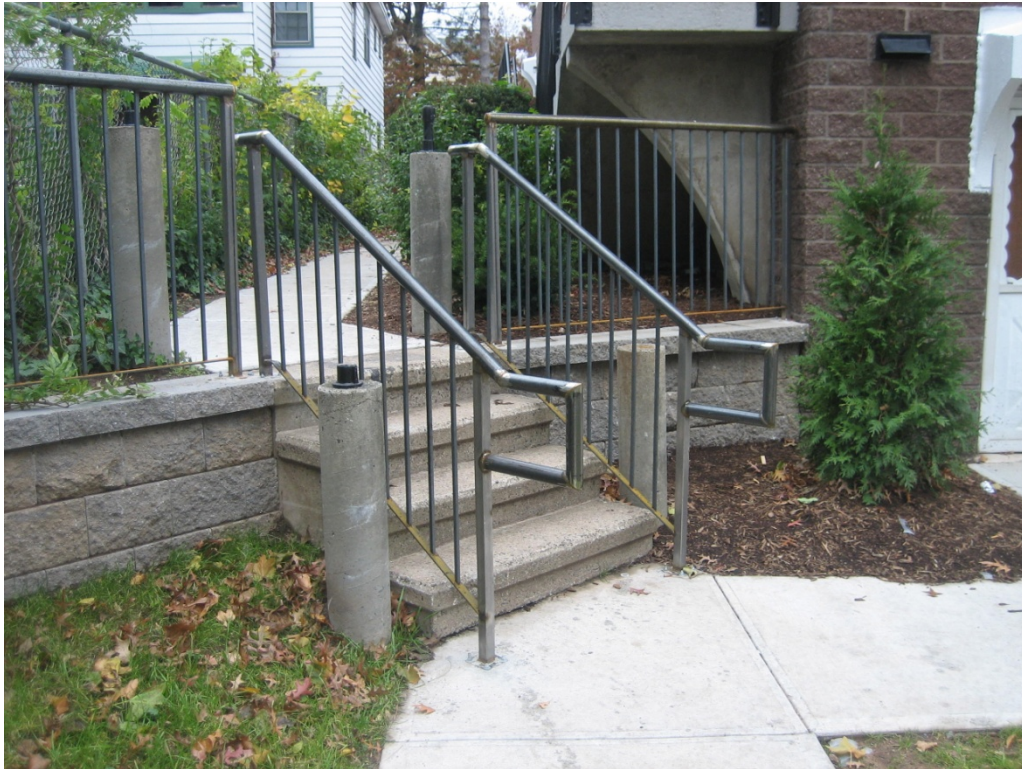
New retaining walls and rails were provided throughout the site which has greatly enhanced the development.

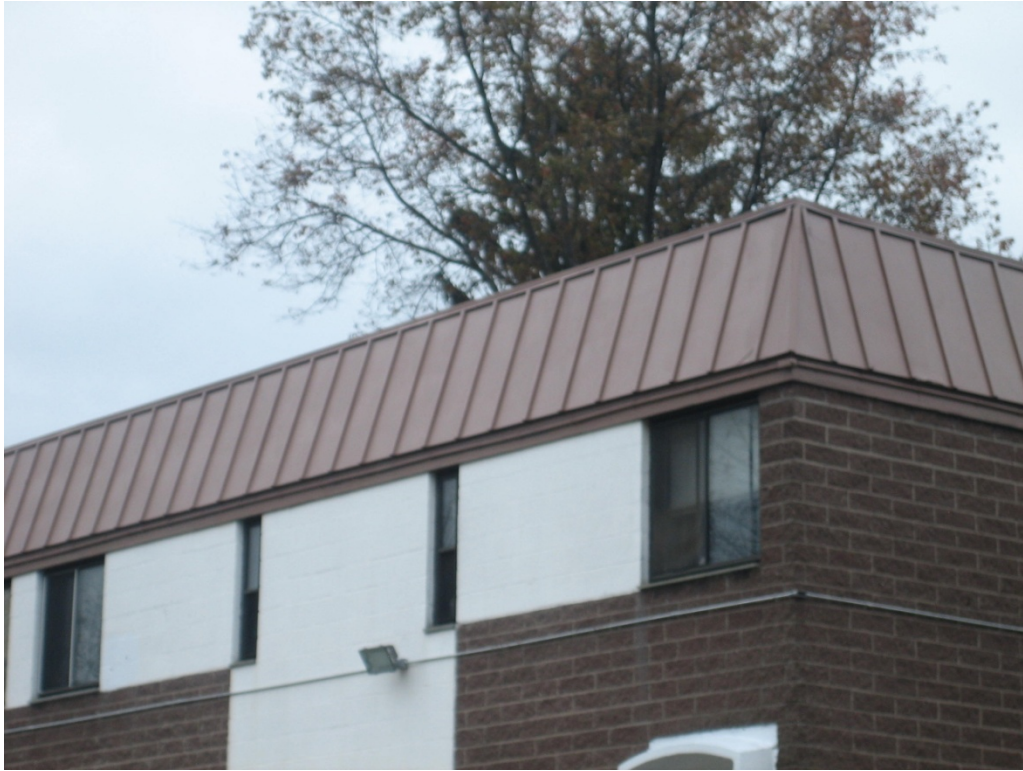
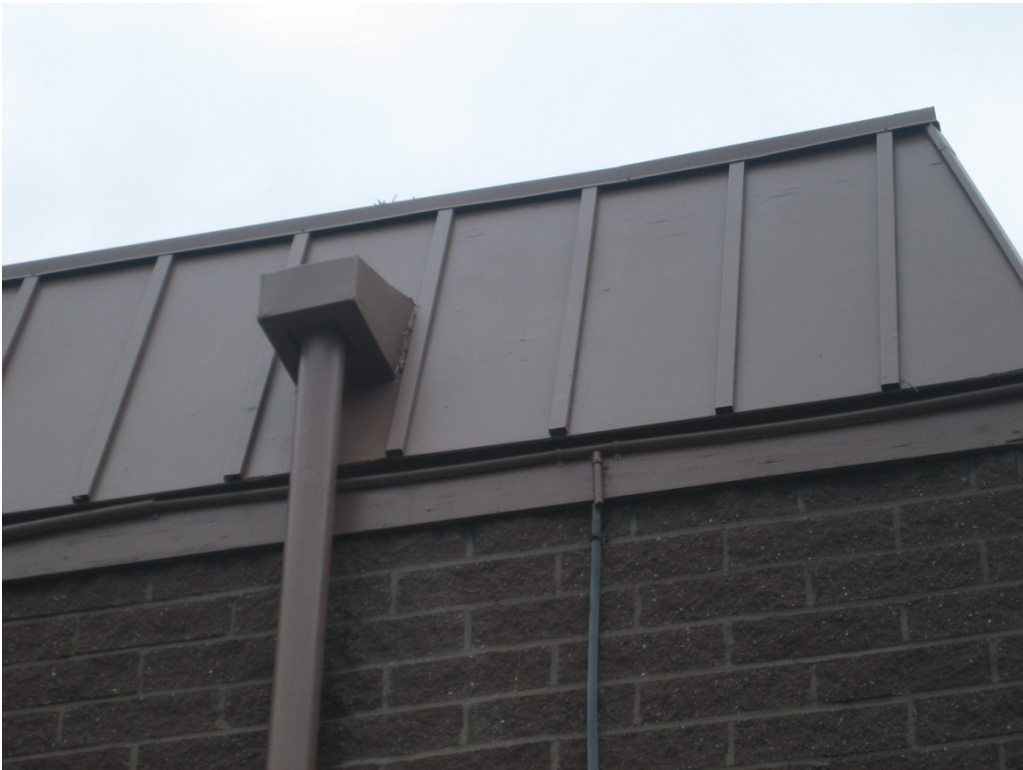
The mansard roof was repaired and painted. A new rubber membrane was provided on the flat portions of the roof surface.

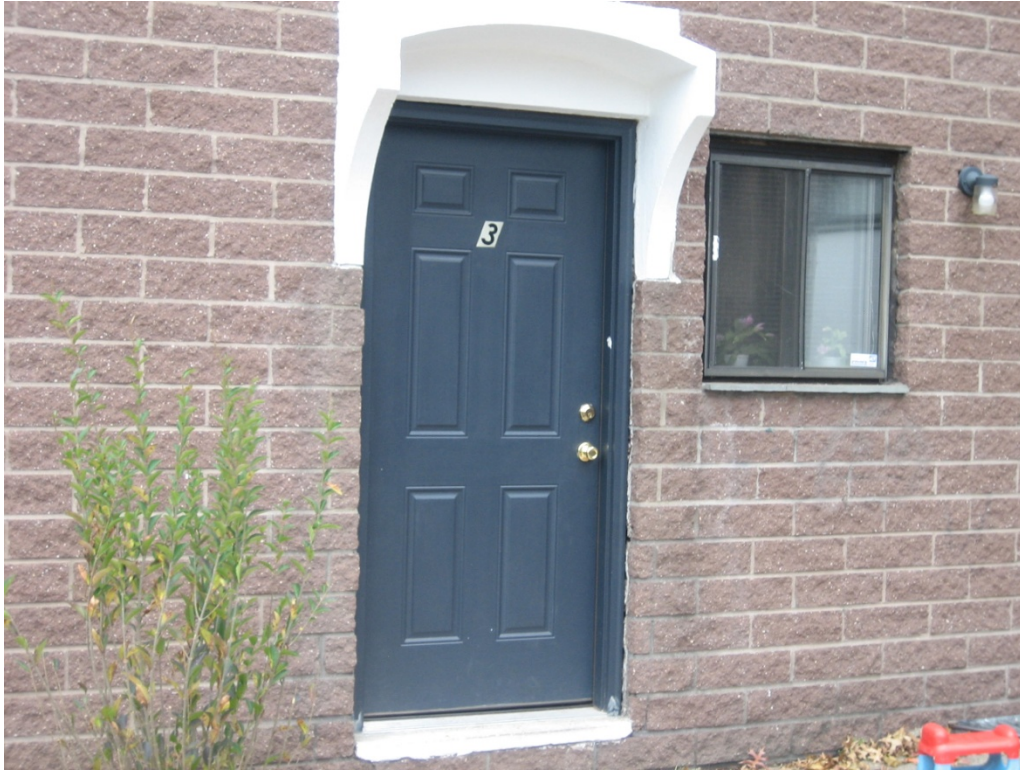
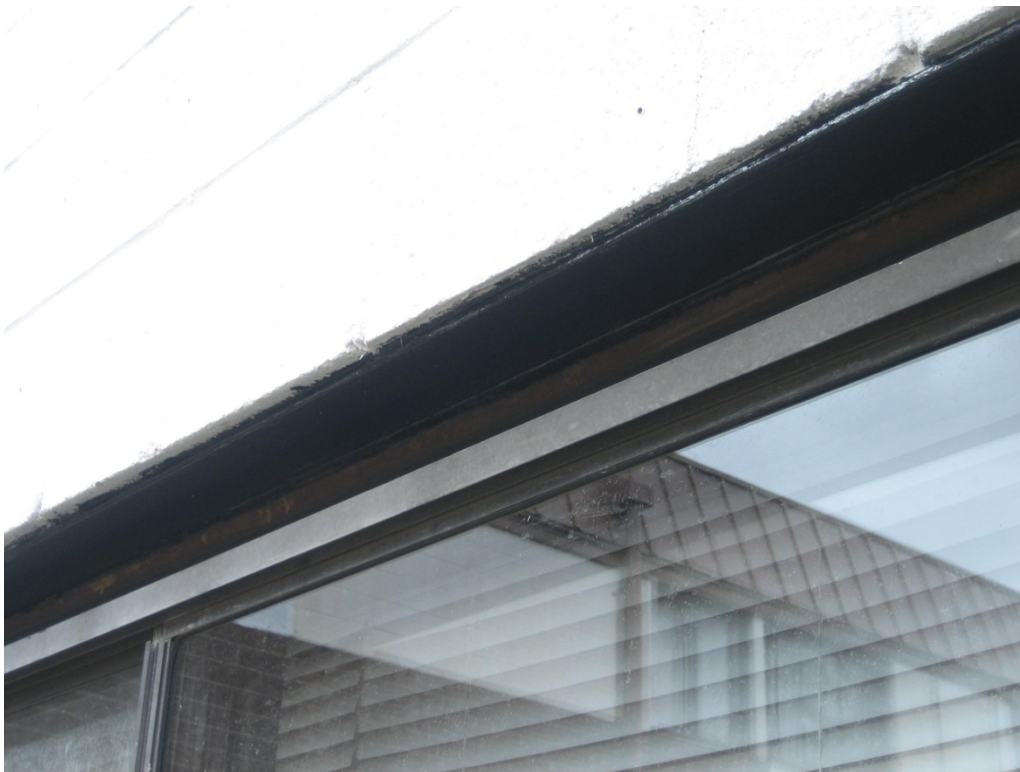
The majority of the apartment entry doors were replaced. All are scheduled to be replaced in the near future. window lintels were painted.

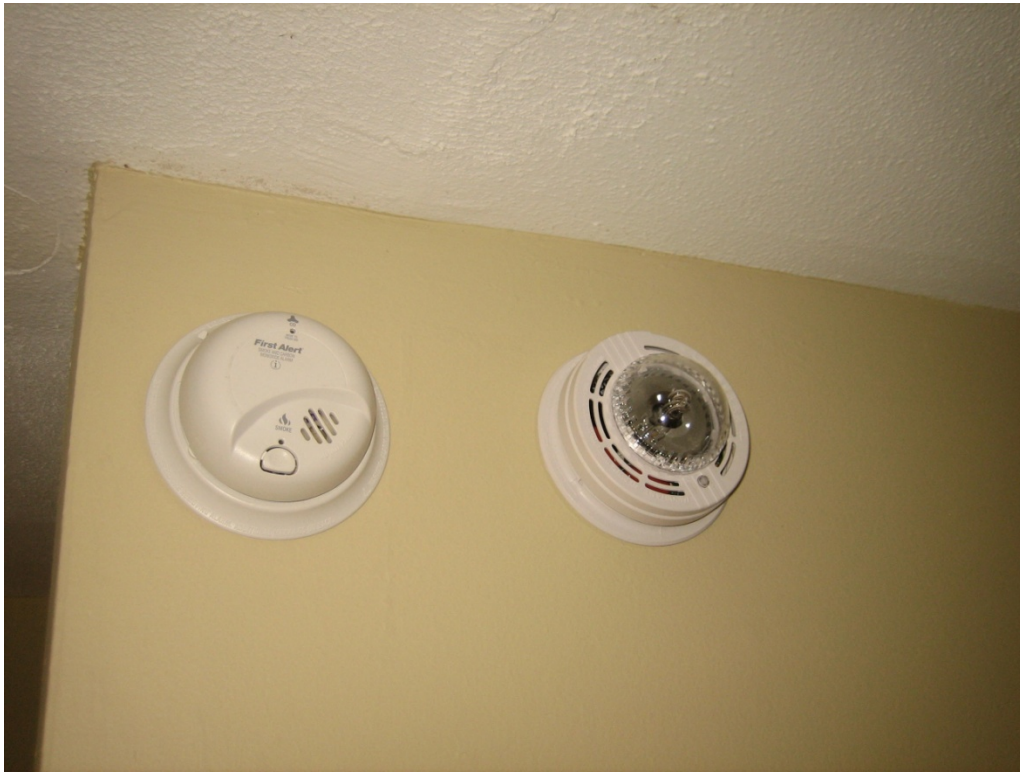
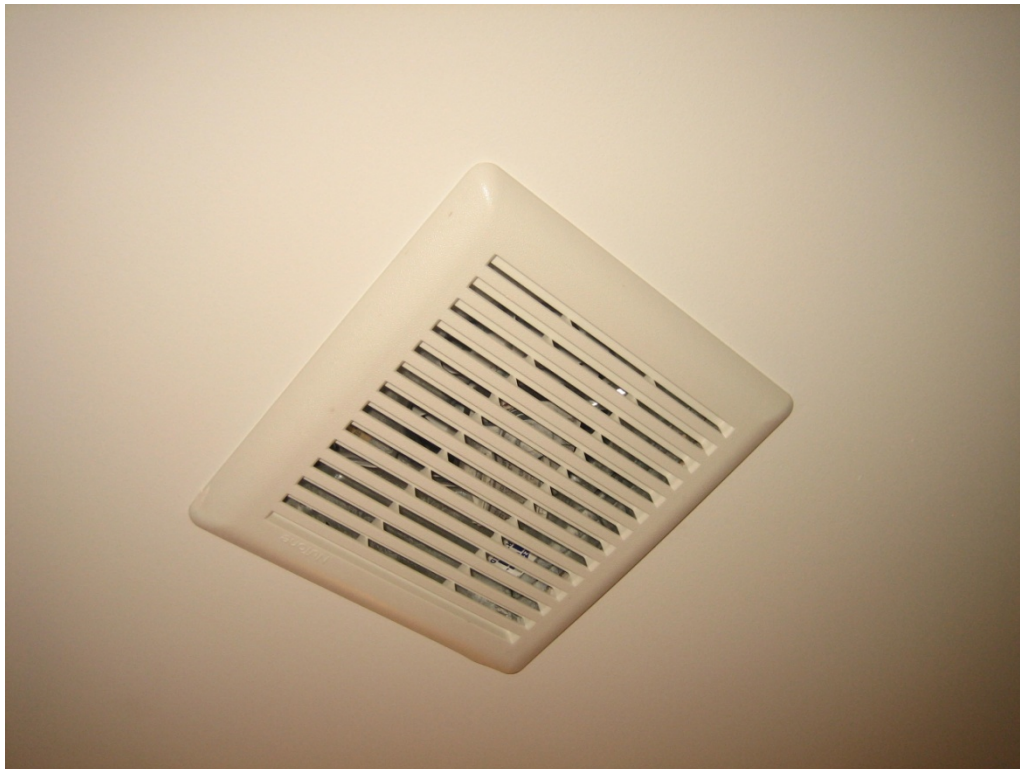
The smoke detectors were fitted with strobe lights in the hearing and vision impaired apartment. The exhaust fans were replaced in most apartment bathrooms.

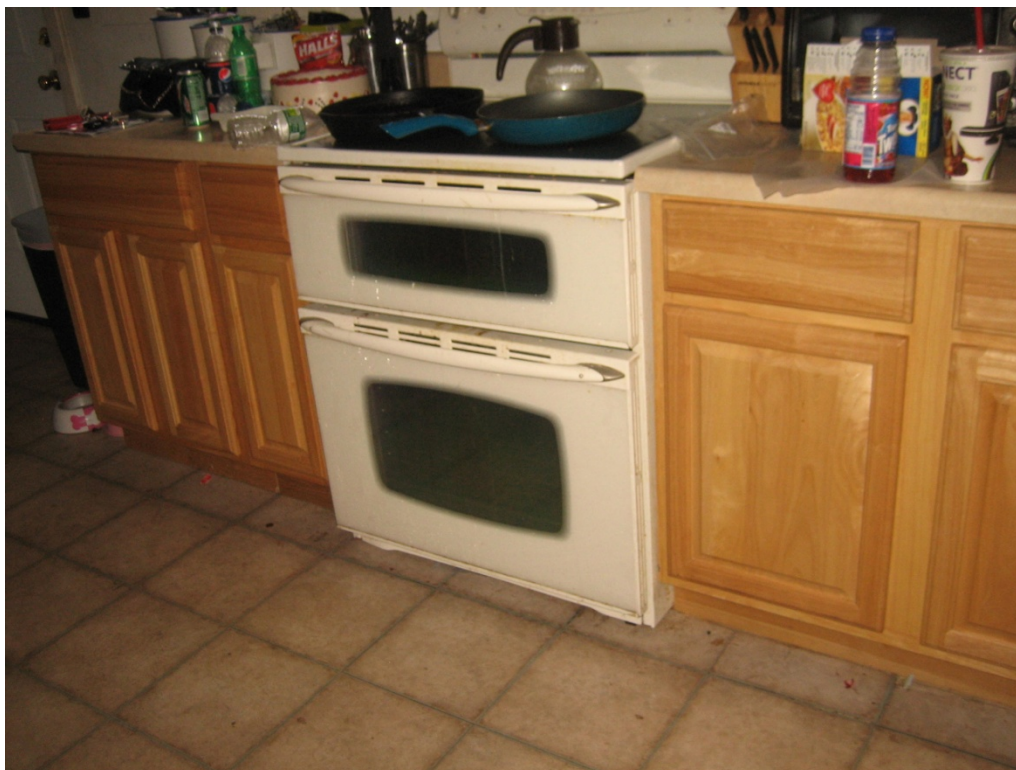
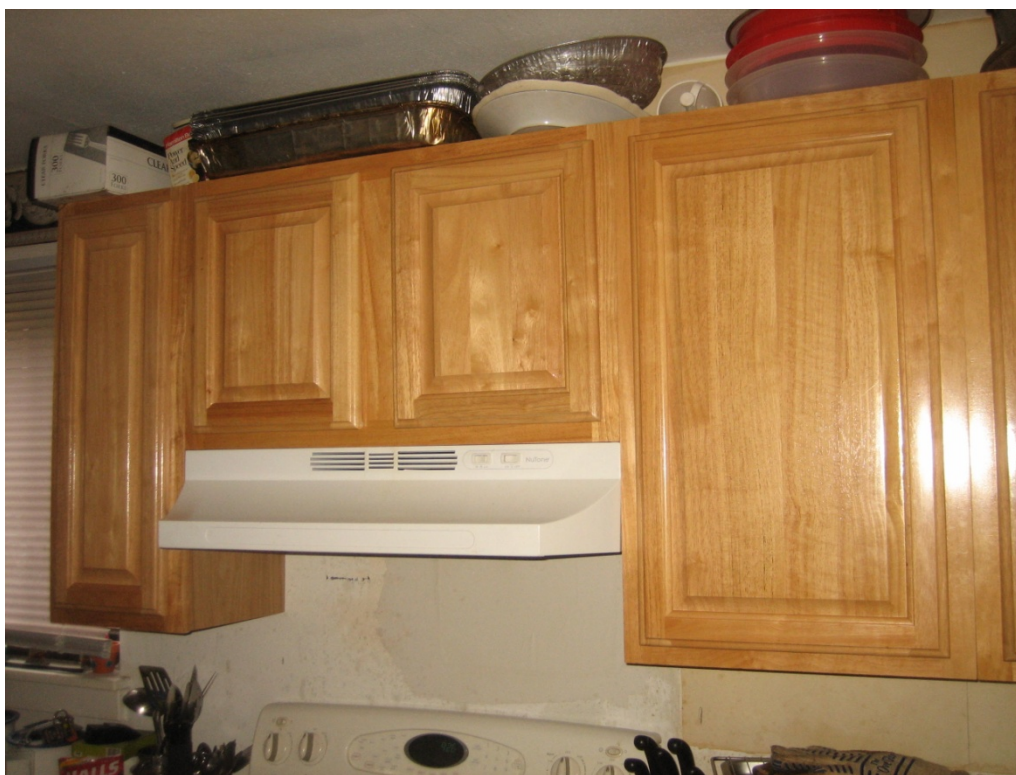
Most cabinets and appliances were also replaced.
