Facility Assessment

Sacred Heart Church,
New Haven, Connecticut
June 24, 2008

Prepared by:
Timothy J. Callahan AIA
Herbert S. Newman and Partners P.C.

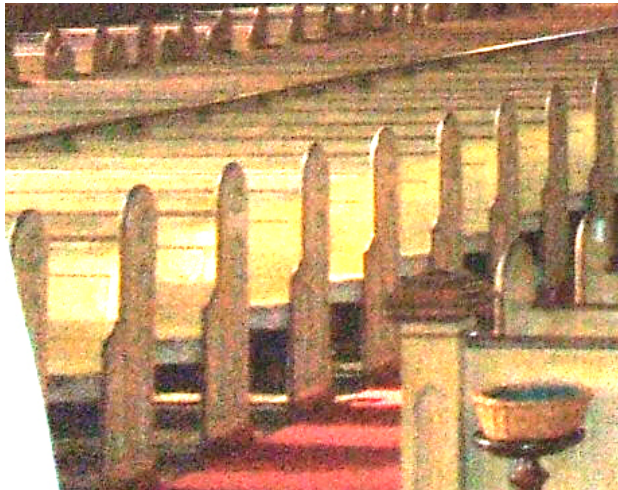
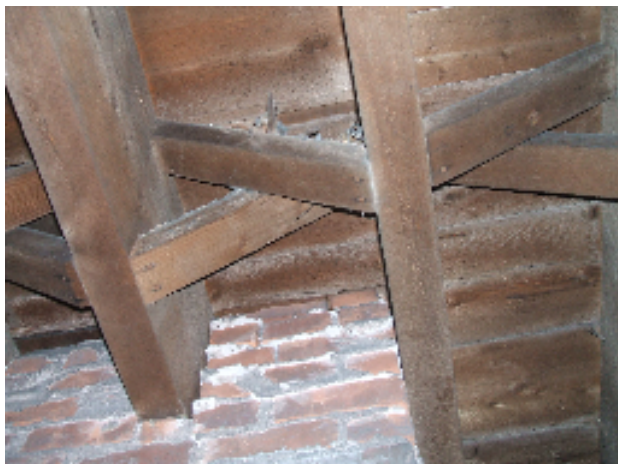
a. Floors

The floors of the church are wood construction bearing on masonry walls and piers. The altar floor is wood joists with plywood sheeting and carpet finish. The nave and transept are structural wood joist with plank flooring, carpeting in the aisles and exposed wood finish under the pews. The choir loft is wood joist with wood planking. The floor has several worn areas that have patched with plywood.

The flooring at the choir loft should be repaired. The floor patching should be secure at all areas. The wood plank floor should be patch and repaired. The carpet at the altar is worn and separating from the sub floor. The altar carpet could be replaced with thin set tile or wood flooring. The remainder of the floors may continue to function as they have in the past. Most improvements would be cosmetic in nature. The floor creaking could be solved by furring and anchoring the floor.

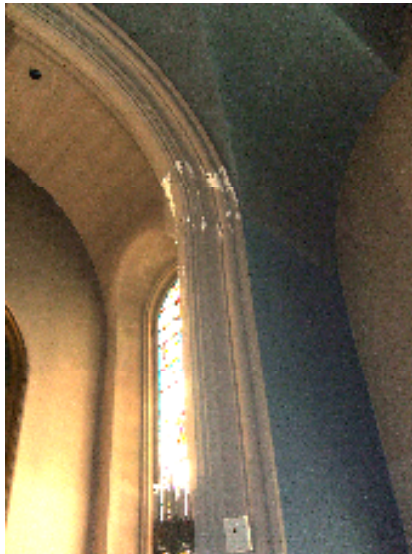
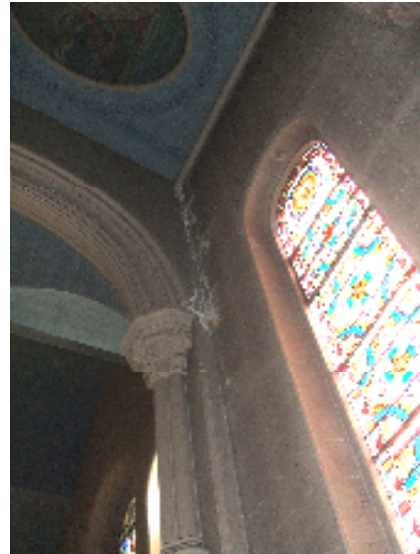
b. Walls

Most walls throughout the building are painted stucco walls. In a few areas there is visible cracking and spalling from what appears to be water infiltration. Throughout the building there is surface cracking that is characteristic of a building of this age. The paint surface has faded and discolored over time.

The interior wall should be patched, painted and repaired upon completion of the flashing, drain pipe and gutter improvements (see roofing description in next section Exterior Architectural Elements).

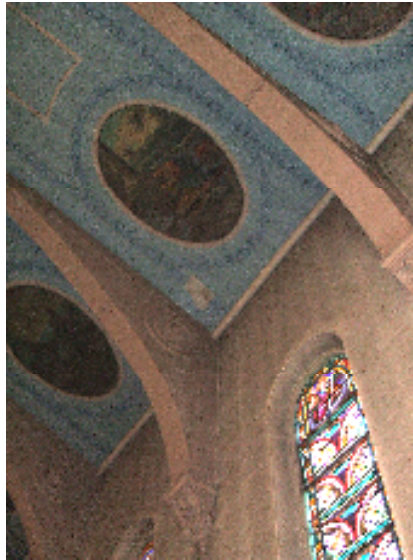
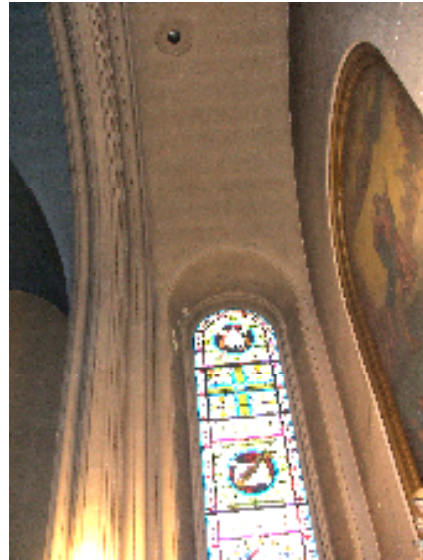
c. Ceilings

Most ceilings throughout the building are painted stucco. In some areas there is visible cracking and spalling from what appears to be water infiltration. Throughout the building there is surface cracking that is characteristic of a building of this age. The paint surface has faded and discolored over time.

The interior ceilings should be patched painted a repaired upon completion of the flashing, drain pipe and gutter improvements (see roofing description in next section Exterior Architectural Elements).

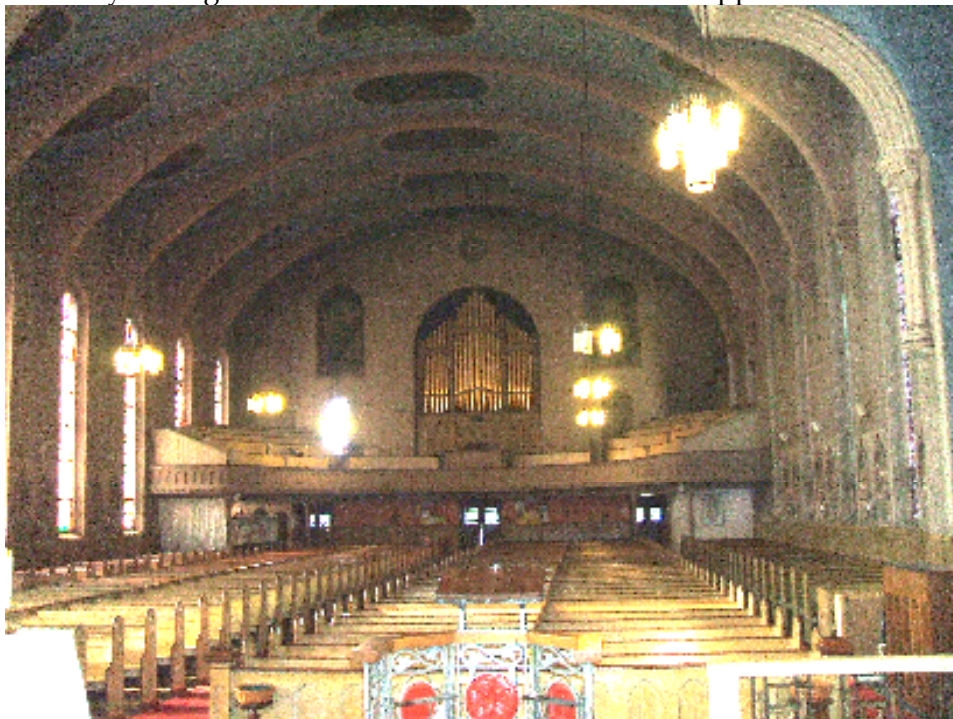
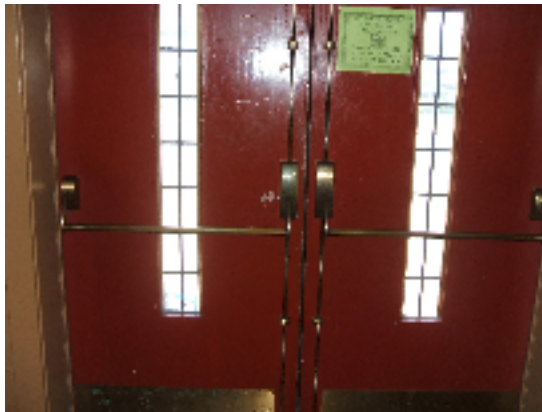
d. Exit Doors

The current arrangement of doors at the front and rear sides of the church provides a balanced egress pattern. Parishioners can exit from behind the altar, at each transept and at three locations in the narthex. The hardware is currently exiting crash bars. The doors are not handicapped accessible.

At this time the local fire marshal has reviewed the egress plan and there are no requirements to add egress doors or change the exit hardware. The panic hardware could be updated to meet the current code at the discretion of the parish.

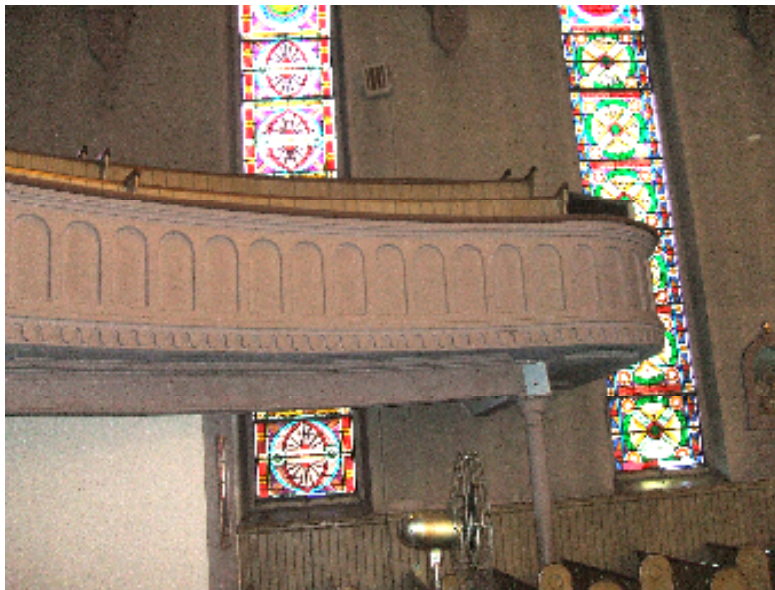
e. Millwork and Pews

Most of the woodwork at the pews, altar and balcony show signs of age and wear. Most of the surface damage is due do exposure to sunlight and physical contact. The railing at the balcony does not meet current railing height requirements.

Any improvements would be cosmetic in nature. Any of these improvements and upgrades would be at the discretion of the parish.

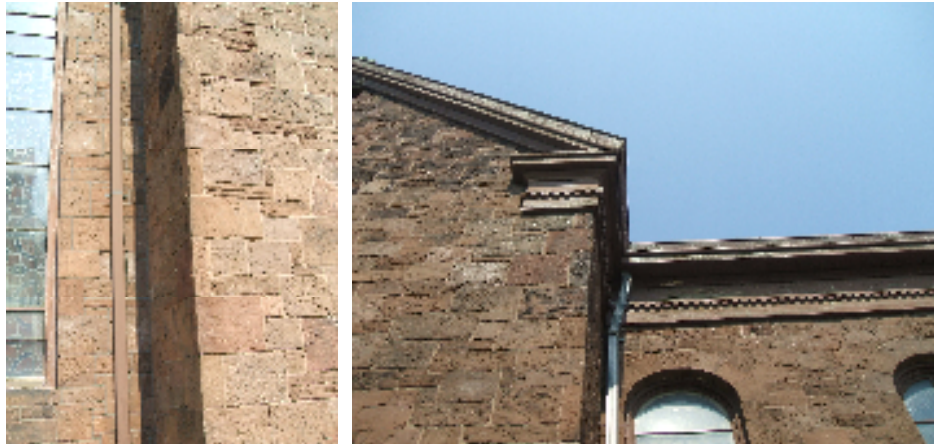
a. Exterior Wall

The exterior wall is a bearing wall of solid masonry construction. The stone is rough cut brownstone with concrete mortar at the joints. The condition of the stone is excellent. It appears the building was re-pointed from the transept joint to the front façade. The transept and the back altar wall have visible gaps and cracks at the mortar joints

The exterior walls should be re-pointed at the transept and altar walls. The nave and narthex have been re-pointed and do not need this work at this time.

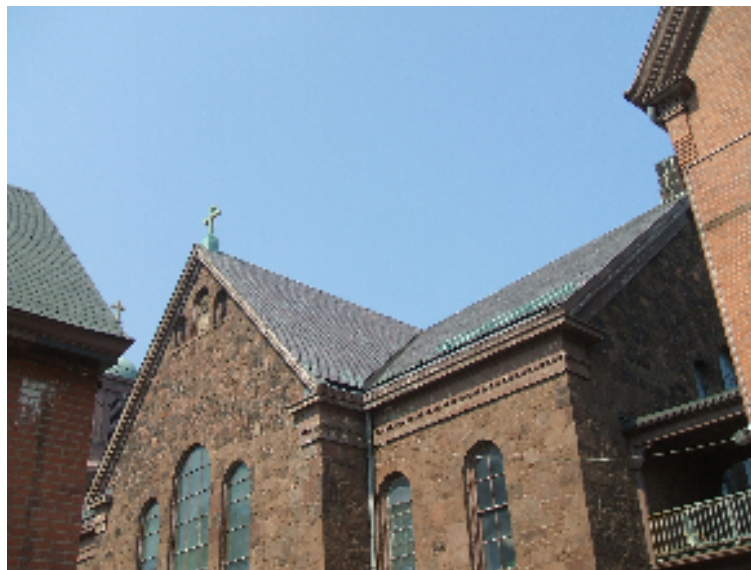
b. Roofing

The roofing is slate with steel and copper flashing. The gutters are integrated into the roof and the downspouts are mounted to the exterior. There are visible signs of water infiltration at the gutters and down spouts. This appears to be within the gutter lining at the transition joints at the transept. There is also water infiltration at the flashing on the chimney transition at the back altar wall.

The roofing should be surveyed more extensively to determine the extent of the leakage. It appears that most of the leaks are at the gutter transitions and at the flashing joints. We recommend re-flashing all of the integrated gutters, and re-flashing at the existing transitions. A survey should be done of the copper roof and flashing at the cupola.

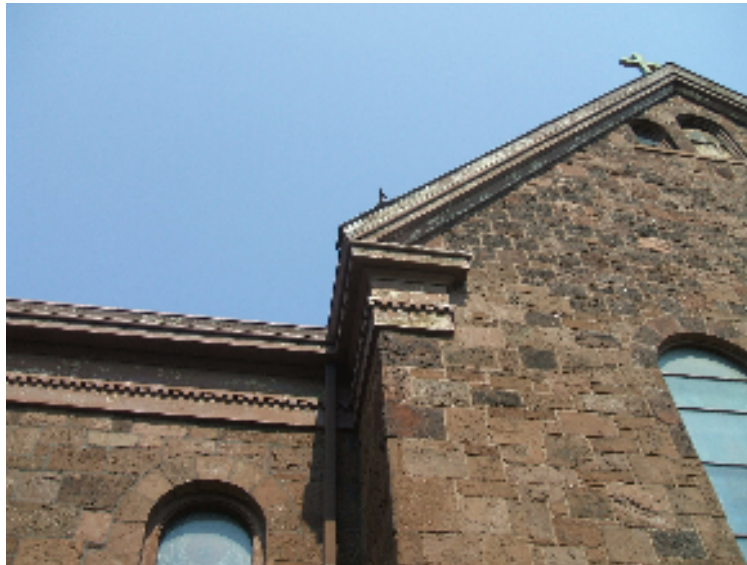
c. Wood Trim and Windows

The exterior windows have wood sills, jambs and heads. The paint is peeling and cracking and the wood is exposed. The wood trim at the cupola and

fascias is also peeling and cracking and the wood is exposed in some areas. The exterior window could be replaced with double glazed low-e glass to improve heat loss.

All of the exterior wood should be scraped, patch, repaired and painted.

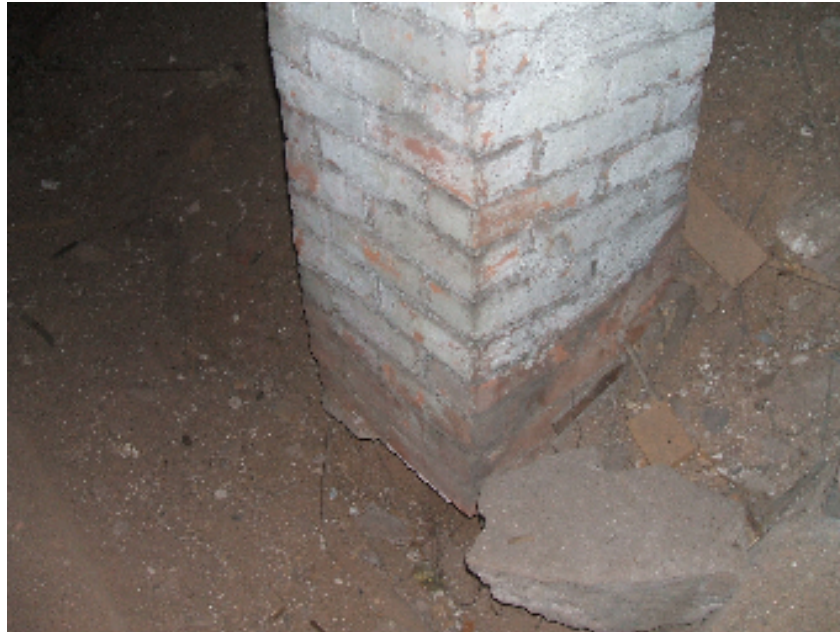
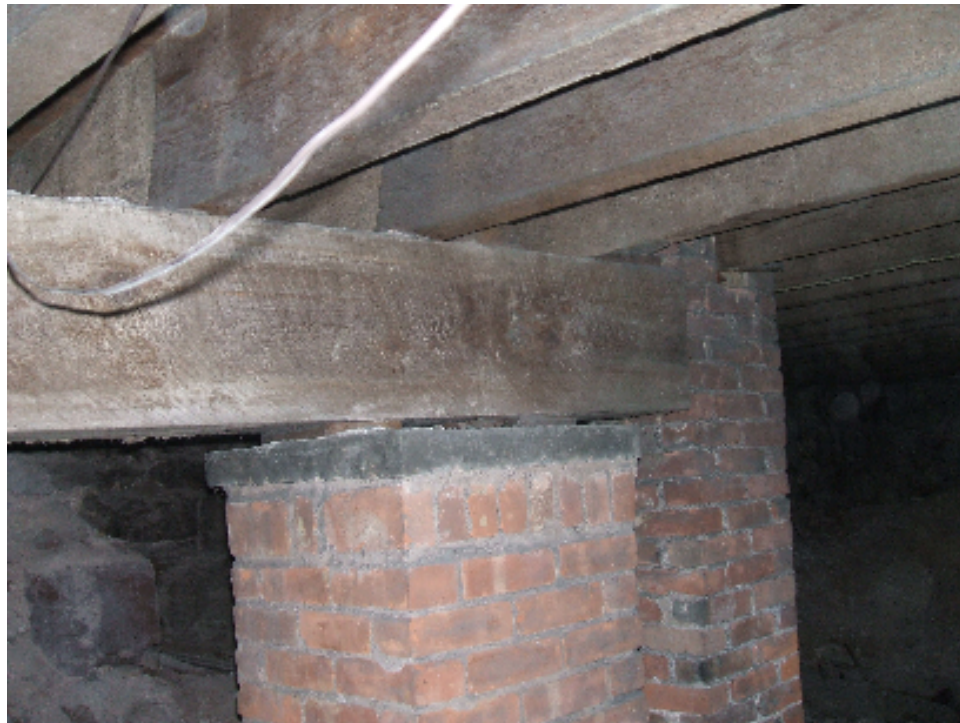
b. Masonry Brick Piers

The brick piers should be examined more closely. From the visual inspection it appeared that one of the piers had an exposed footing at the connection of the transept.

The brick pier at the transept should be further investigated by a structural engineer. It appears that a new concrete footing will need to be poured.

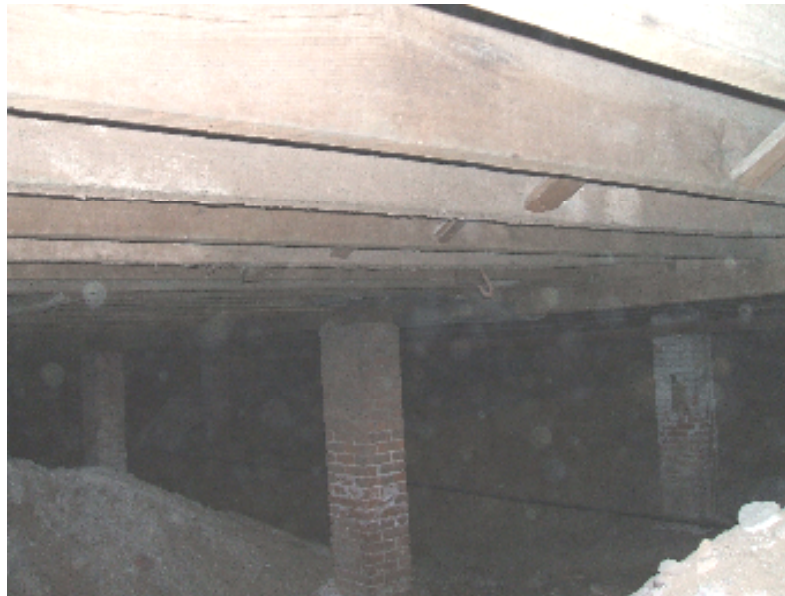
d. Wood Joist Floor Construction

The wood joists and floors are plumb and the bridging ties are secure. From our limited observation there was no water infiltration and the wood was dry and insect free. The church was recently inspected by an exterminator.

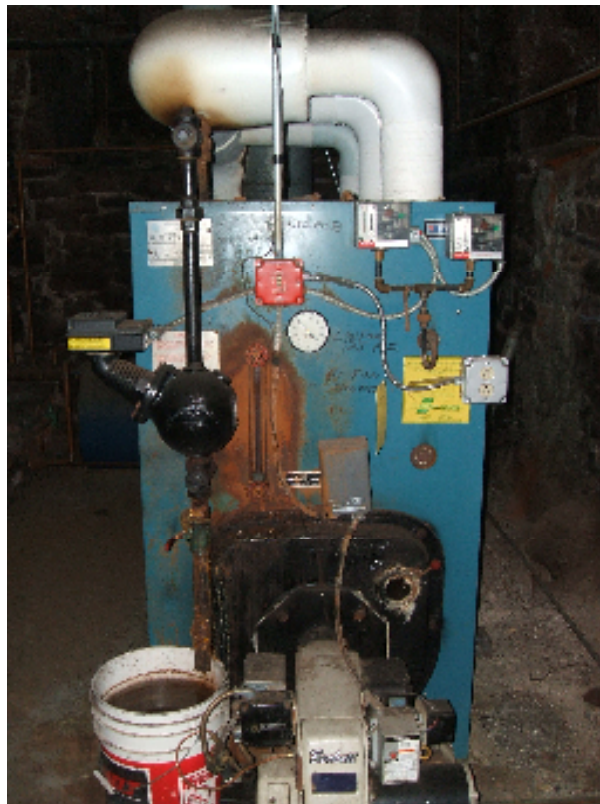
b. Boiler

The building is heated with an oil fired furnace. The boiler was replaced approximately ten years ago.

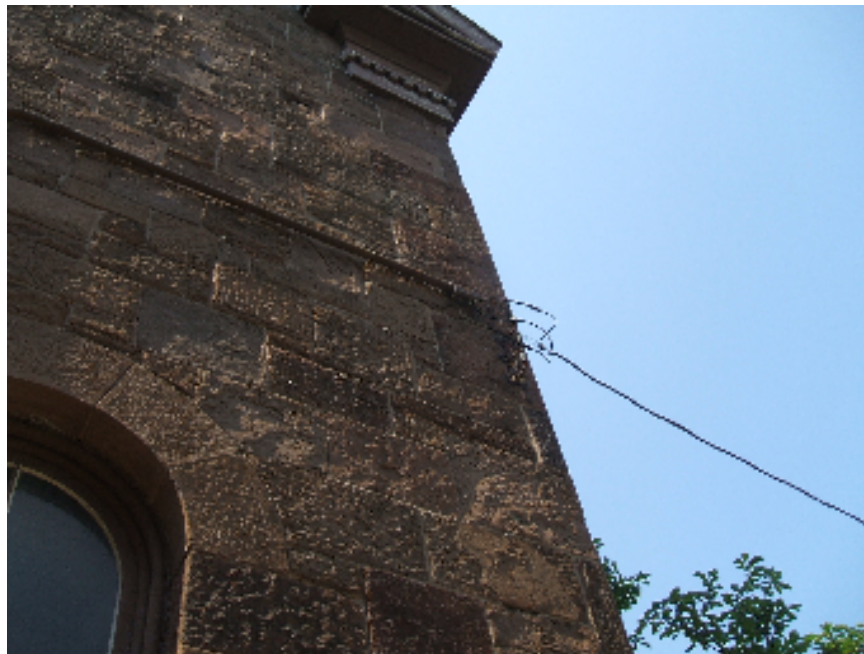
b. Electrical Utilities

The electrical utilities run to the back of the church though overhead service. The utility connection should be upgraded with the proper shielding.

It is recommended that an electrical engineer review the service, and utility connection and make a final recommendation.
