## 71 SHELTON AVENUE – NEW HAVEN, CT

### RADIOACTIVITY AIR SAMPLING REPORT DECEMBER 21, 2019 – JANUARY 17, 2020

STATUS OF WORK PROGRESS

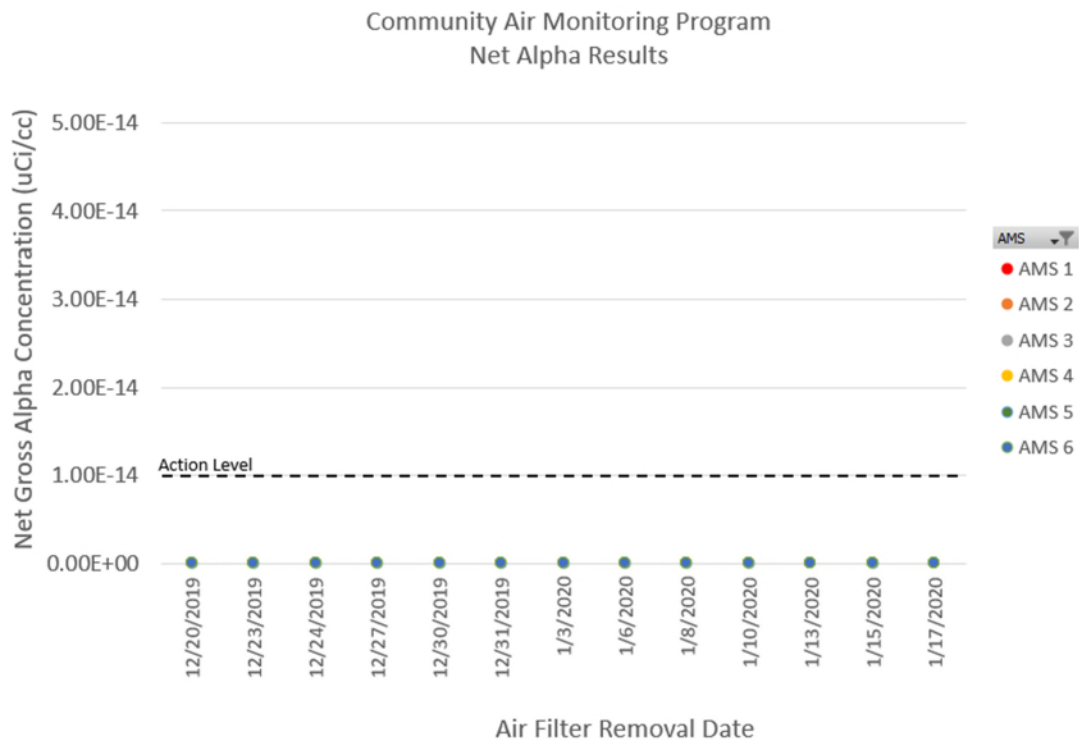
GRAPH 1 – Net Alpha Results from the Community Air Monitoring Stations

From December 21, 2019 to January 17, 2020, there were no monitoring results that were higher the Action Level. The specific site/project conditions associated with the project (e.g., work activities and locations on that day, wind direction, dust controls, data from the other monitoring locations) were reviewed (Table 1) and there were no activities which should have caused an airborne release.

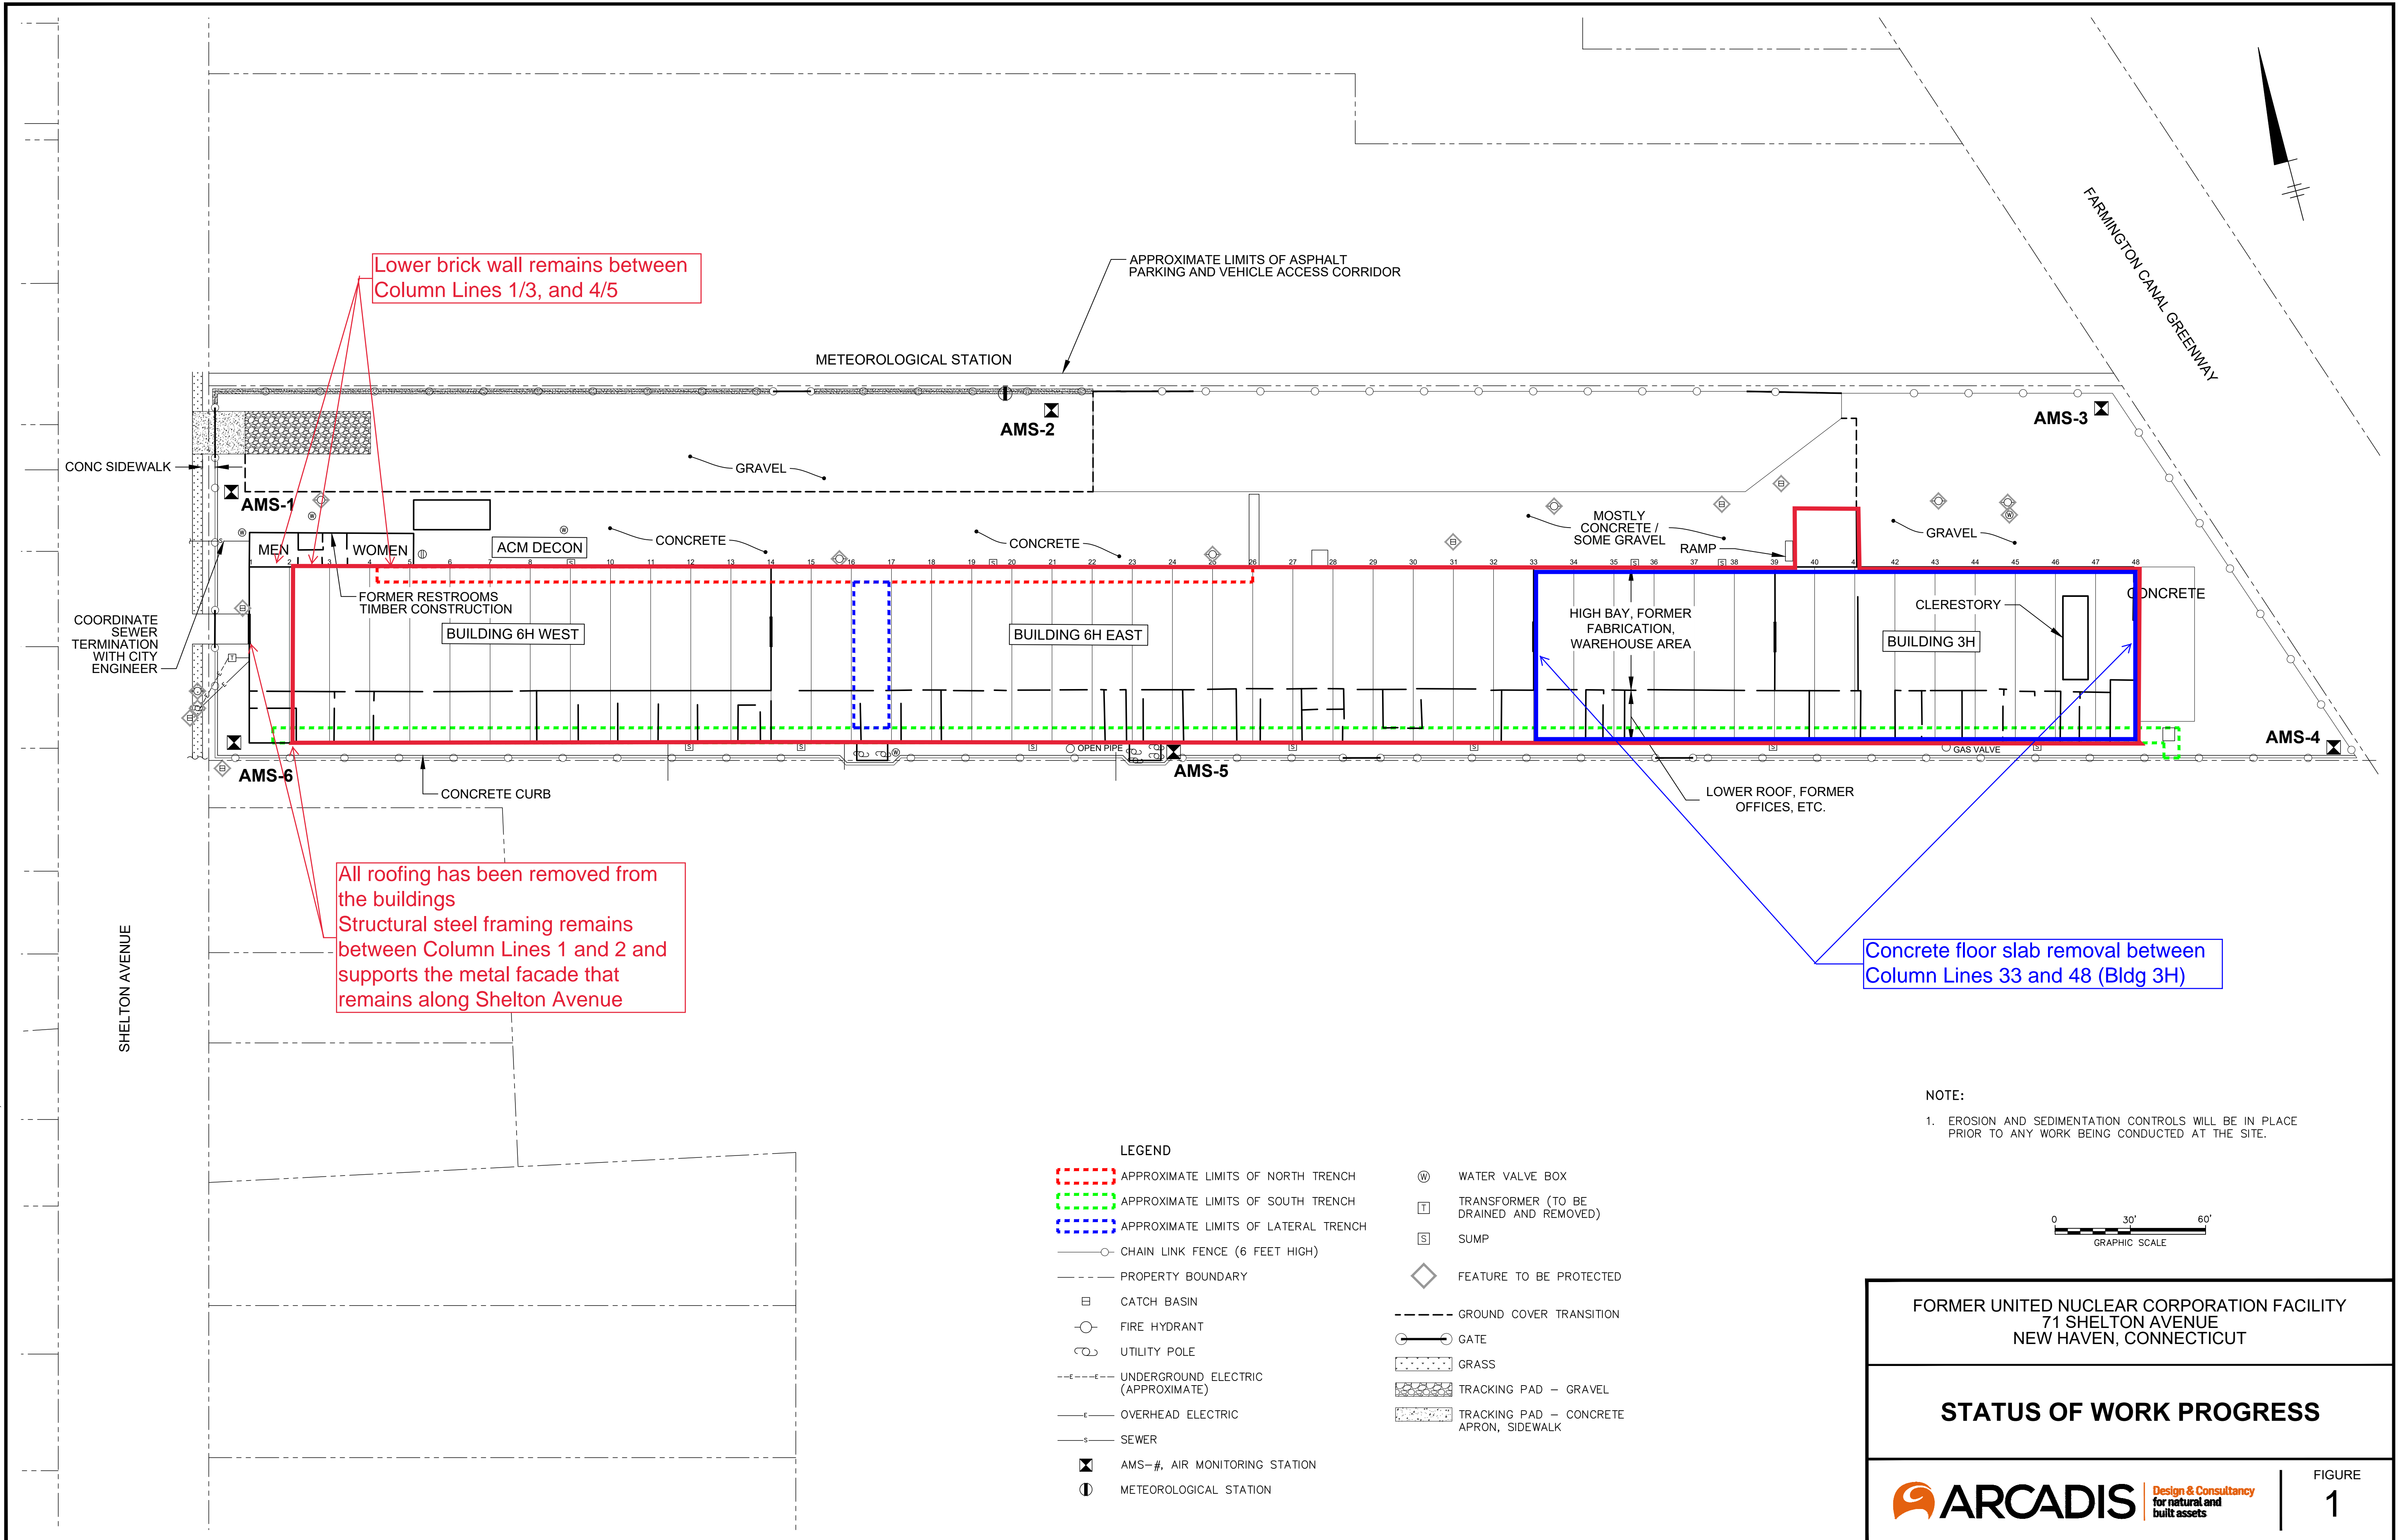
FIGURE  
1

Lower brick wall remains between Column Lines 1/3, and 4/5

All roofing has been removed from the buildings  
Structural steel framing remains between Column Lines 1 and 2 and supports the metal facade that remains along Shelton Avenue

Concrete floor slab removal between Column Lines 33 and 48 (Bldg 3H)

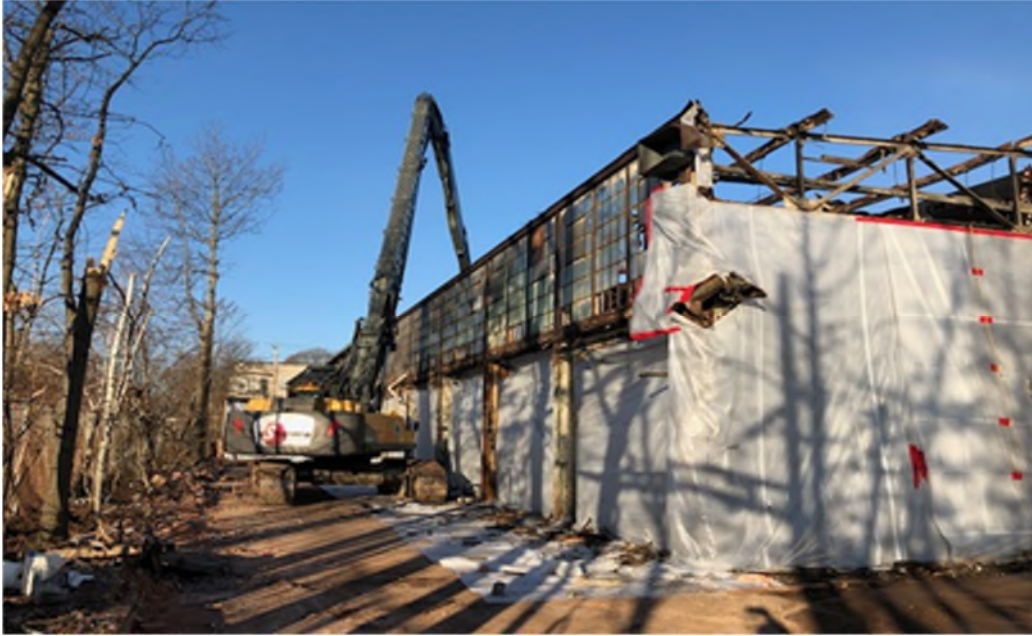
SWC removing roof on southern half of the main building between Columns 14-5.

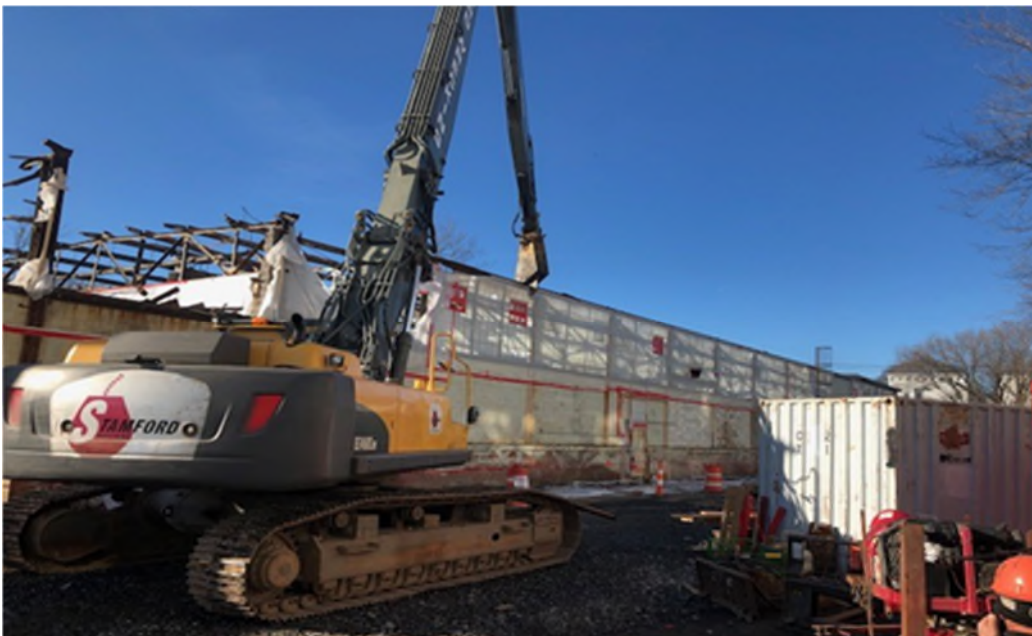
View of window removal.

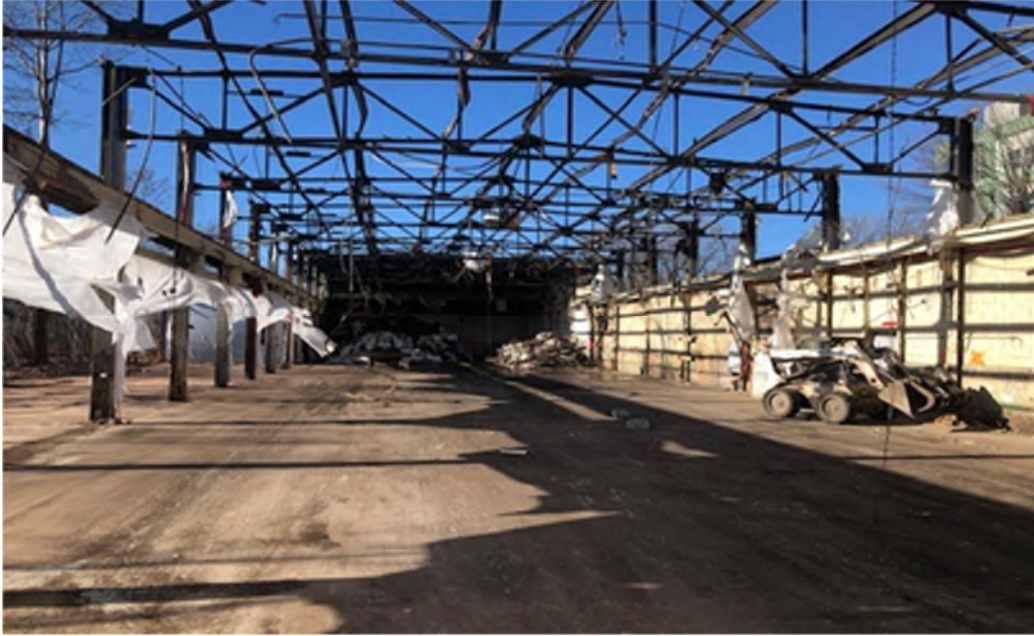
**View following window removal.**

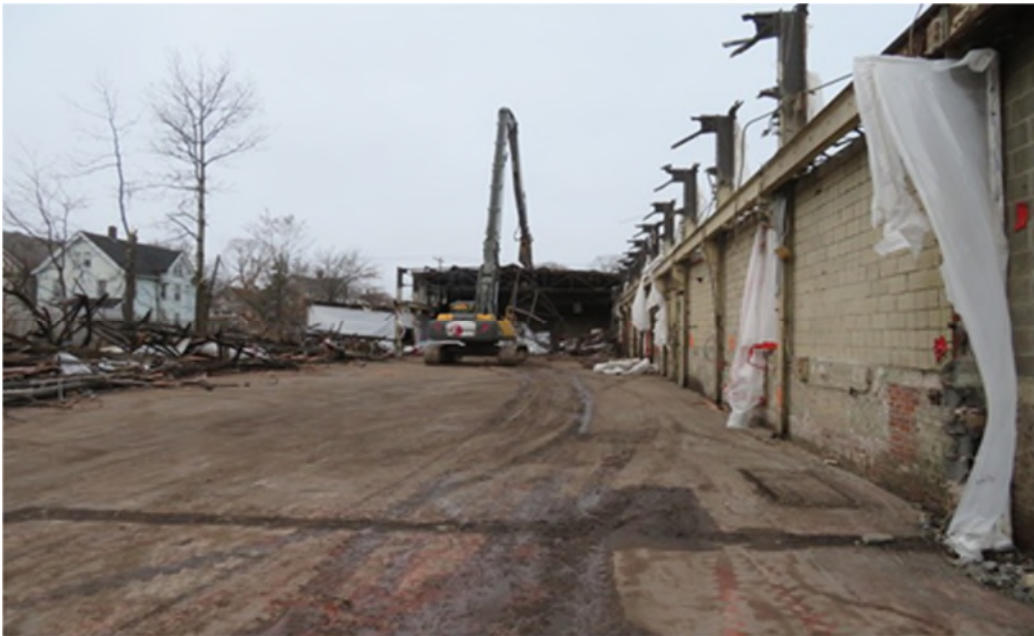
**SWC removing steel rafters from columns 14-5.**

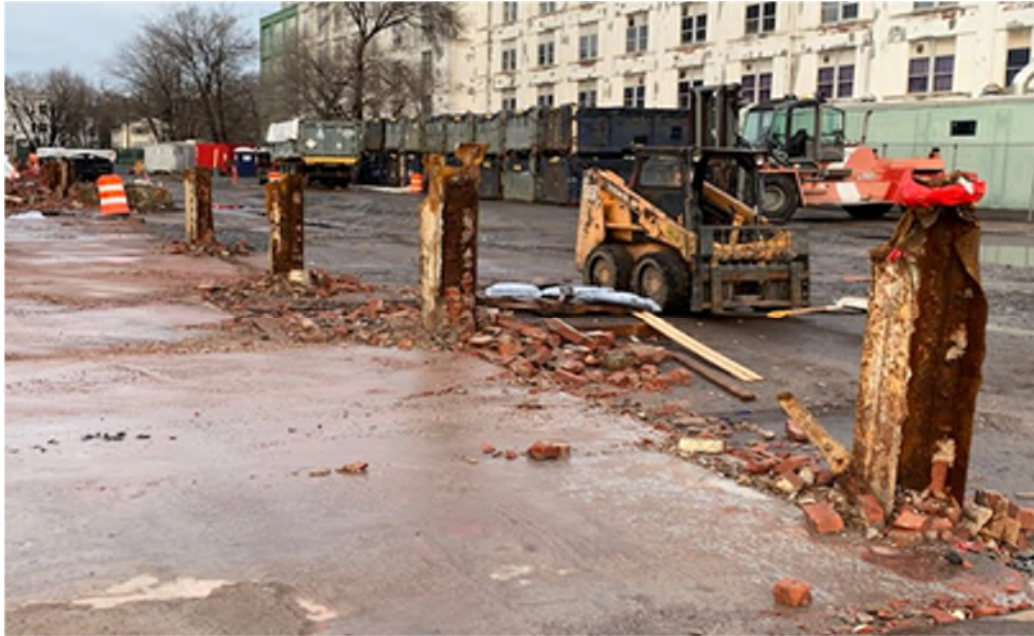
**View of SWC removing remaining knee-wall at column 33.**

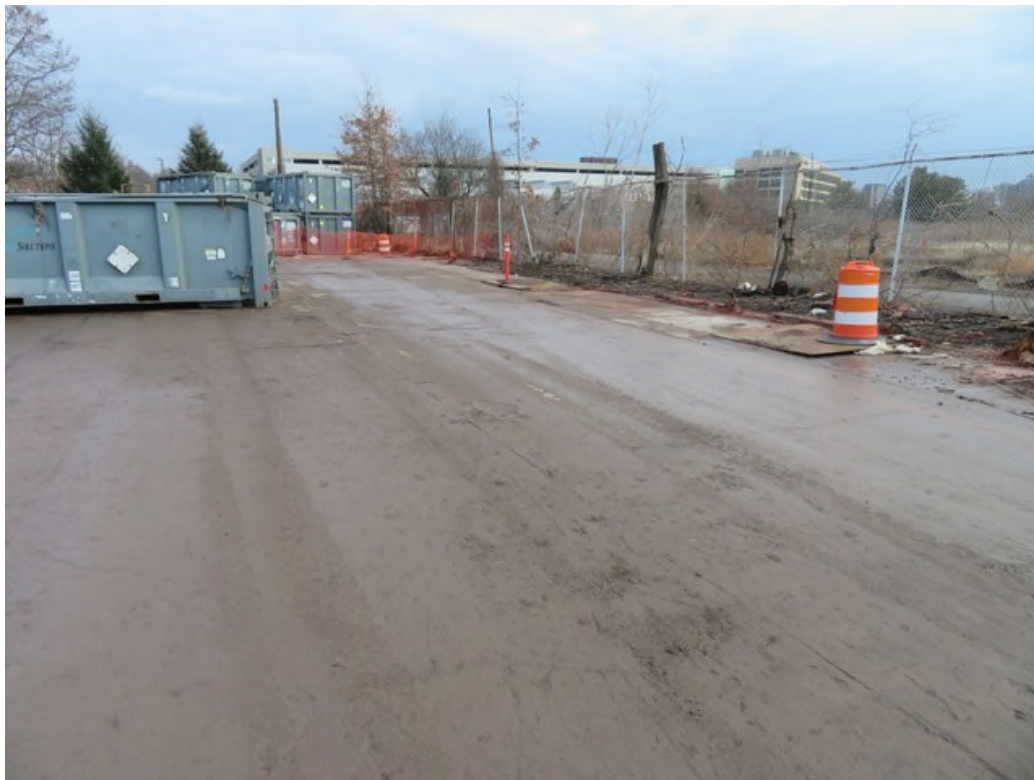
**View of slab cleaning.**

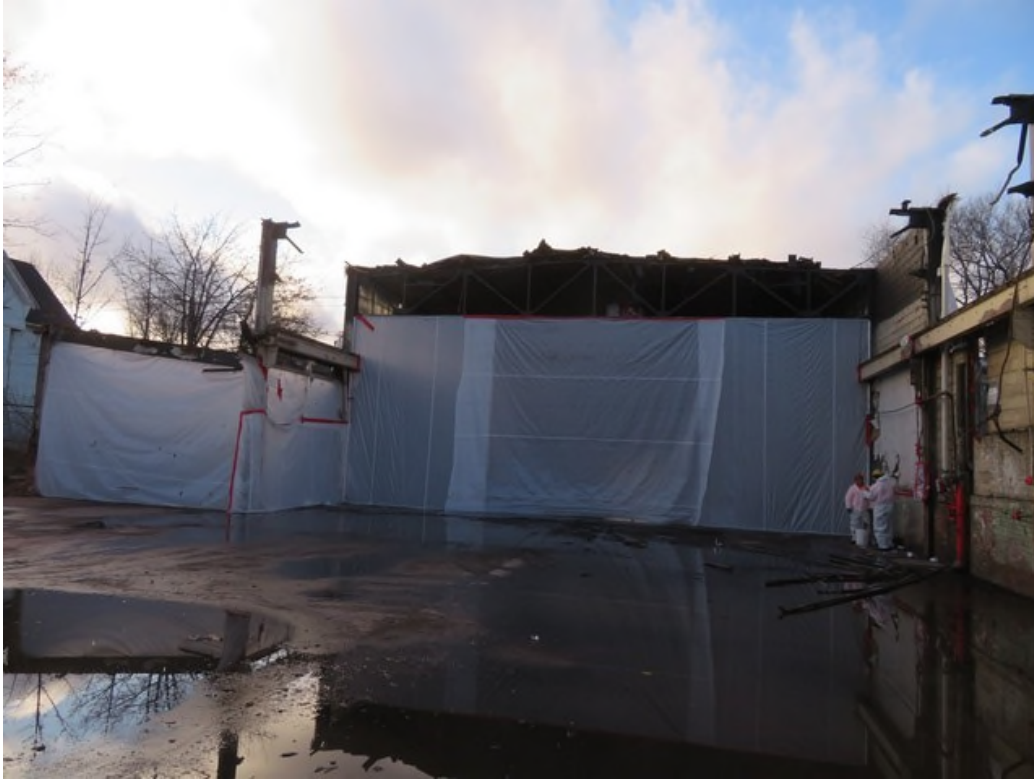
**View of critical barrier installed at column #5 for remaining roof debris removal.**

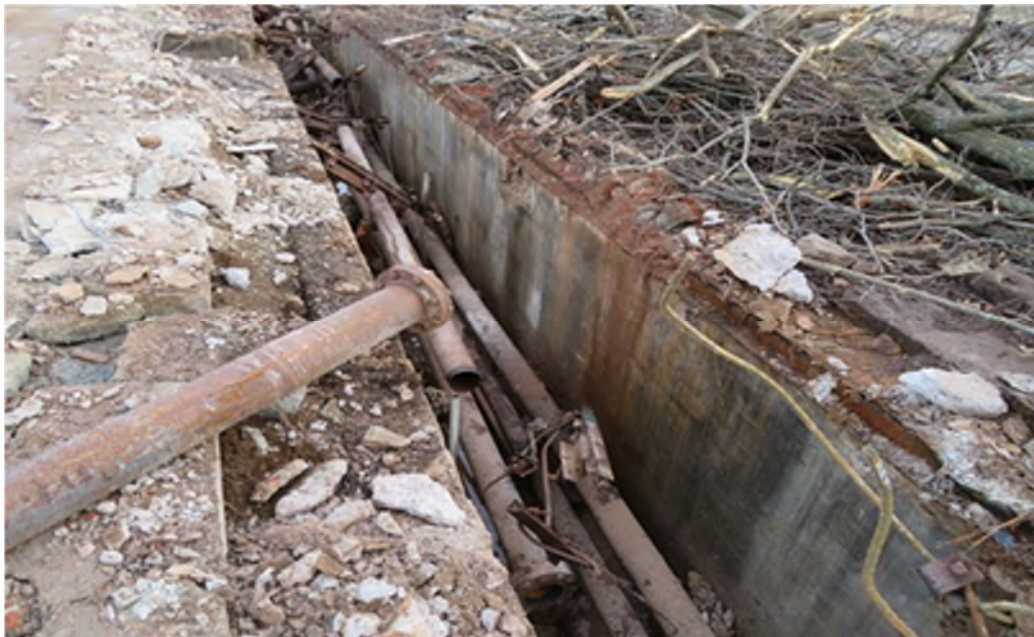
**View of pipes inside southern trench.**

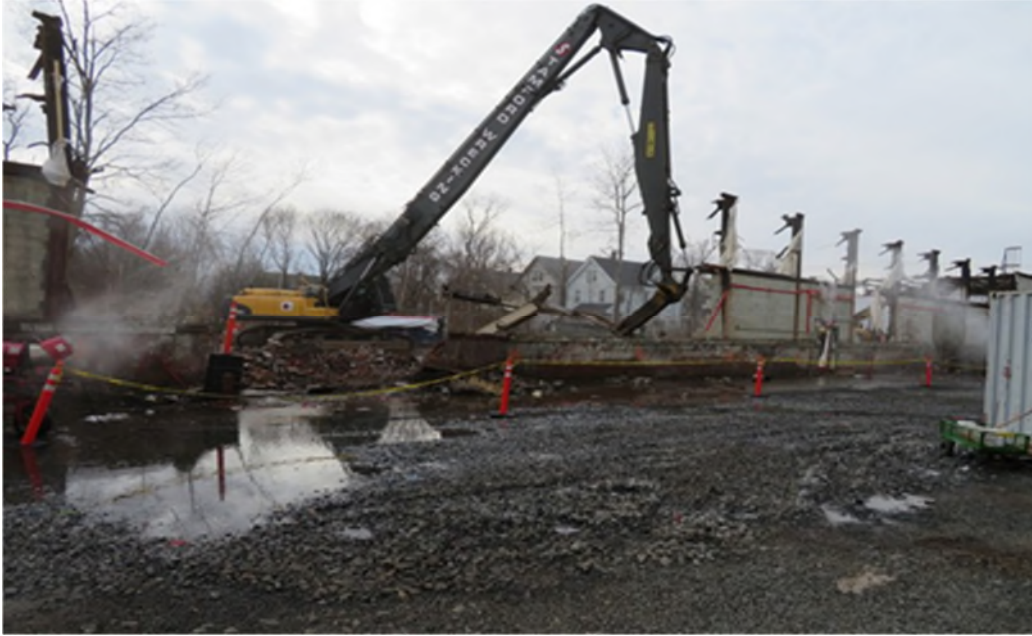
**SWC removing northern wall.**

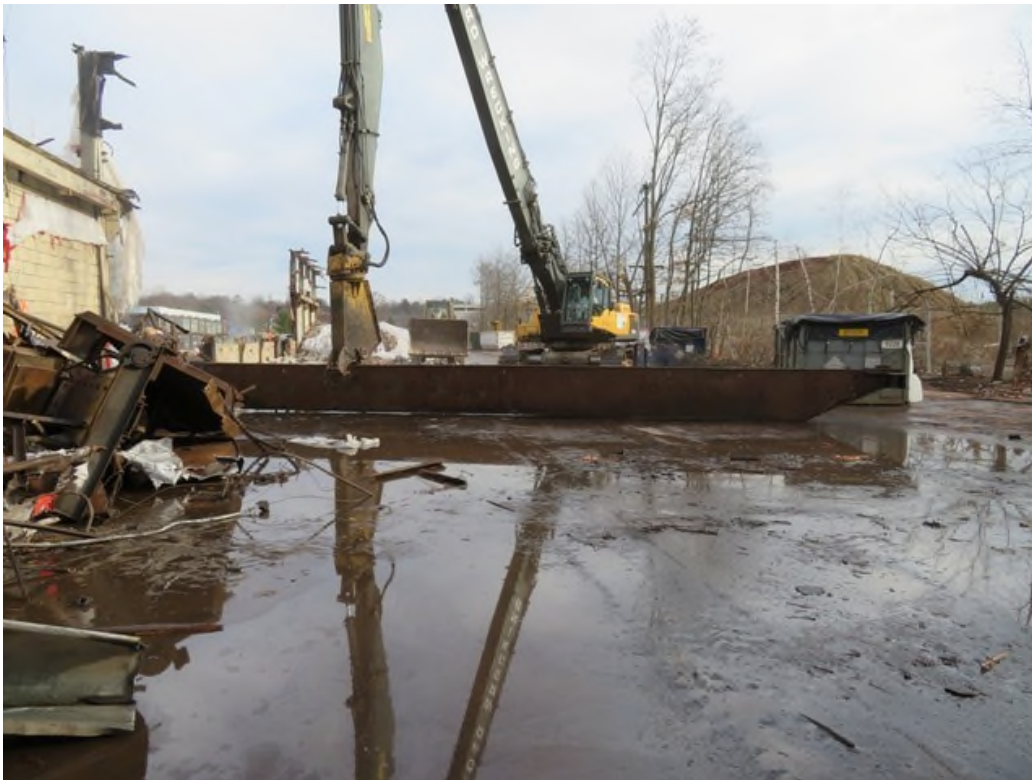
**SWC cutting large crane for loadout.**

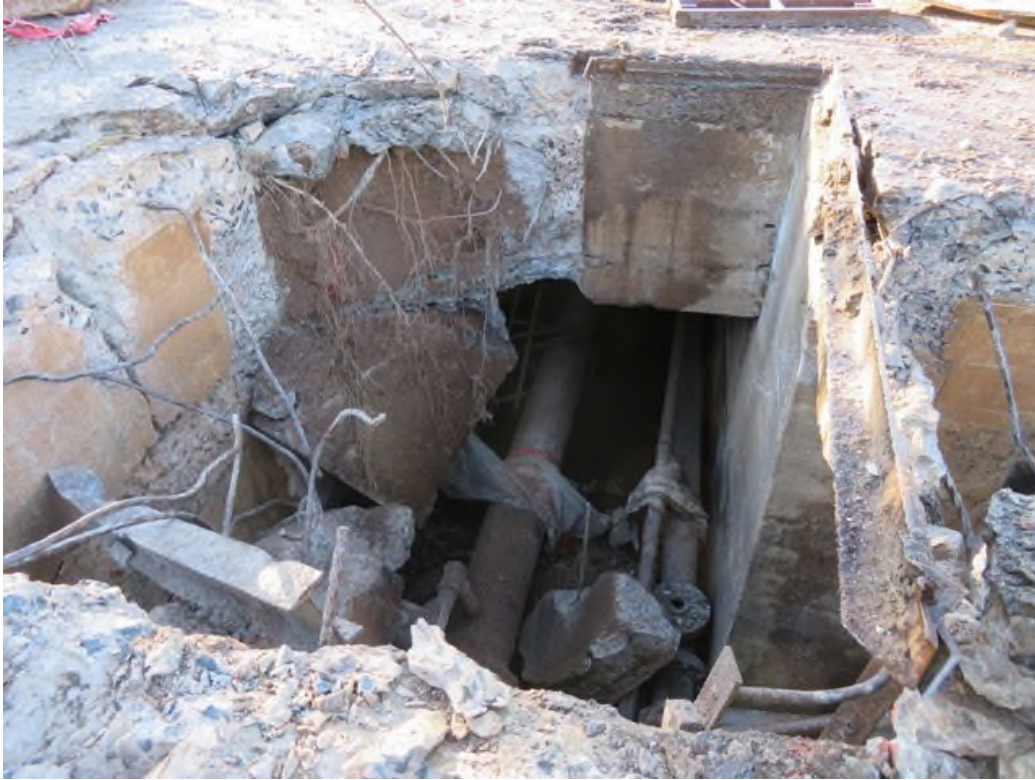
**View of deep tunnel looking south towards Argyle St.**

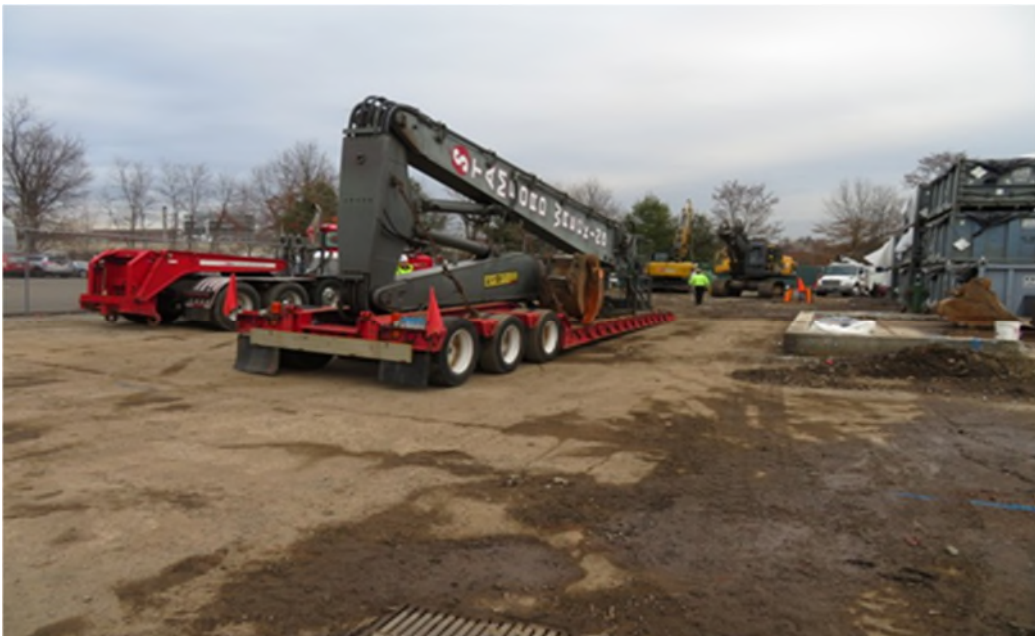
**View of high reach excavator being disassembled.**

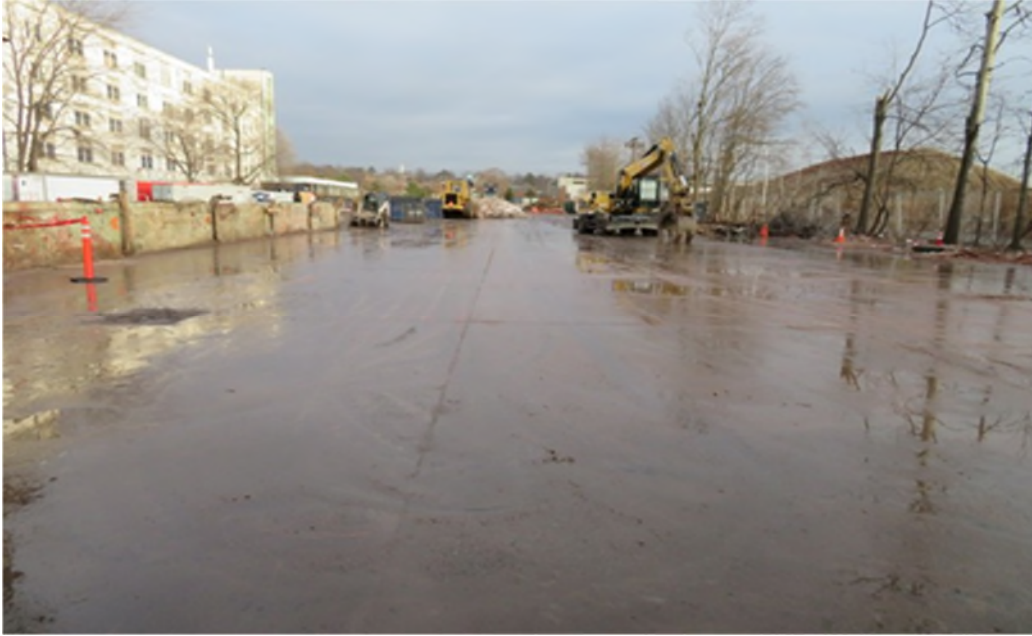
**View of concrete slab at column 1 looking east.**

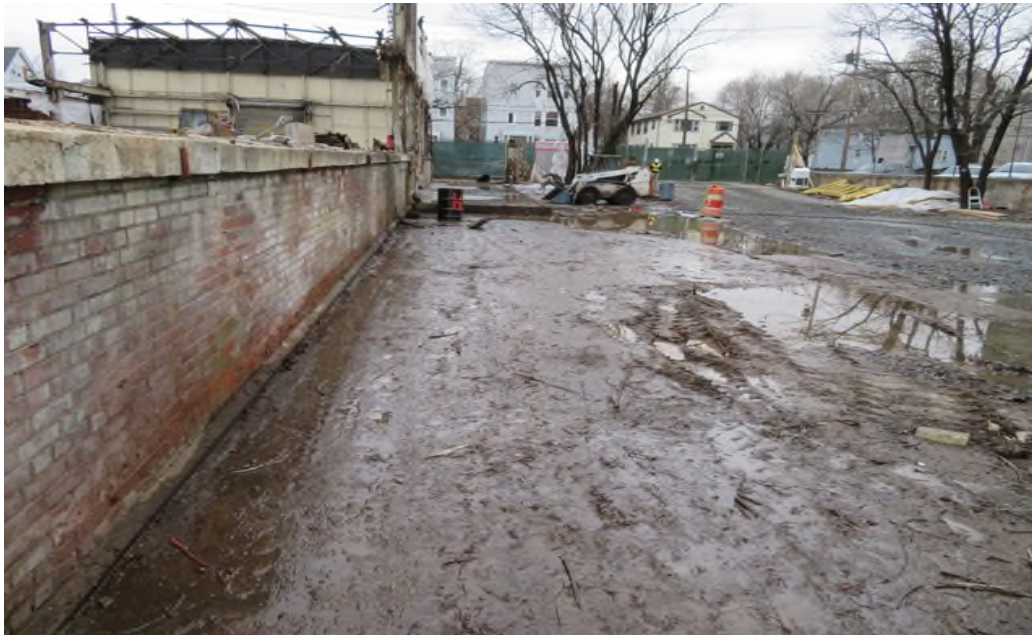
**View of area north of Building 6H following removal of bathroom/addition on the north.**

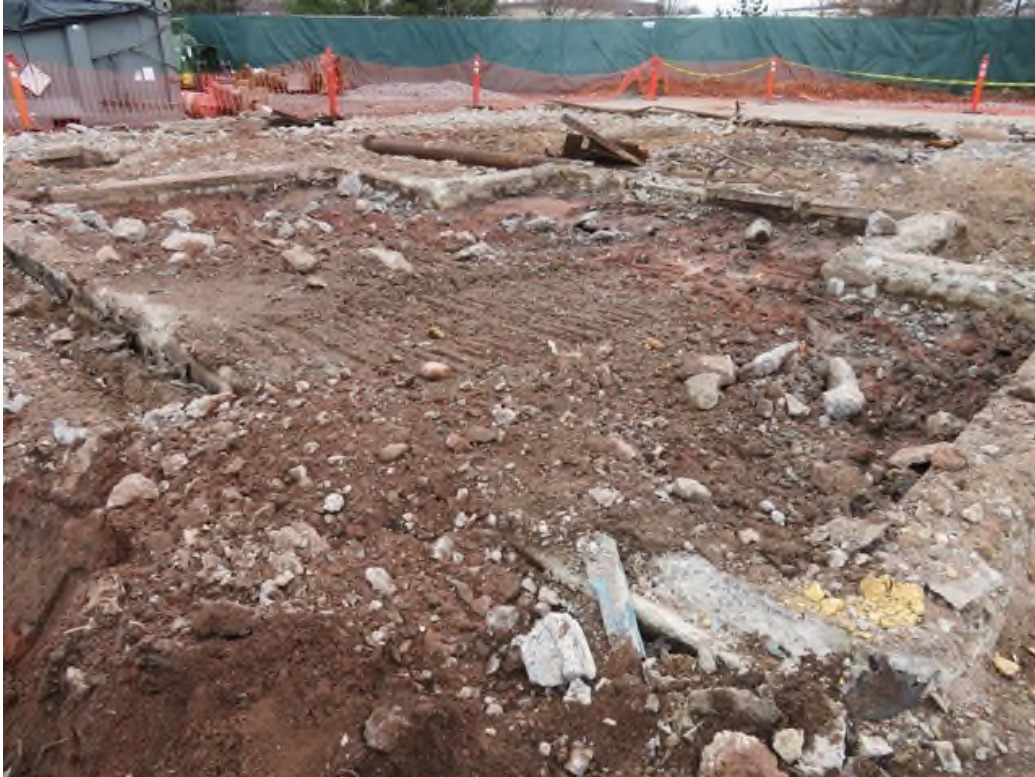
**View of interior foundation walls below the slab in Building 3H.**

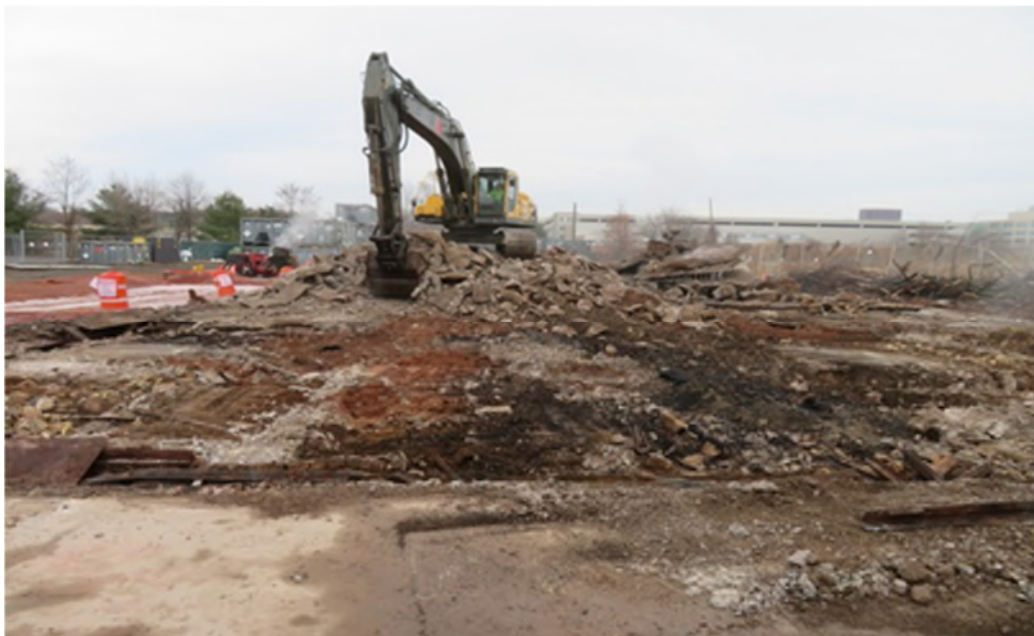
**View of concrete slab removal at column 33 looking east.**

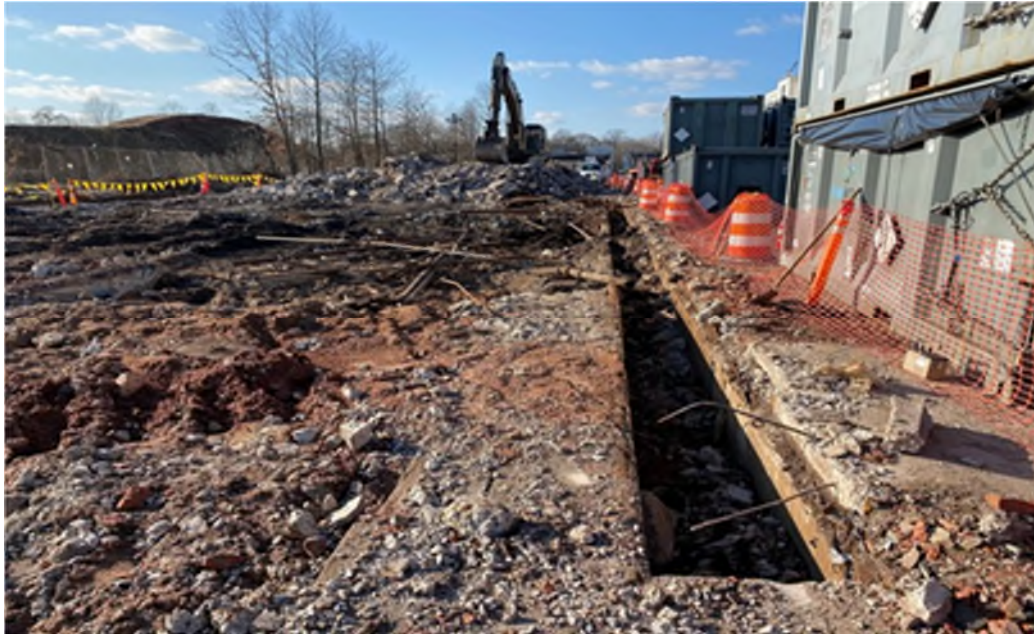
**View of pipe removal in the north trench from column 48-40 looking west.**

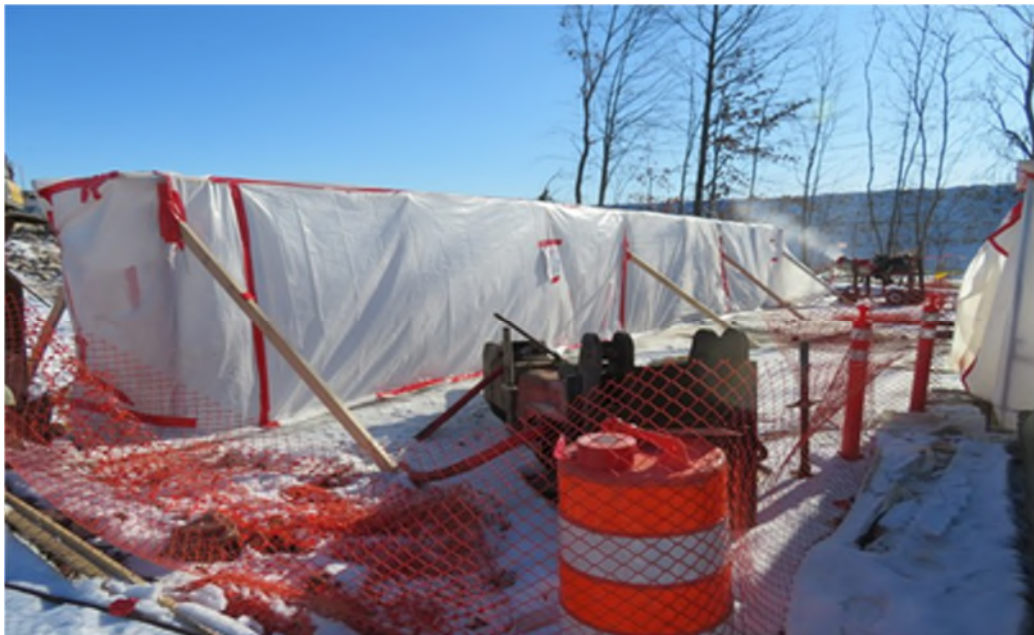
**View of scaffolding frame assembled over ACM material in trench at column 33.**
