FUSS & O'NEILL

RE: Barnard Magnet School - HVAC Mechanical Assessment Final Report

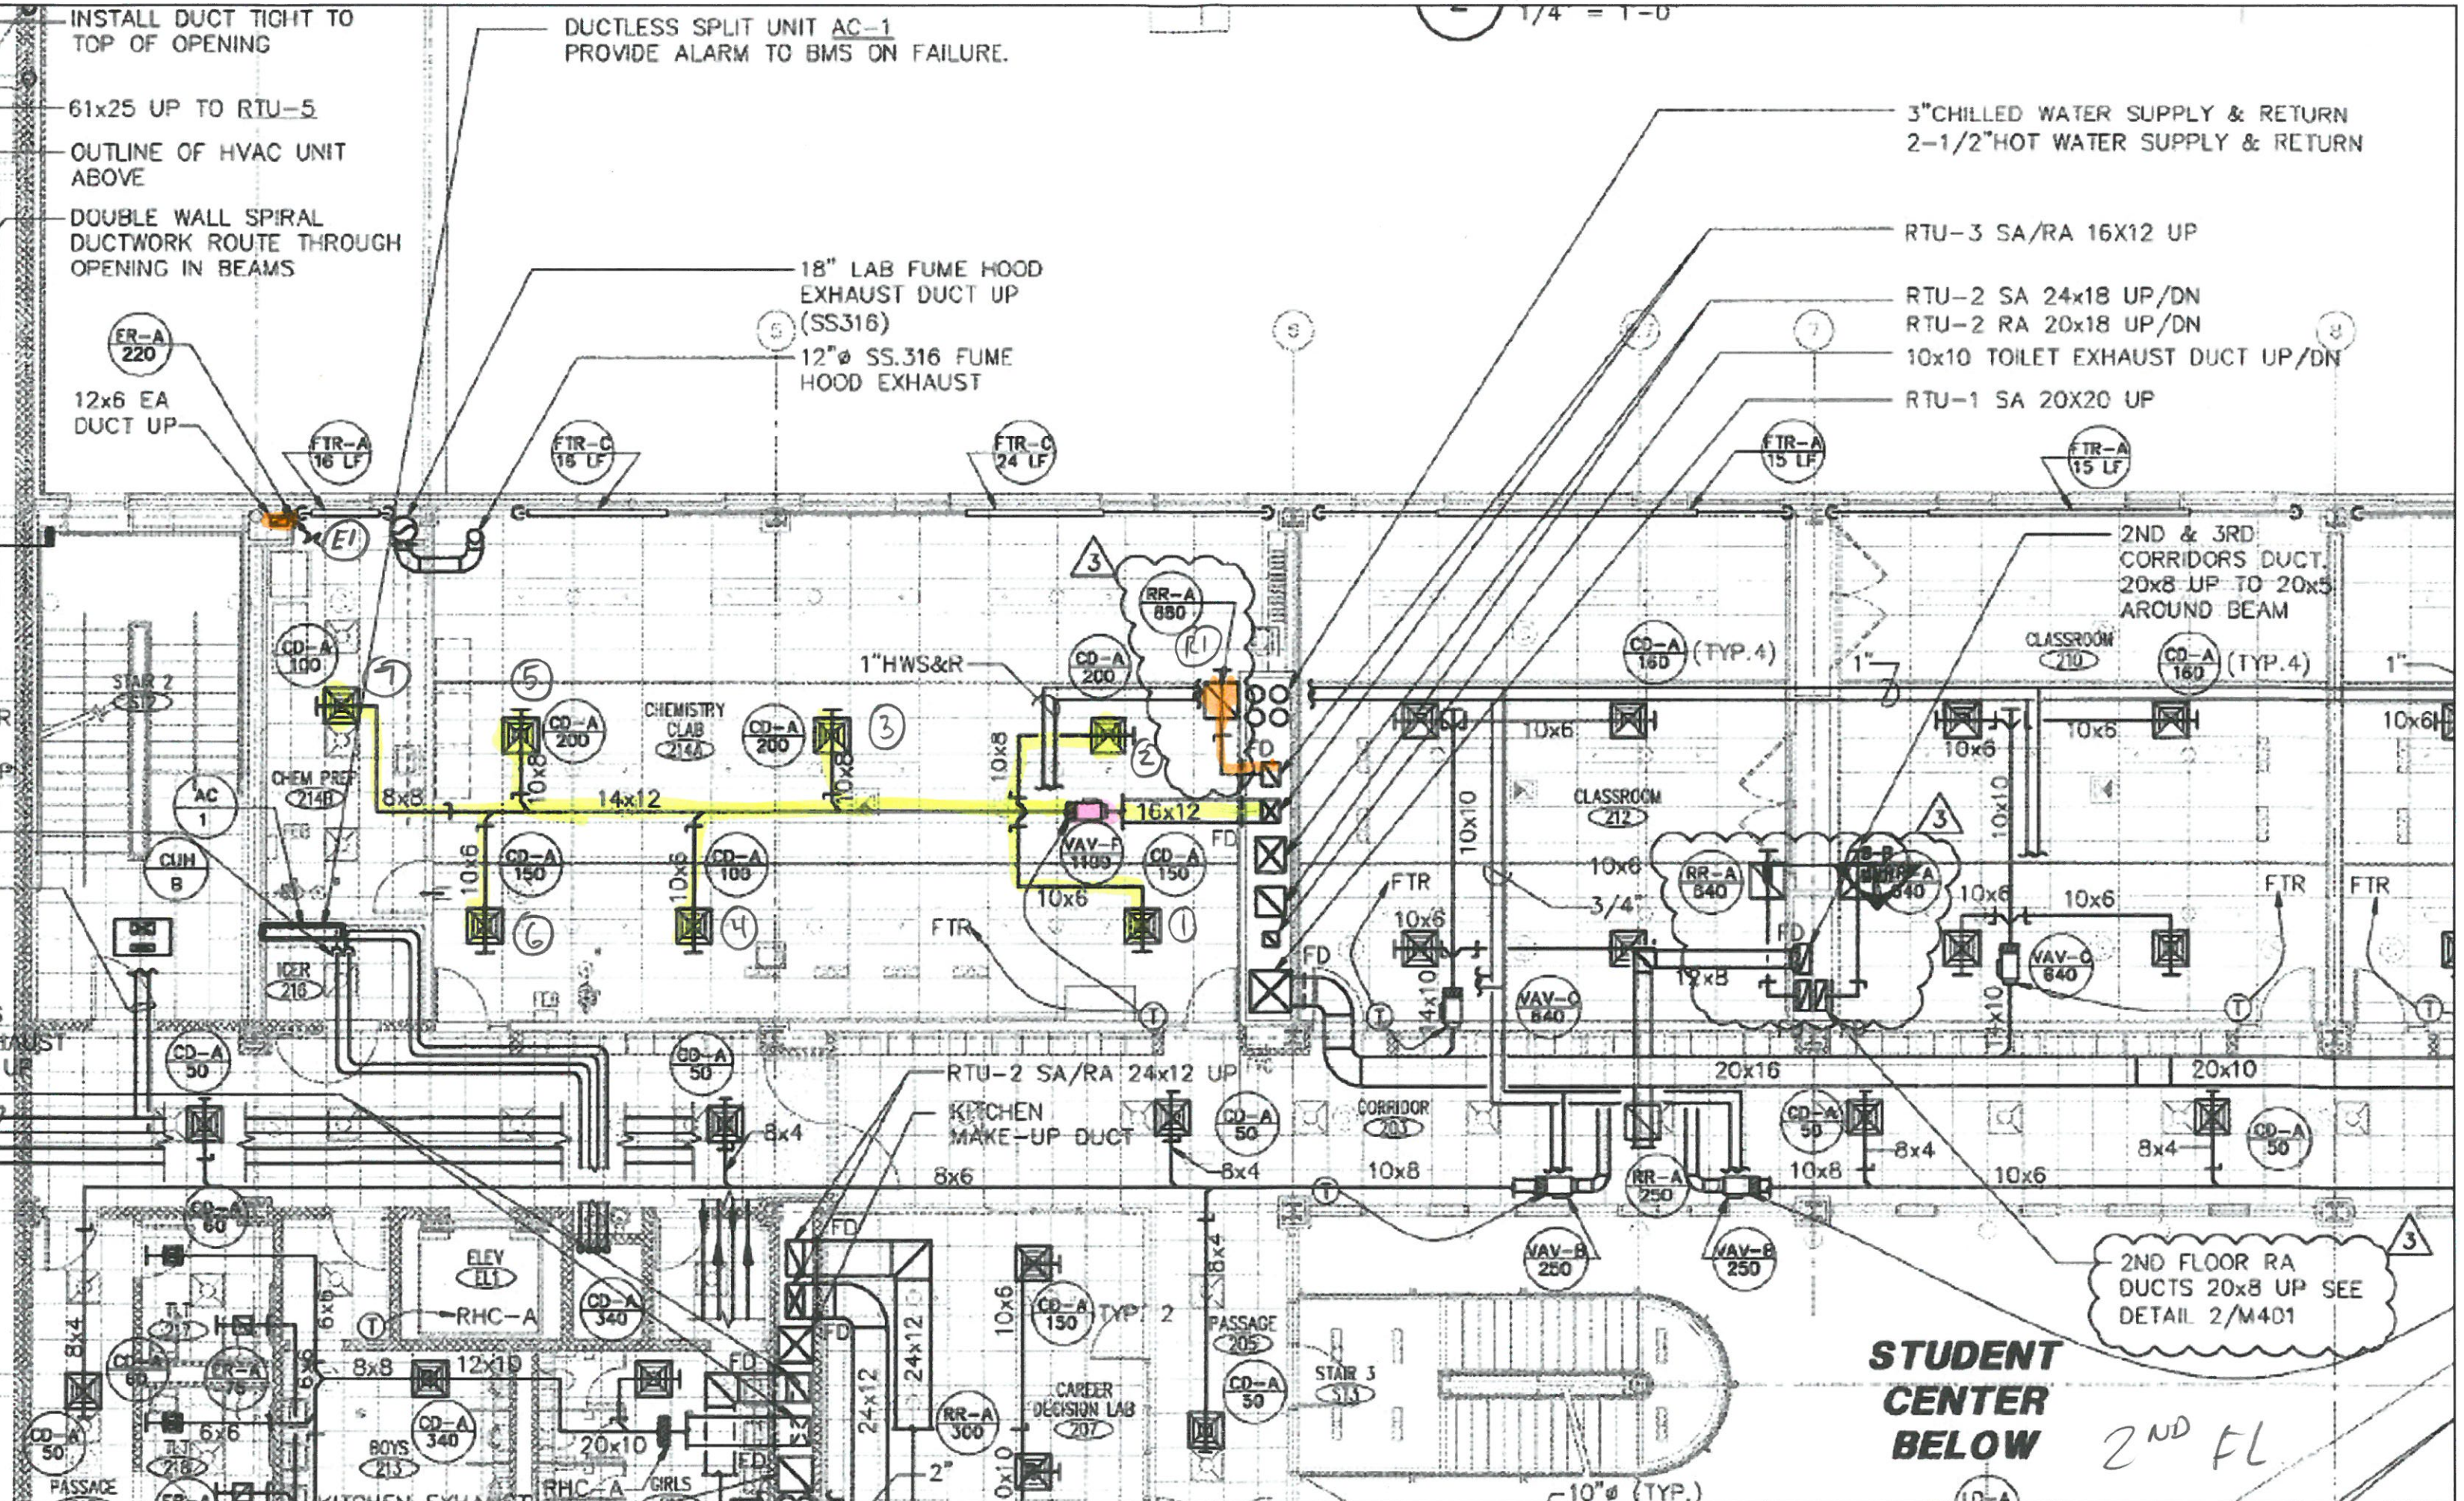
2 LEVEL 3 PARTIAL LE
 1/4" = 1'-0"

2ND FLOOR RA DUCTS 20x8 UP SEE DETAIL 2/M401

STUDENT CENTER BELOW
2ND FL

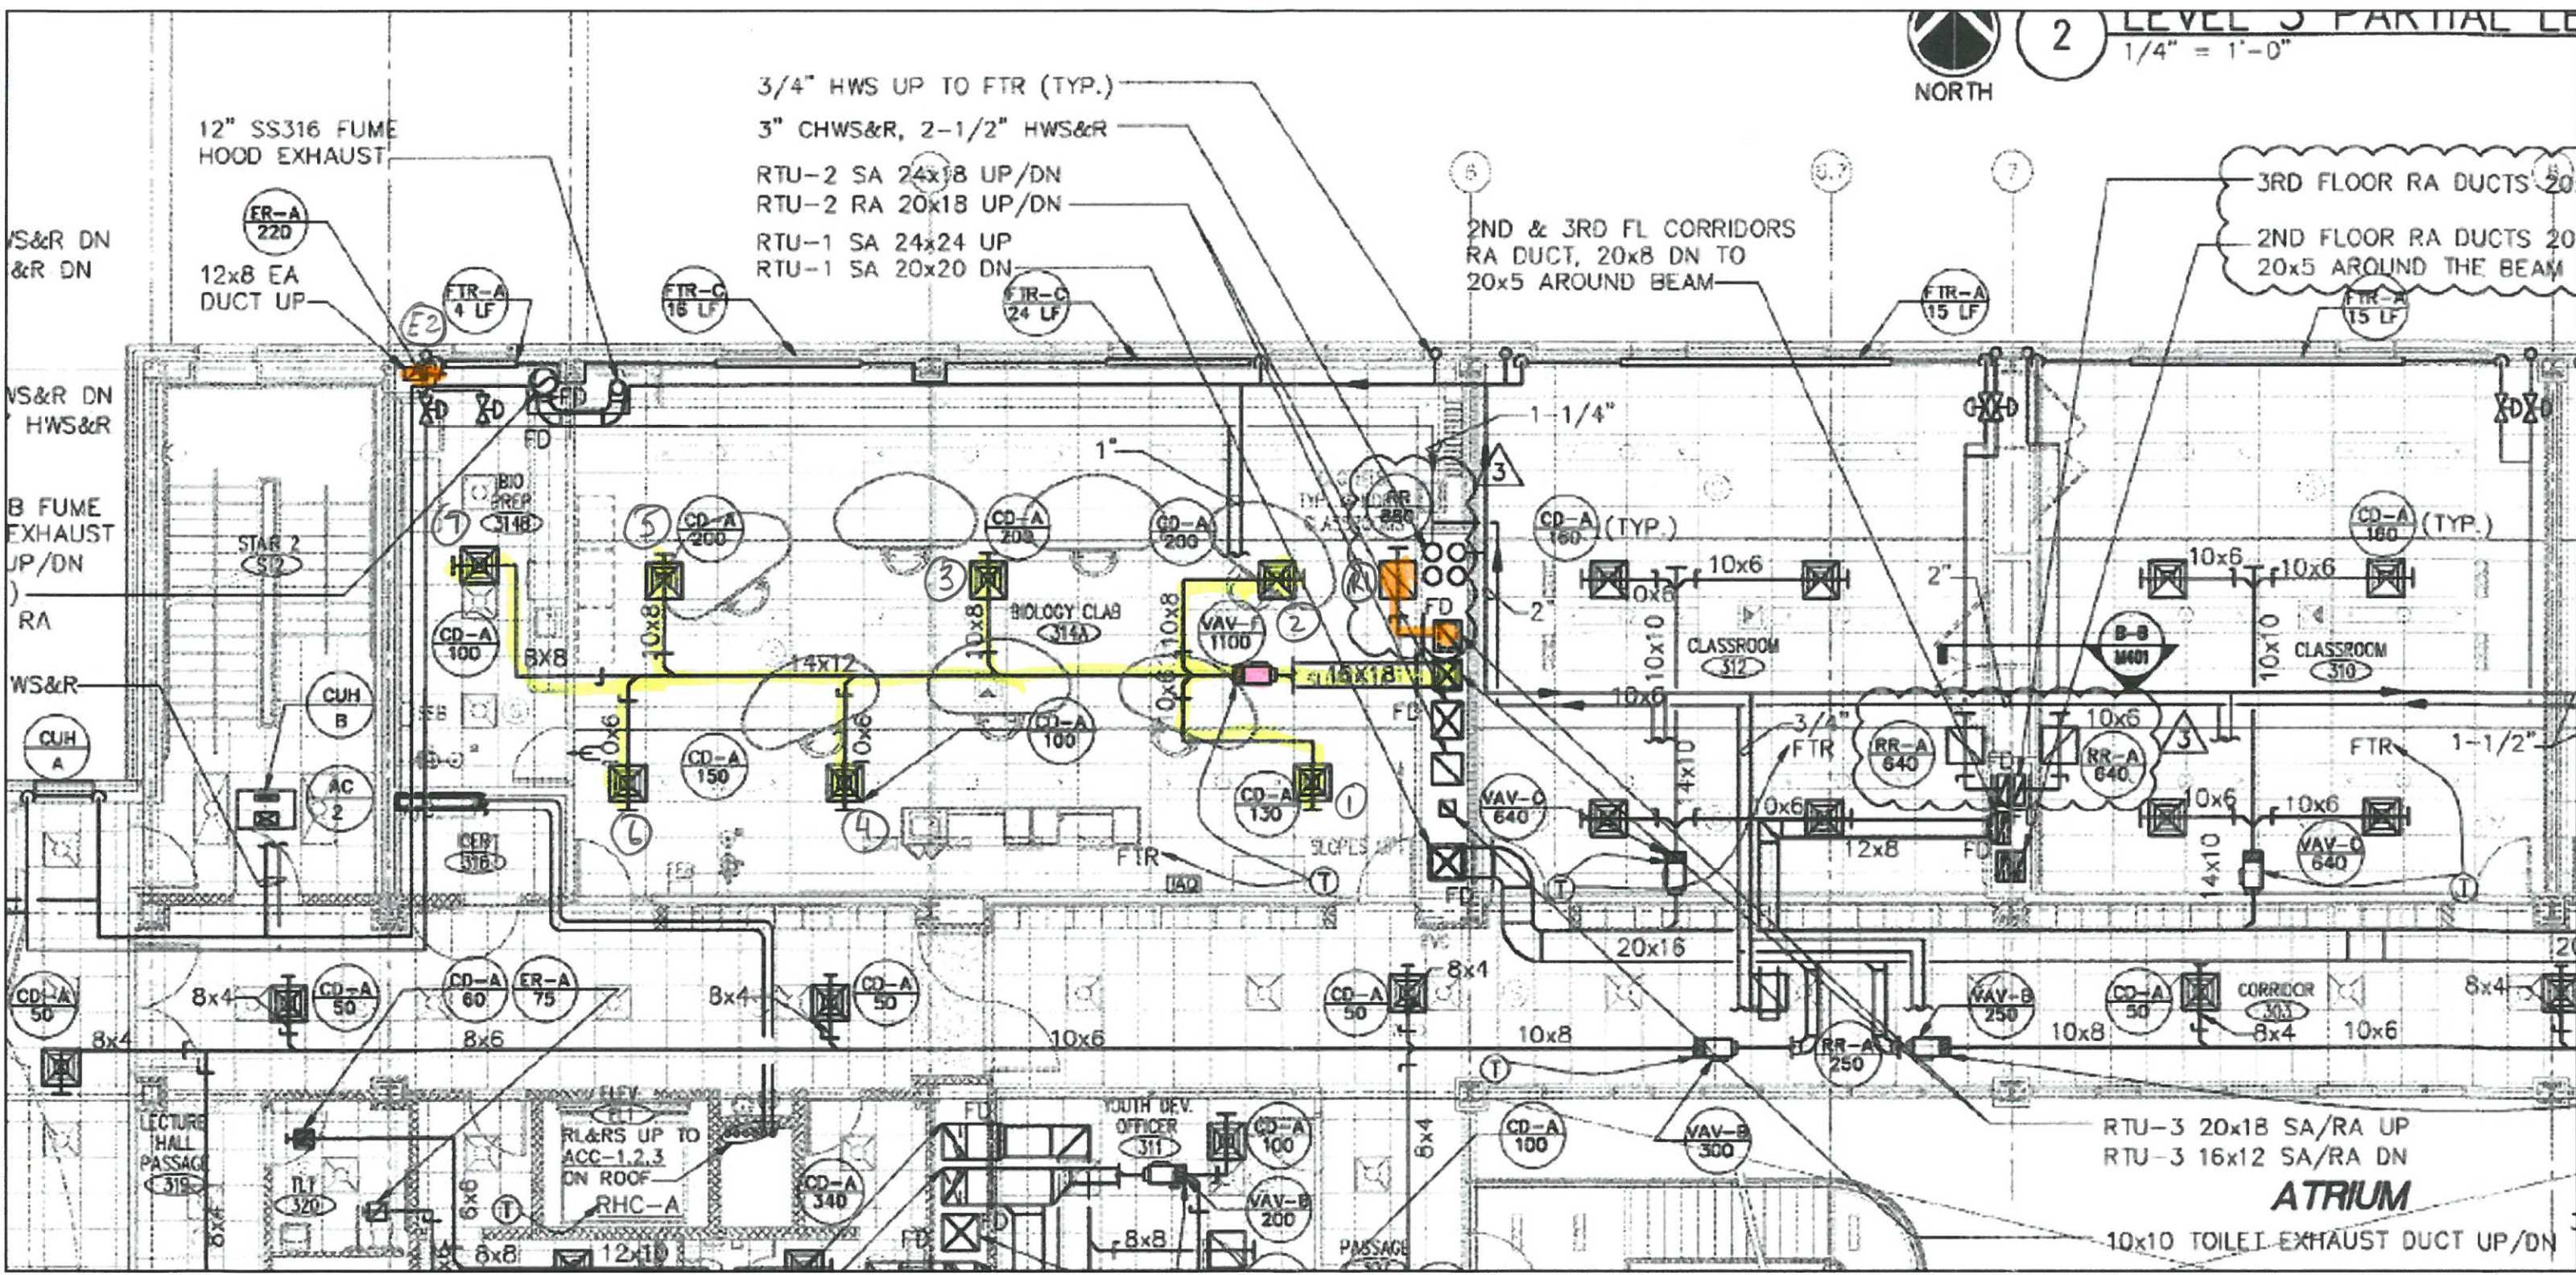
3rd floor

2ND & 3RD FL CORRIDORS
 RA DUCT, 20x8 DN TO
 20x5 AROUND BEAM

3RD FLOOR RA DUCTS 20x8
 2ND FLOOR RA DUCTS 20x5
 20x5 AROUND THE BEAM
