NEW HAVEN BRIDGE CONDITION REPORT

June 2019

**City Of New Haven
Engineering Department**

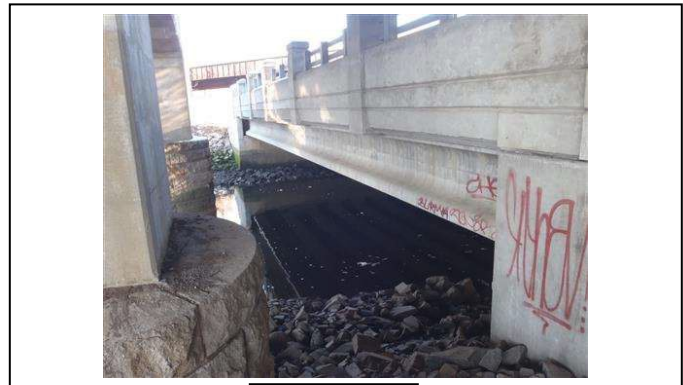
Elevation

Status Summary: This structure was replaced in 2016 and is in very good condition. Leakage from the sidewalk joint at the NW end of the bridge was noted in the inspection report. Per an email circulated internally within CDOT, the scour rating of '2' for this structure should be revised to an '8'.

Suggested Work: Inspect retaining walls along embankment and investigate repair responsibility – these are beyond the scope of bridge repair work.

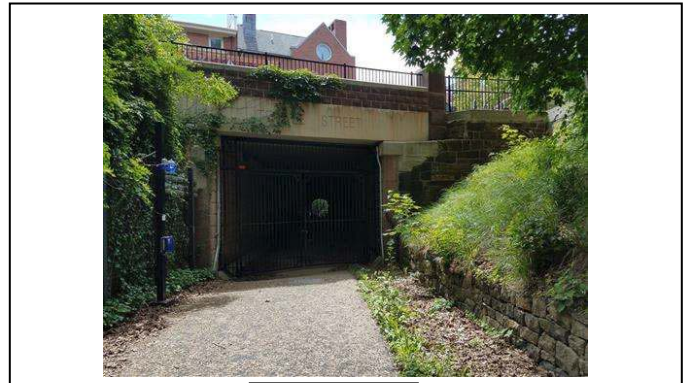
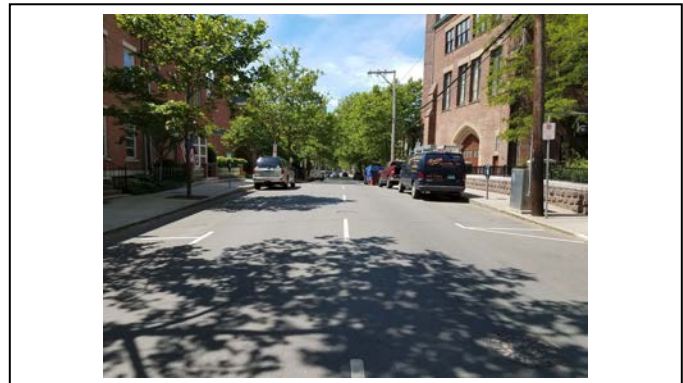
Elevation

Status Summary: This bridge was replaced in 2009 and is in overall good condition. The overlay has transverse cracks $\frac{3}{4}$ " wide at both deck joints. Significant loss of bearing between three beams and their bearing pads on the southern abutment was reported in 2015. Several beams were also noted to be in contact with the abutment seats, causing shear cracks in the beams.

Suggested Work: Request updated inspection and ADT from State. Determine changes in condition of beams with loss of bearing and/or shear cracks. Additional deterioration may require rehabilitation to extend the bridge's useful life. Cracks in overlay should be sealed.

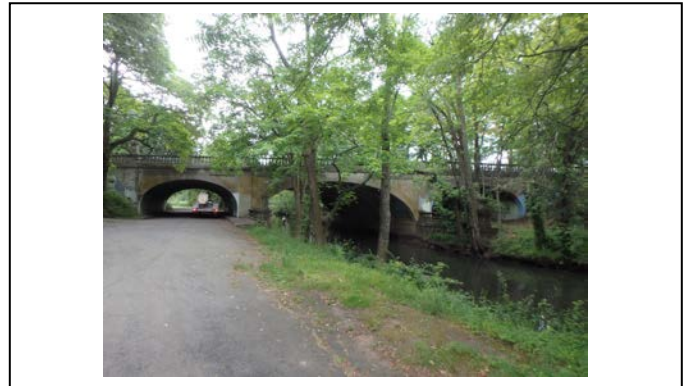
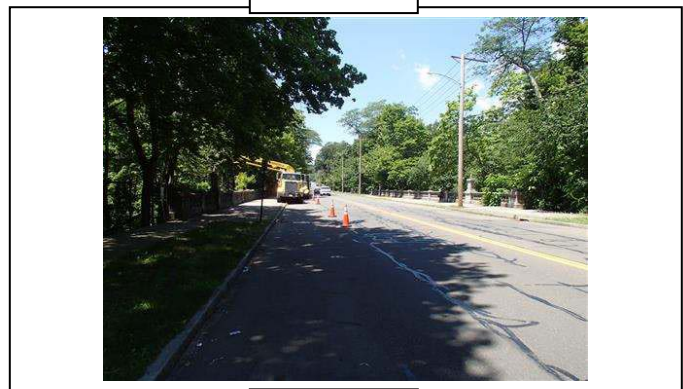
Elevation

Status Summary: This bridge is in generally fair condition. The overlay is in good condition, typical map cracking is present. The major rehabilitation project in 1974 replaced the deck and other minor structural repairs. There is now map cracking throughout the deck and significant efflorescence at joints between deck and ribs. The girders have efflorescence, hollow areas, and spalls up to 3" deep – section loss of exposed rebar has been observed. The abutments have areas of heavy scale, active leakage at interface with deck and ribs, map cracking, and spalls up to 5" deep. The wingwalls and piers are in similar condition to the abutments. The outlet pipes in both piers has been broken within the structure causing additional scale at the pier. A load rating using the Concrete Judgement Rating system was performed in 2000 and determined an inventory rating of 34 TN.

Suggested Work: This bridge will be a candidate for a major rehabilitation project within the next 10-15 years. It should be closely monitored for further structural deterioration, and the load rating updated if anything is found.

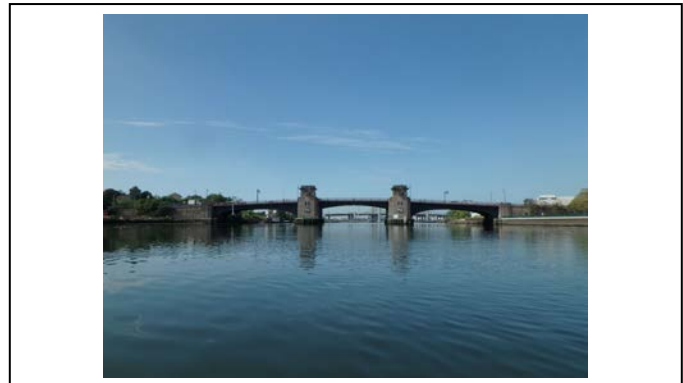
Elevation

Status Summary: This bridge is generally in satisfactory condition. The open expansion joints are misaligned and missing bolts. The superstructure is in fair condition. It has several areas of significant section loss (5% - 24%) focused at the stringers in the approach spans, floor beams have corrosion and section loss varying from 19% - 53%, corrosion and pitting is typical on the main girders. It should be noted that much of this corrosion happened prior to the 2008 rehabilitation project and was painted over during that project. Due to the section loss in the superstructure a load rating request was made in Feb. of 2018. The machinery is rated to be in fair condition. There is debris accumulation from animals and material passing through the deck and joints. The substructure has typical 2" deep spalling, with hairline cracking and efflorescence all within acceptable tolerances.

Suggested Work: Due to the significant financial burden a major rehabilitation to this structure would enact, break out projects to perform isolated structural steel repairs should be considered, based on the load rating results, and additional inspection, within the next five years.

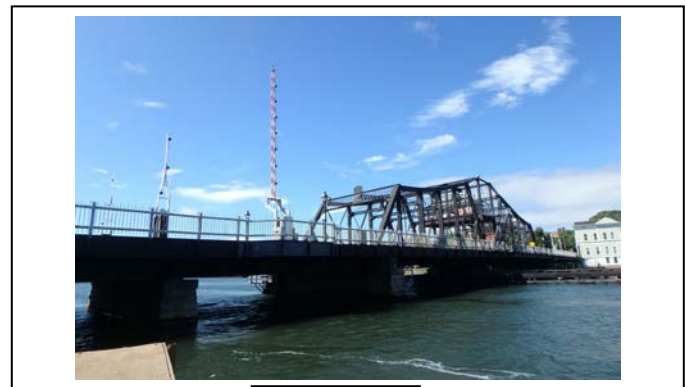
Elevation

Status Summary: Due to the condition rating of '4' for the electrical components, and '2' for mechanical components, this bridge is considered to be in poor condition. A project is current in design to replace the approach spans, rehabilitate the truss, and replace the mechanical and electrical components of the bridge.

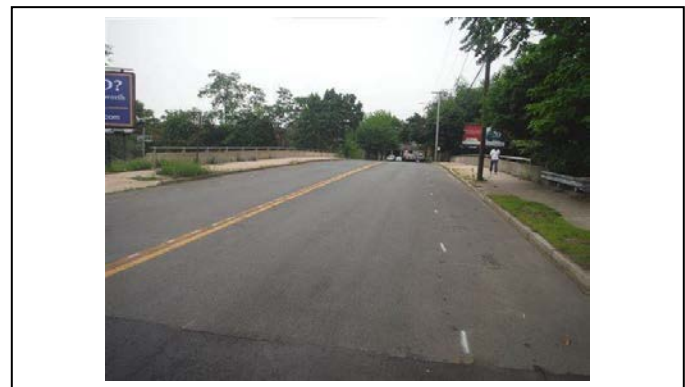
Elevation

Status Summary: Due to the condition rating of '4' for the substructure this bridge is considered to be in poor condition. The City has applied and received a commitment to fund letter from the State & Local Bridge Program to perform a rehabilitation. That project is currently in the design phase and is expected to be ready for bid in the Winter of 2019.

Suggested Work: Rehabilitation of the intermediate piers and fender system. Increase stream bed protection from scour. Concrete repairs to the substructure. New waterproofing membrane, overlay and joint replacement. Sidewalk improvements and parapet modification to bring the guardrails up to current FHWA standards.

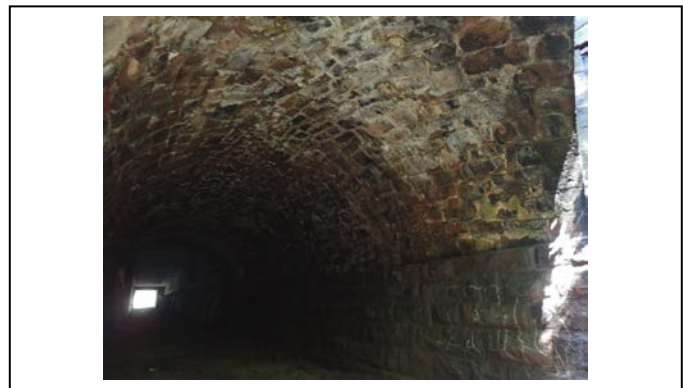
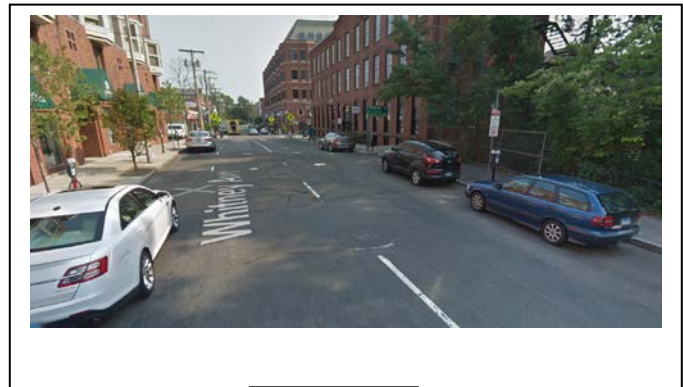
Elevation

Status Summary: A project in 1983 repainted the masonry and included overlay and sidewalk repairs. The structure is currently in overall good condition. Moderate efflorescence along the superstructure is evident, no significant loss of mortar or voids are apparent within the exposed arch.

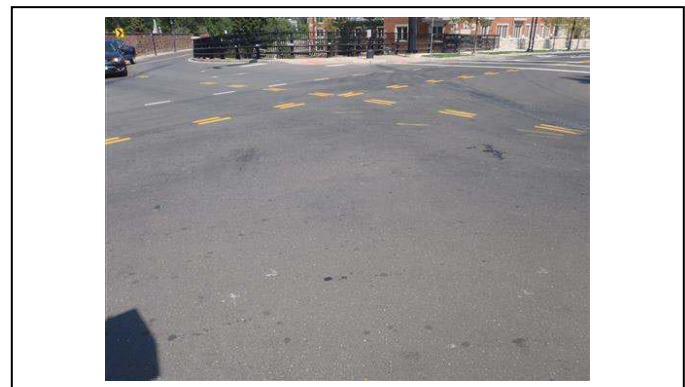
Elevation

Status Summary: This bridge is in overall good condition. A judgement-based load rating was performed in 2002 and found the inventory rating to be 34 TN. The overlay is in very good condition. The sidewalk at the SE approach has settled 1/2". The superstructure is in very good condition. Asphaltic plug joints are beginning to show signs of wear, the substructure has typical leakage staining and hair line cracks all within acceptable tolerances.

*A vehicle collision damaged a 30' section of bridge rail at the SE parapet – it will be replaced ASAP.

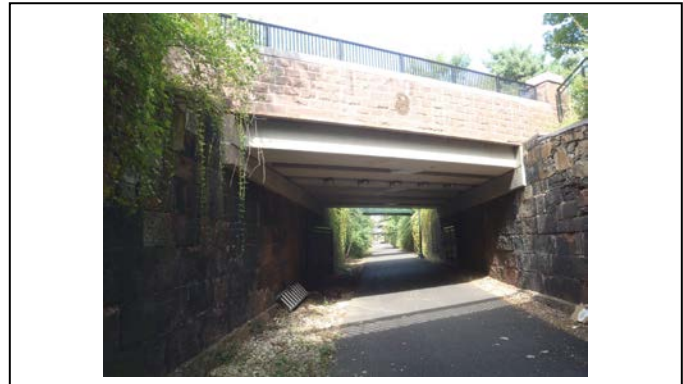
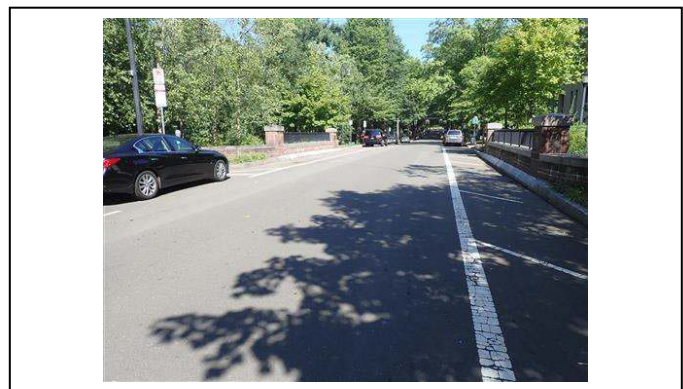
Elevation

Status Summary: This structure is in very good condition. This bridge was replaced in 2009. The substructure has some minor edge spalls, cracks, and efflorescence is noted at the backwall. No significant deficiencies were found during the most recent inspection.

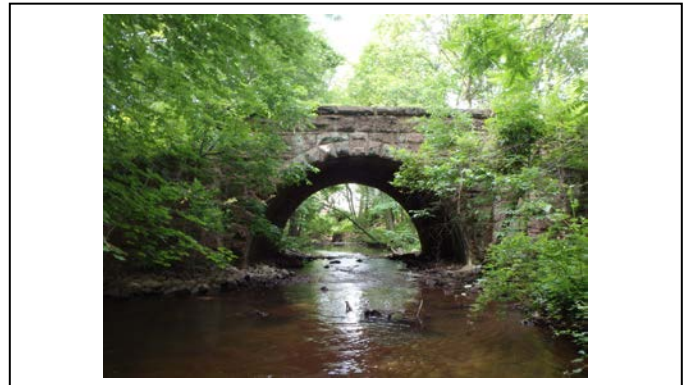
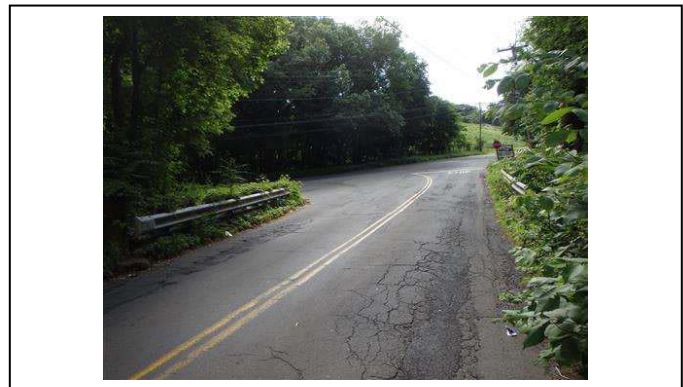
Approach

Status Summary: This bridge is in satisfactory condition overall. The overlay is in poor condition; it does not extend the full bridge width, leaving exposed ballast and allowing vegetation to grow adjacent to the parapet. The SE approach guardrail has collision damage, and no transition – neither the parapet or guardrails meet FHWA standards. The superstructure arch has sections of missing mortar up to 4" deep, several small voids and some cracks in stones. Erosion between 2'-2.5' is noted at each wingwall, and vegetative growth is typical on all the exposed masonry. Fallen trees and debris were inhibiting the streams natural flow as of the most recent inspection.

Suggested Work: In consideration of the age and complexity of this structure a preservation project should be considered to improve and extend the current condition of the superstructure. At a minimum the overlay should be replaced within two years, and masonry repointed. Vegetation should be cleared annually and damaged guardrail replaced.

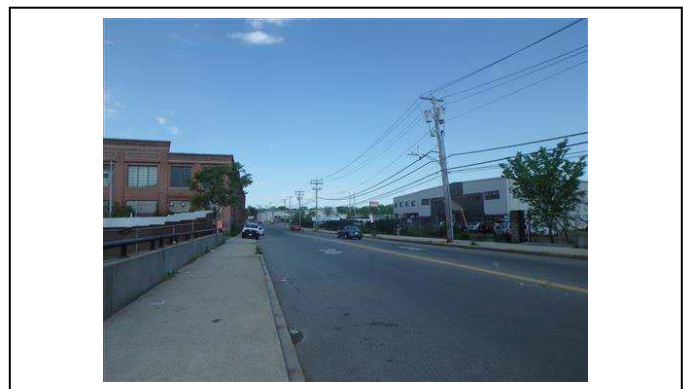
Elevation

Status Summary: This bridge is in satisfactory condition. There is a section of broken sidewalk that has settled 2" at the abutment, and a section on the bridge with severe scale. The superstructure has hairline cracking and minor spalls all within acceptable tolerances. The substructure has edge spalls up to 2" deep and hairline cracking. A keeper block on abutment 1 has fractured full width.

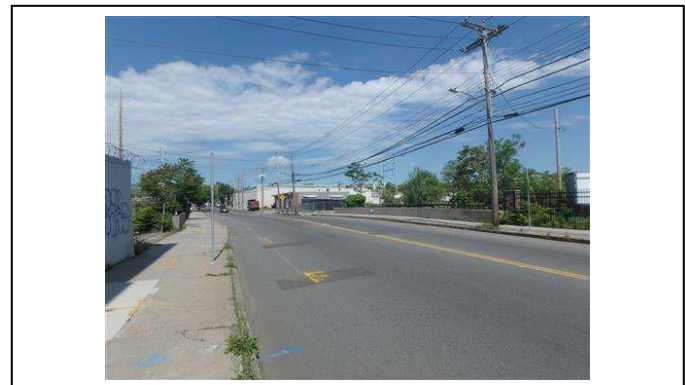
Elevation

Status Summary: This bridge is in satisfactory condition. The overlay and joints are in overall good condition. Some efflorescence is noted between girders, and typical spalling up to 3/4" deep. Vertical misalignment of up to 1" is noted and has been consistent since 2013 with no change. The abutments have minor spalls within acceptable limits. The footing of abutment 1 has been exposed due to scour for a 30'x30" section. No other channel conditions were noted to have changed over the last two inspection cycles.

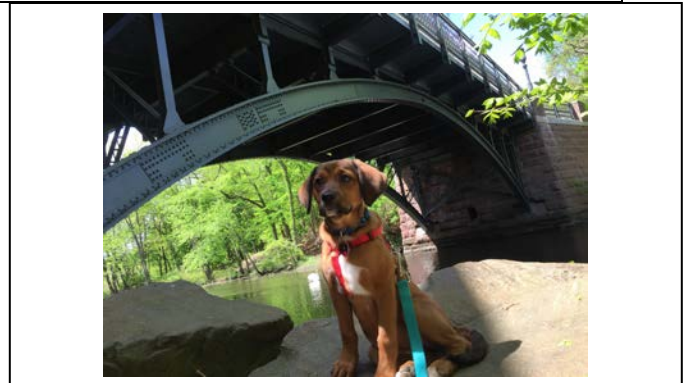
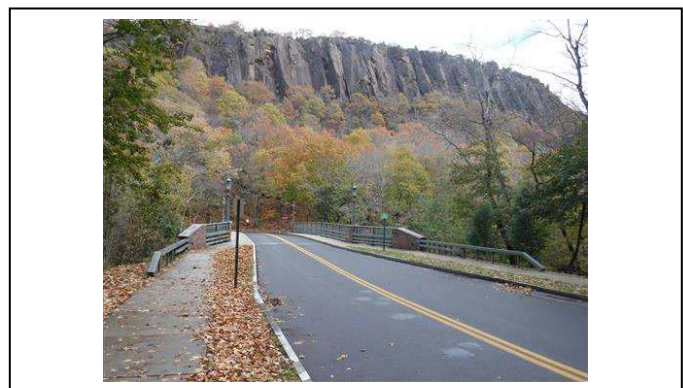
Elevation

Status Summary: This structure was rehabilitated in 2013 and is in good condition. Minor raveling and wear noted on the overlay with some efflorescence below the deck. The abutment stems have non-structural masonry facing with 5%-10% mortar loss. There is a 1.5" opening between wingwall 1A and abutment 1 indicating settlement.

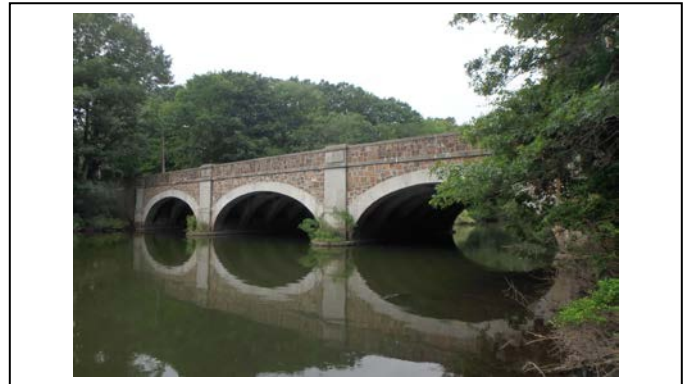
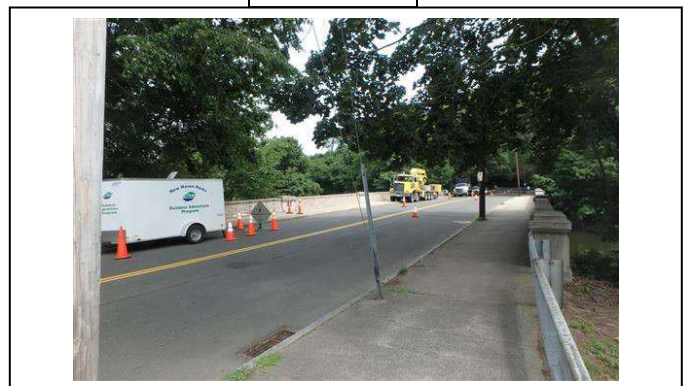
Elevation

Status Summary: This bridge is generally in good condition. The overlay has typical minor map cracking and wear. The parapets, approach guardrail and transitions are in overall good condition. Sidewalk uplift is present at the SW corner. There is efflorescence between the spandrels of the arch, scaling and 1/16" wide cracks in the arch ribs, with several spalls approximately 6'x3" deep exposing delaminated rebar. The substructure is in good condition, showing minor efflorescence and isolated cracking. Piers exhibit random spalls up to 7" deep, hairline cracking of the concrete and loss of mortar in the masonry. Scour holes up to 1' in depth occur adjacent to the piers, no significant erosion or debris within the channel.

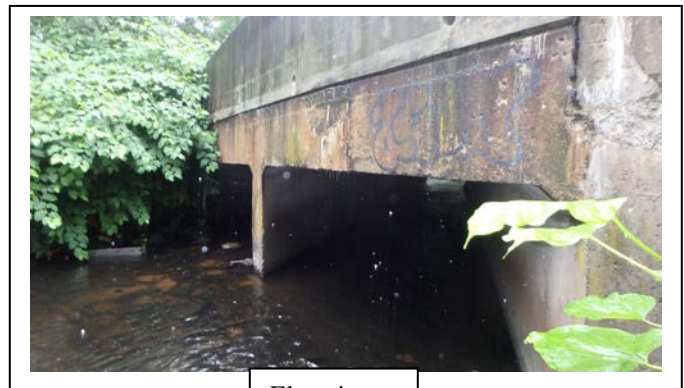
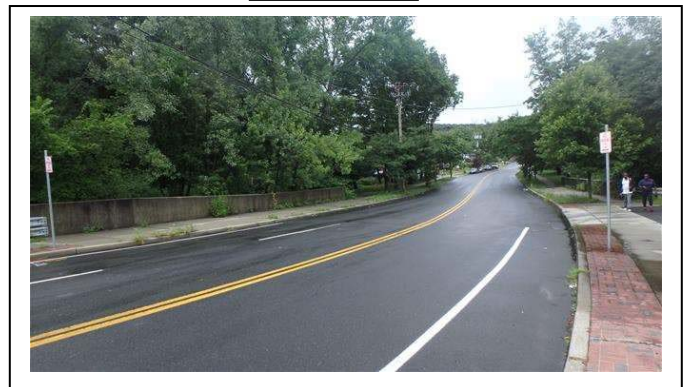
Elevation

Status Summary: This structure is in fair condition. The overlay was recently replaced. Debris and sediment buildup within the barrels is leading to scour and negative channel conditions. The roof has efflorescence, spalls up to 1.5" deep, and hairline cracking. Walls have isolated hollow areas, 1/8" wide vertical cracks and efflorescence.

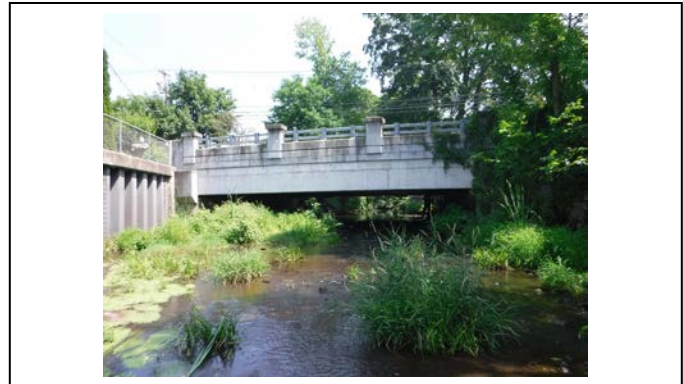
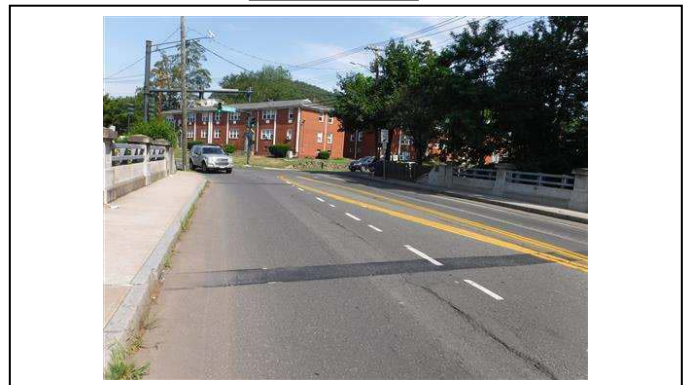
Elevation

Status Summary: This structure is in good condition. There are isolated potholes, and paving seams from 2"-5" wide. Minor efflorescence staining along joints of girders, and typical 1/2" misalignment. Loss of bearing at girders reported however girders show no signs of distress. The substructure has two areas of delamination or punky concrete and minor spalling, all non-critical. Scour holes have developed adjacent to the footing which is exposed per plan. The stream is controlled by retaining walls leading to and away from the bridge. Approx. 40' from the bridge a portion of privately owned retaining wall has collapsed and since been stabilized by vegetative growth.

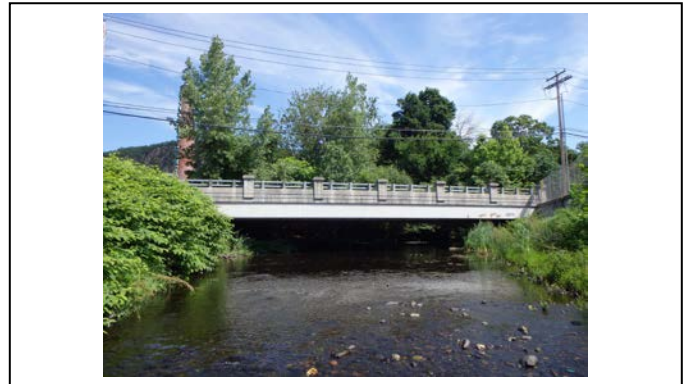
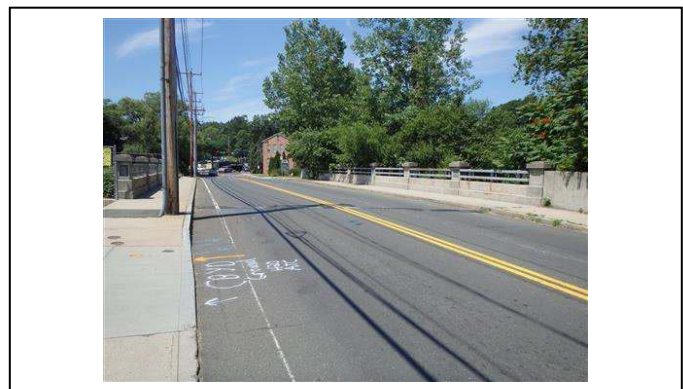
Elevation

Status Summary: This bridge is in good condition. The overlay has minimal longitudinal cracking. Superstructure has superficial cracking, and 1.25" vertical misalignment. There are no approach guardrail or transitions at the SE and SW ends of the bridge. There is evidence of leakage on the abutment at bridge joints, but the substructure is in good condition. There are localized significant areas of scour and aggradation adjacent to the abutments, with heavy buildup at abutment 1.

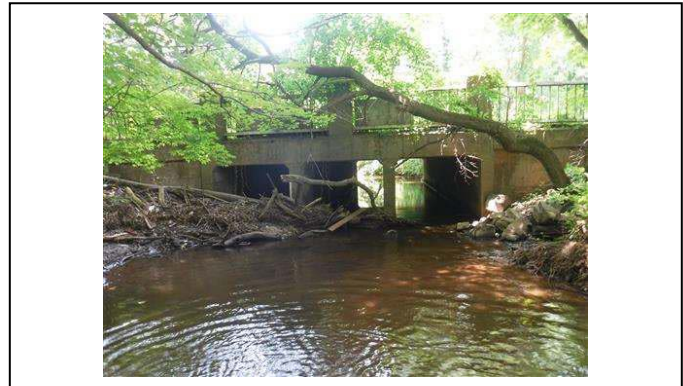
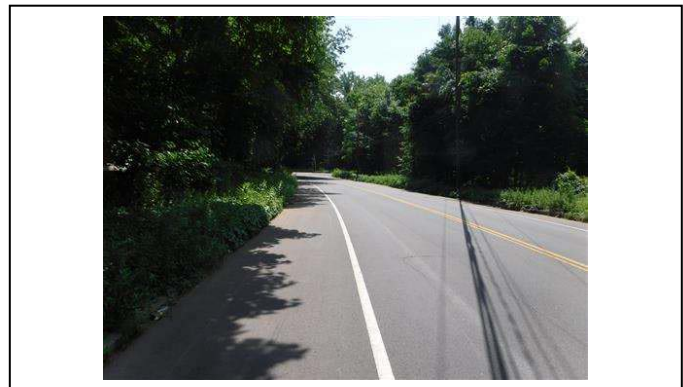
Elevation

Status Summary: This bridge is in fair condition structurally. The sidewalk on the bridge has been overgrown, and has curbing settled. There are no catch basins at or adjacent to the bridge and during storm events water will stagnate on a significant portion of the bridge up to 4" in depth. The CIP concrete culvert has map cracking with efflorescence concentrated at cold joints. There are several locations of spalls and honeycombing up to 3" deep. Significant debris accumulation has effectively blocked cells 1 and 2 reducing the available channel flow and causing additional scour with aggradation.

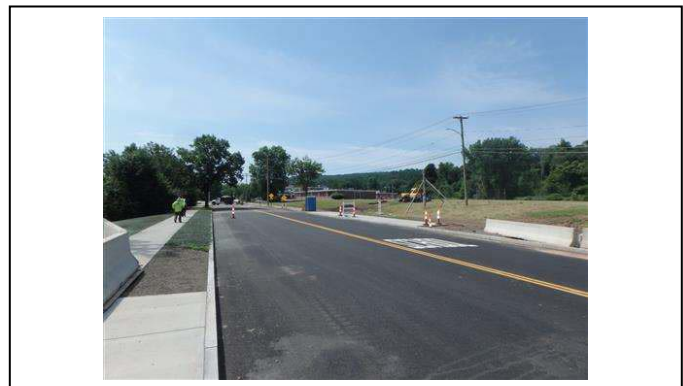
Approach

Status Summary: This structure was replaced in 2016-2017 and is in very good condition.

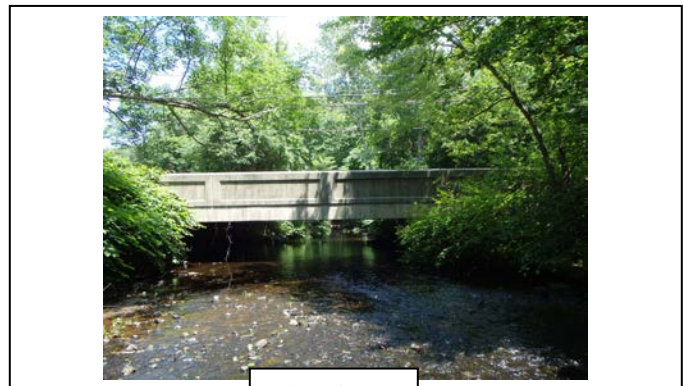
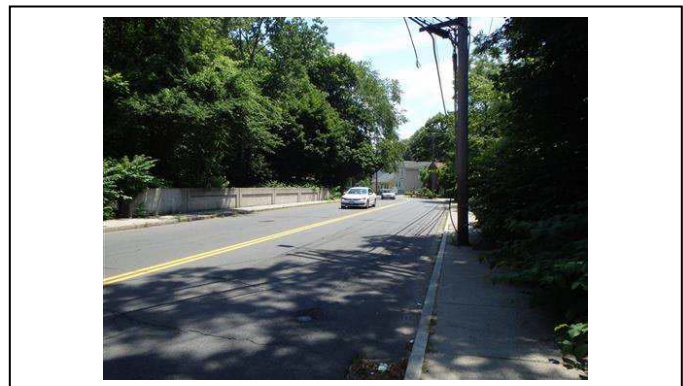
Elevation

Status Summary: This bridge is in good condition. The overlay has typical wear, cracking up to ¼" wide, the deck joints have been paved over. Approach sidewalks have settled 2" below the bridge sidewalk. Superstructure has minor spalls and ¾" vertical misalignment, all within acceptable limits. Isolated hollow areas were identified on the abutments as well as hairline cracking. Minor erosion exists along the channel and scour 2' deep at abutment 2.

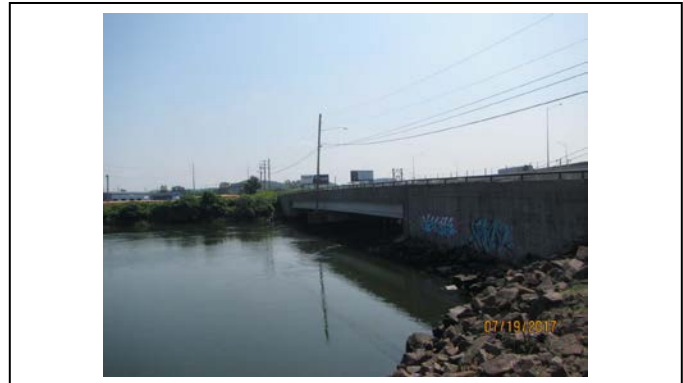
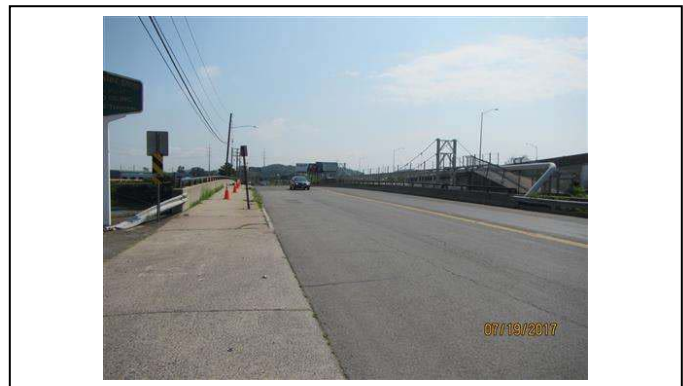
Elevation

Status Summary: This bridge is in overall satisfactory condition. Moderate cracking and typical wear are apparent on the overlay, and there is a 1/2" of sidewalk settlement at the SW end of the bridge. SW approach rail is missing 4 anchor bolts. The expansion joint compression seal is debonded for 75% of its length. The superstructure is in fair condition; there is typical hairline cracking as well as more significant spalls up to 2.5" deep exposing strands/rebar. The substructure exhibits typical spalling and hairline cracking within acceptable limits. Protective coating of the steel encased piles at the piers has failed and corrosion of the steel is in the early stages. Aggradation of material up to 4.5' at the piers and scour to 1.5' at the abutments was recorded in 2017.

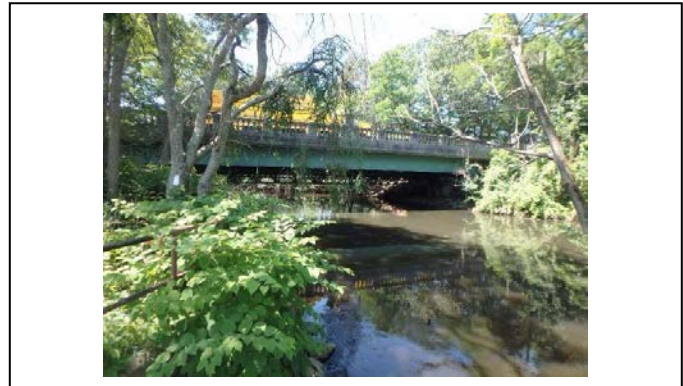
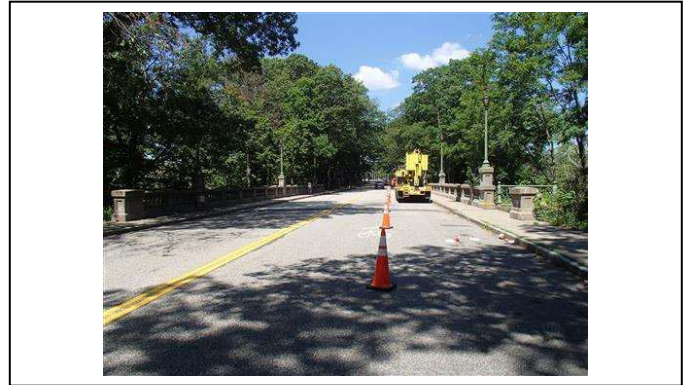
Elevation

Status Summary: This bridge is in generally good condition. There is minor cracking and typical wear on the overlay. The superstructure is in good condition, 90% of the protective coating is still effective nominal rusting is evident. Minor typical cracking of the abutments, with isolated spalls up to 2" deep. Stone masonry wingwalls exhibit 23" deep voids with missing mortar. There are localized scour holes within the channel adjacent to abutment 1 at a 36" outlet pipe.

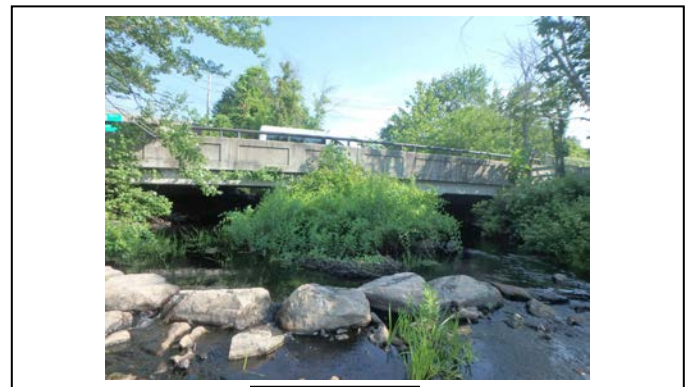
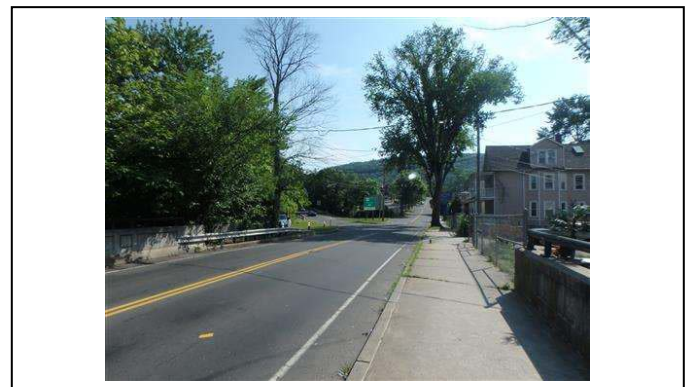
Elevation

Status Summary: This structural is in overall good condition. Nominal map cracking is present on the overlay, with one 1/2" transverse crack full width where the expansion joint was paved over. The superstructure is in good condition with signs of typical wear. Significant efflorescence was observed between superstructure units 10 and 11 at the gutter line. Typical spalling on both abutments is evident and is within tolerable limits. There is a 1/8" shear crack in the center pier and typical hairline cracks.

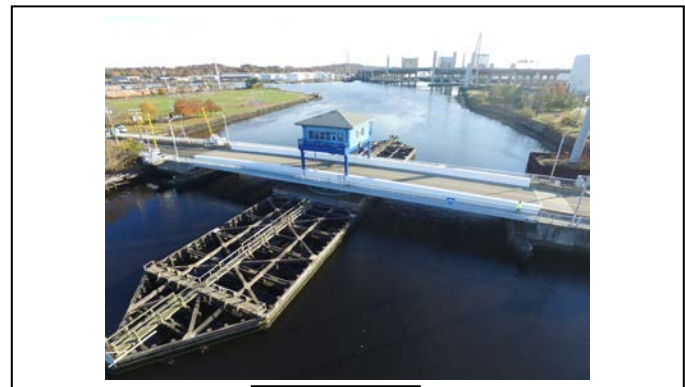
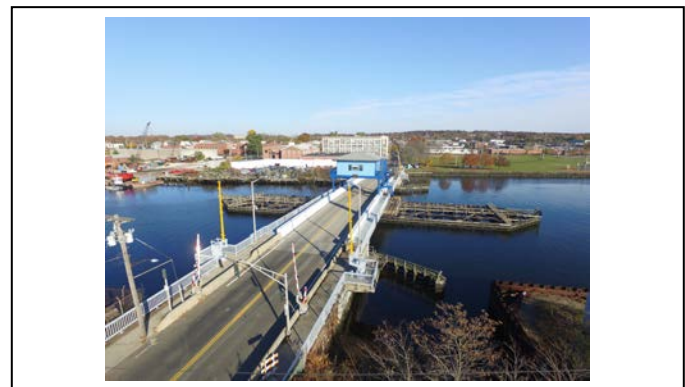
Elevation

Status Summary: A major rehabilitation project was completed in 2018 to replace structural steel elements of the superstructure, replace to wearing surface, replace the bridge joints, and make significant repairs or replacements of the mechanical components that operate the bridge.

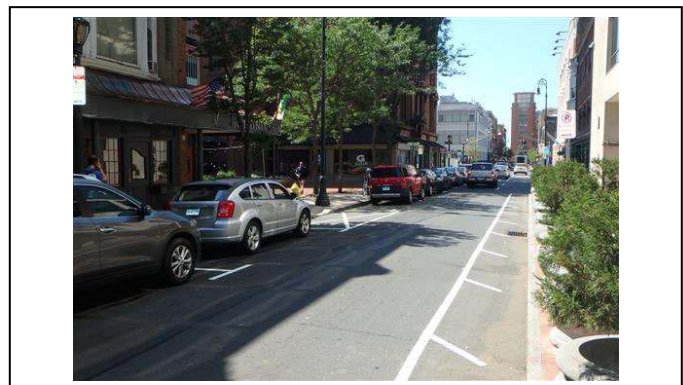
Approach

Status Summary: This structure is generally in good condition. The bridge portion of it extends from the curb line West of Pitkin Plaza and across Orange St. A load rating was performed in 2001 using the Concrete Judgement Rating method and an inventory rating of 34 TNs was determined. The superstructure has isolated areas of map cracking with efflorescence and spalls up to 3" deep.

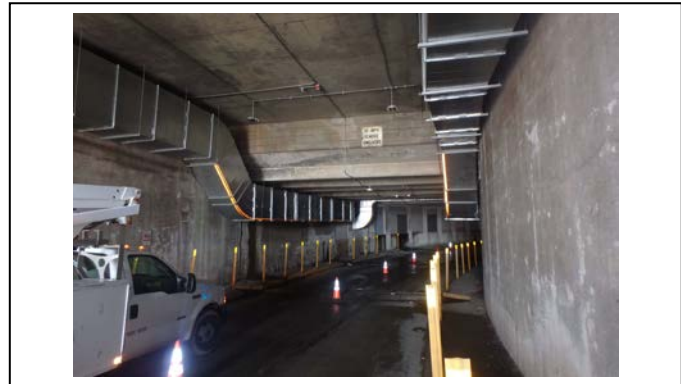
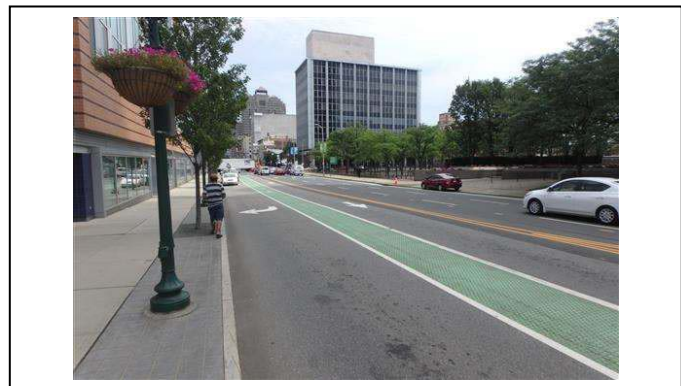
Elevation

Status Summary: This structure is in satisfactory shape. The superstructure consists of inverted pre-cast reinforced concrete t-beams, 7'x2' hollow areas over tunnel traffic were noted. Both abutments have typical map cracks and spalls 1/2" deep, abutment 2 has a full height crack at the southern end.

Suggested Work: Monitor for active leakage and further efflorescence. Inspect abutment 2 for shear crack, cause and repair procedure if necessary.

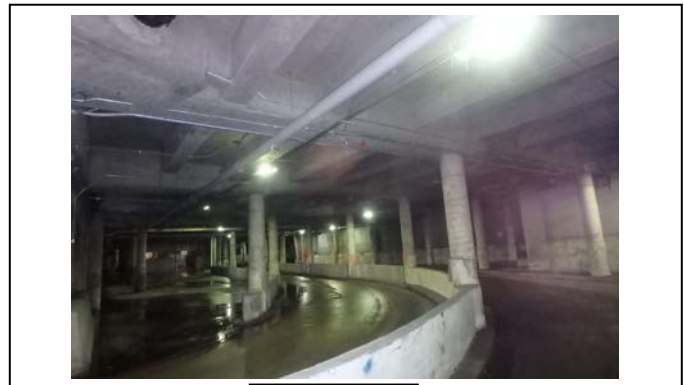
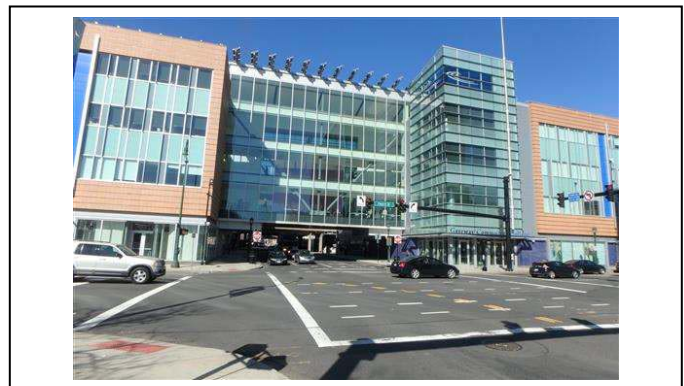
Elevation

Status Summary: This structure is in overall satisfactory condition. A major rehabilitation project took place from 2015 through 2016 to perform structural repairs, replace the ventilation system throughout the tunnel and to install fire detection equipment. A load rating was performed in 2001 using the Concrete Judgement Rating method and determined an inventory rating of 34 TN. Superstructure has isolated spalled 1/2" deep, and typical hairline cracking. Pier cap 3 was sounded and recorded as up to 80% hollow or deboned. Pier 1, column 1 was also found to have approximately 80% hollow areas.

Suggested Work: The noted pier cap and piers found to have 80% hollow areas should be further investigated as soon as possible. If report is confirmed an isolated repair project should repair those components.

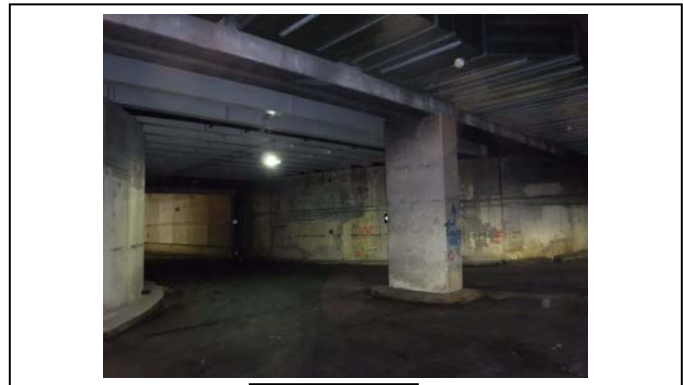
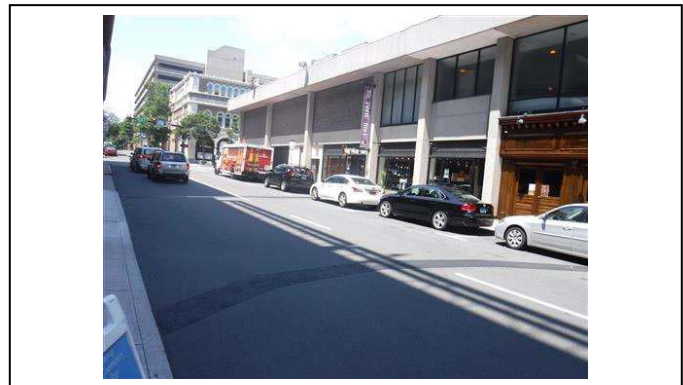
Elevation

Status Summary: This structure is in over all good condition. The superstructure and deck were replaced, and substructure rehabilitated in a 2017 project. Inspectors noted a 'gouge' in the web of girder 6 and attributed it to construction damage – it may simply be damage to the paint overlay. Efflorescence and transverse cracks were noted on the underside of the deck at closure pours.

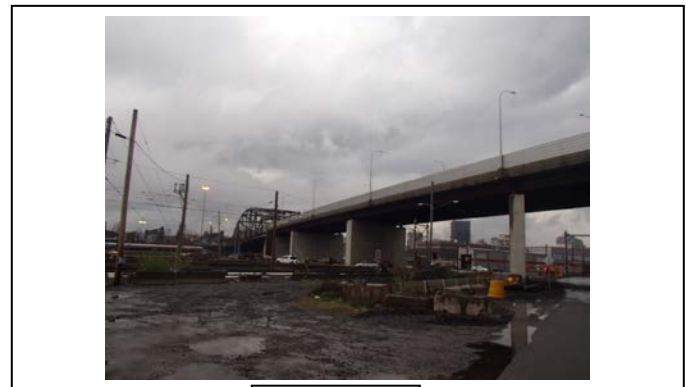
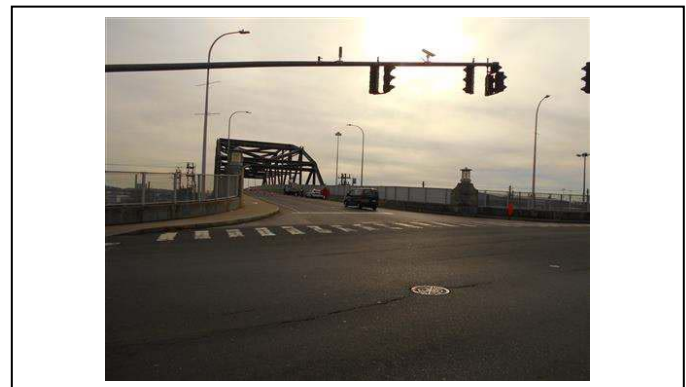
Elevation

Status Summary: This structure is in overall good condition. In 2018 in partnership with the State the bridge expansion joints were replaced in three locations and conduit expansion joints on both sides of the parapet were replaced. The street-light pole at the SE approach has impact damage and a cracked weld at its base. The truss bracing has waves in the flanges in span 2, and a later brace has bowed 1". The substructure has typical map cracking within acceptable tolerances. Several bearing pads are noted as map cracking, horizontal cracks, punky concrete, and one anchor bolt has been broken.

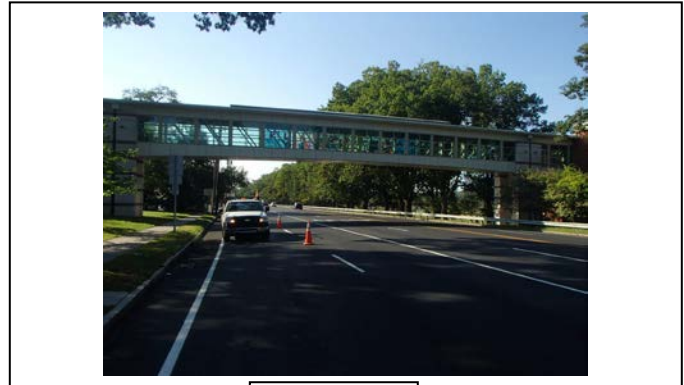
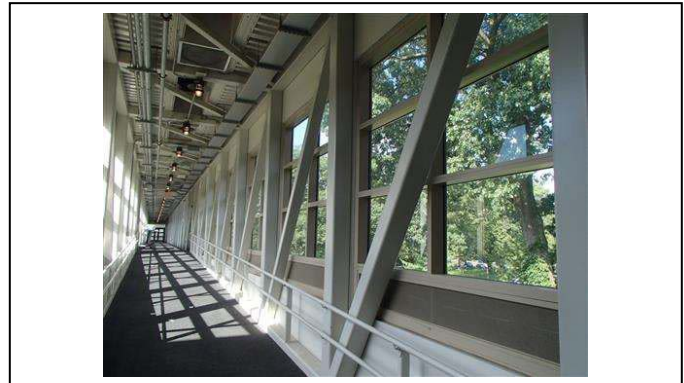
Elevation

Status Summary: This structure is in very good condition; no significant defects or signs of distress were observed. It services pedestrians over route 34 between the adjacent middle school and West River Park. This structure is on the State's biennial inspection list and an updated report will be provided to the City every two years.

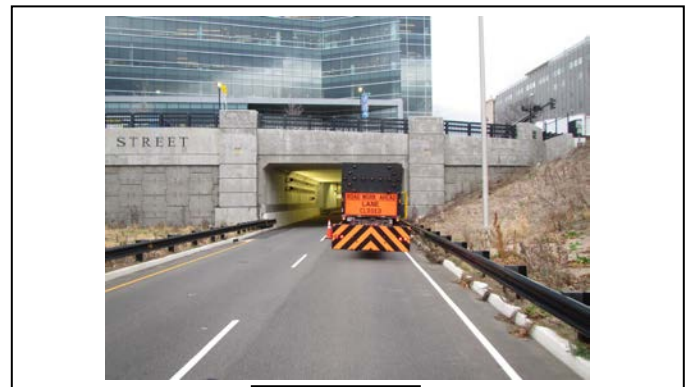
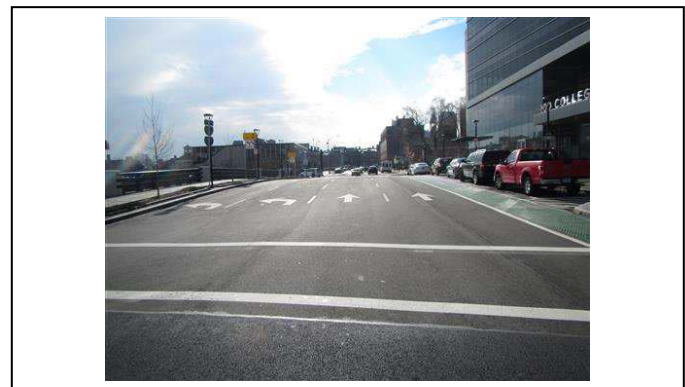
Elevation

Status Summary: This structure was replaced in 2015 and is in overall good condition. Hairline cracking within acceptable tolerances, mortar loss between units and some efflorescence leakage along joints were observed. The adjacent building owners sent complaints about leakage within the structure creating a hazard and damaging the building's interior finishing. The City investigated the leak and determined it was outside the structure's footprint and the responsibility of the adjacent property owner. A report on the findings was distributed in February of 2018.

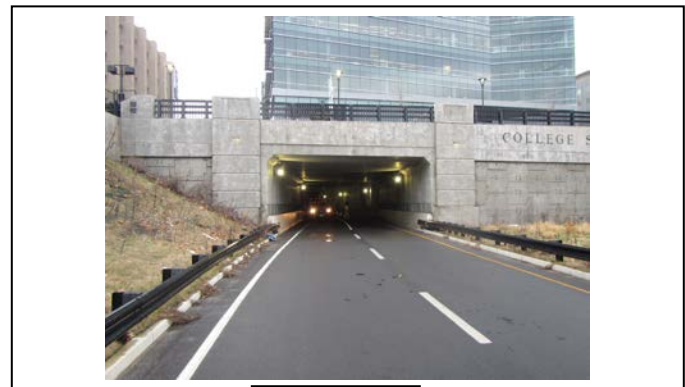
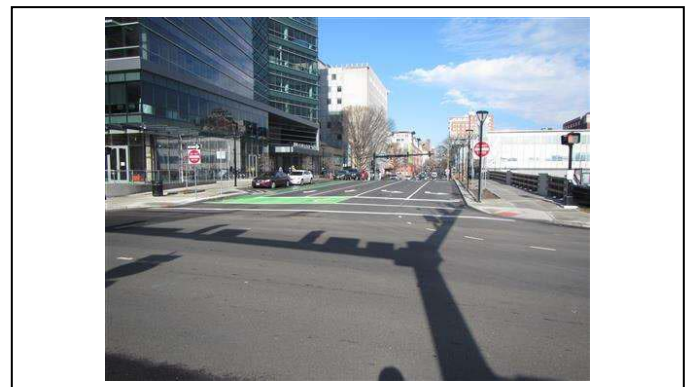
Elevation

Status Summary: This structure was replaced in 2015 and is in overall good condition. Hairline cracking is noted throughout the pre-cast structure within acceptable tolerances. Efflorescence was observed on the bottom of the slab, and walls around locations of mortar loss. Notices have been received of ice/water between units 17 & 18 over the roadway.

Suggested Work: A trough cannot be installed due to height clearance restrictions. Under dry conditions the mortar between units 17 and 18 should be fully chipped out and oakum rope installed to divert water.

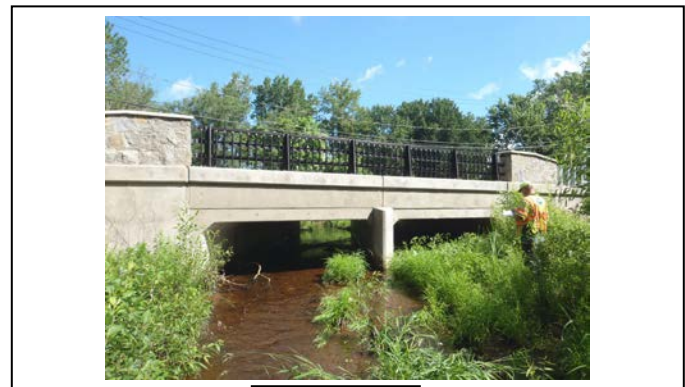
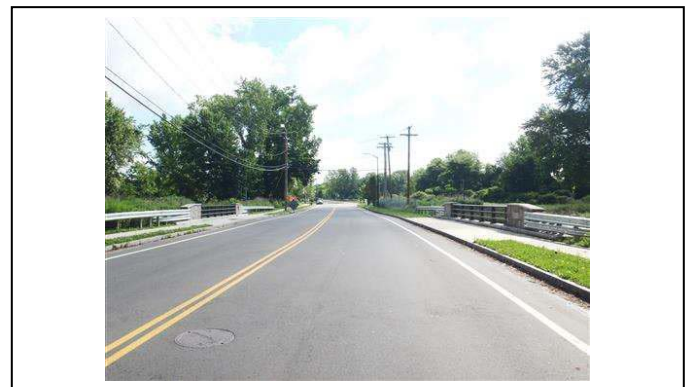
Elevation

Status Summary: This structure was replaced in 2016 and is in very good condition. Vegetation encroachment in the Northern span was noted to be damming flow and causing further aggradation within the channel.

Suggested Work: An effort should be made to cut back vegetation and restore the channel to its original flow conditions by removing aggradation within the culvert. The current conditions equate to a 50% reduction in available flow rate.

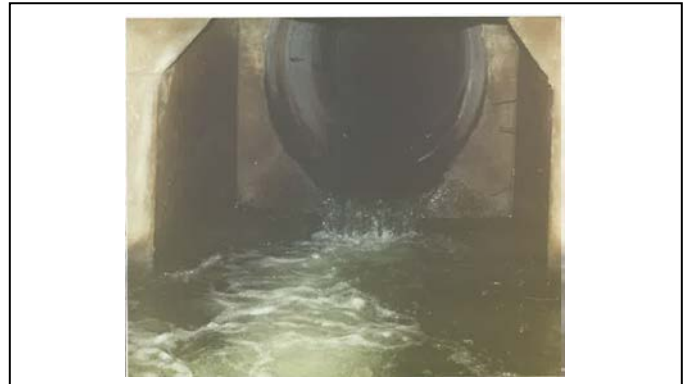
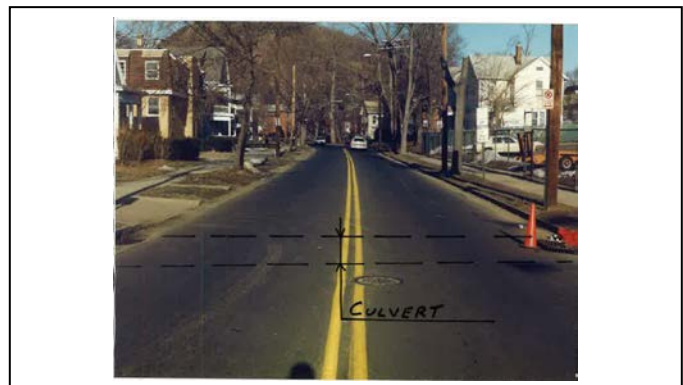
Elevation

Status Summary: This structure has not been inspected since 1991 and there are no reliable record drawings of it.

Suggested Work: This structure should be fully inspected and if found to be in poor condition, load rated as well.

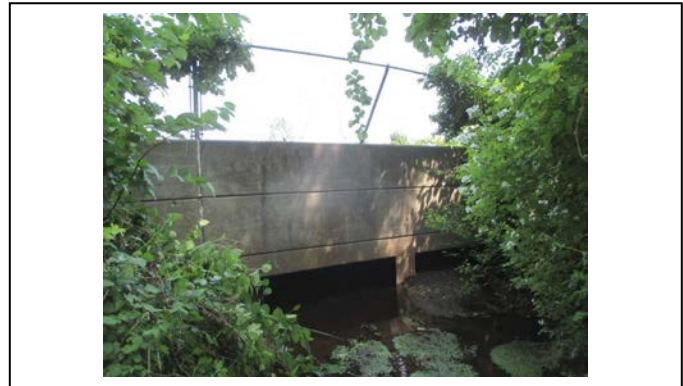
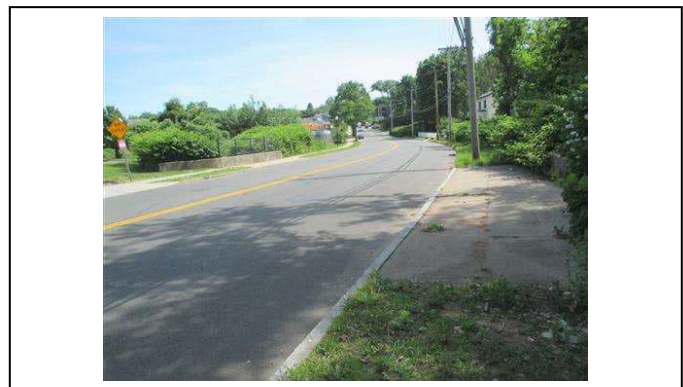
Elevation

Status Summary: This structure is in satisfactory condition. The overlay has minor wear and cracking within allowable tolerances. Light scaling is observable on the interior culvert walls. One of the two cells through the culvert has filled with debris and can no longer convey water. The western sidewalk and parapet are overgrown by vegetation.

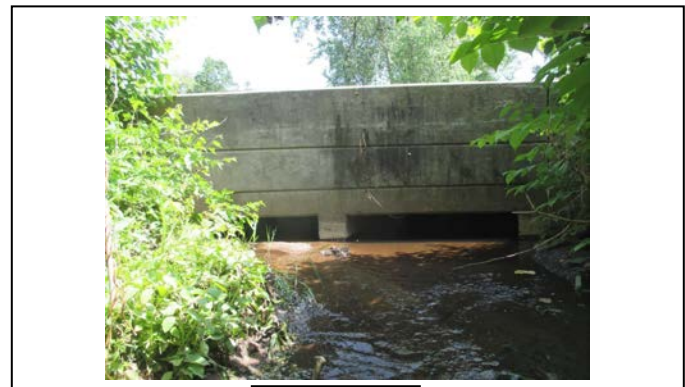
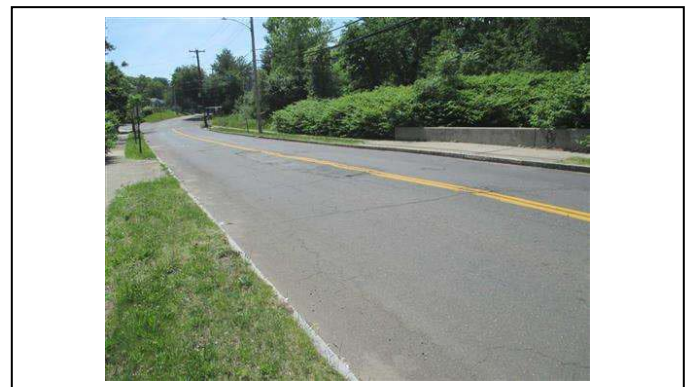
Elevation

Status Summary: The structure is in satisfactory condition. Overlay has significant map cracking up to 1" wide. There is some minor sediment build up occurring within the cells of the culvert. Light scaling is noticeable on all the internal walls of the culvert. Vegetation grows over the parapet on both the North and South sides of the bridge.

Suggested Work: Cut back vegetation every Spring. Replace overlay and waterproofing membrane within 5 years. Perform full structure inspection by 2022.

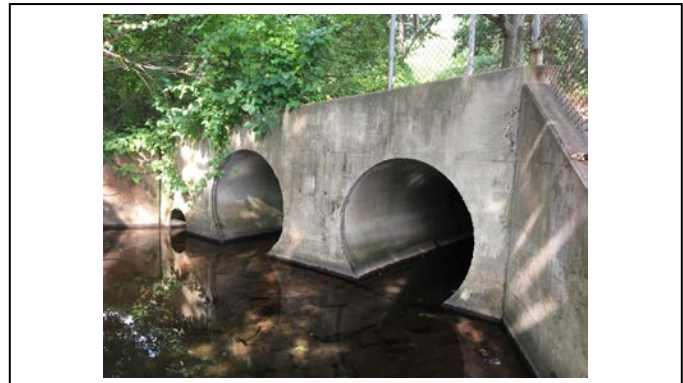
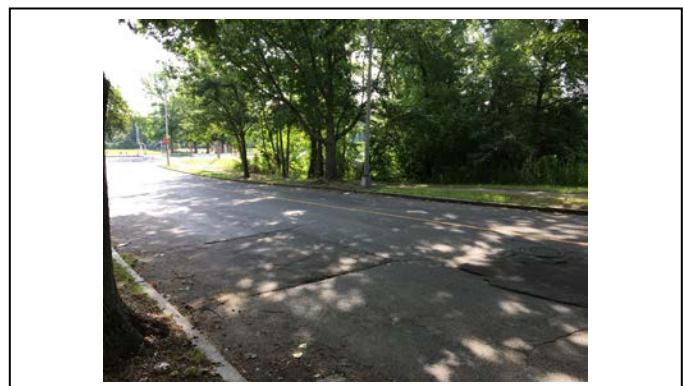
Elevation

Status Summary: This structure is in satisfactory condition. It is made up of two RCP and CIP headwalls with wingwalls at either edge of the roadway. The most recent inspection was 1991 and there are not reliable record drawings of the structure. The pipes were in good condition at the time of the inspection. The headwalls have some rotational translation and hairline cracking.
