NEW HAVEN BRIDGE CONDITION REPORT

June 2019

**City Of New Haven
Engineering Department**

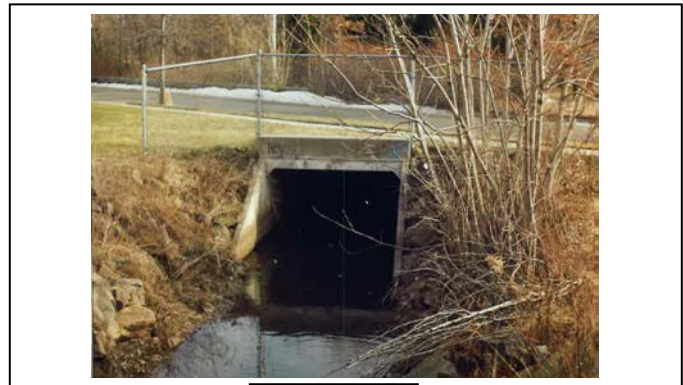
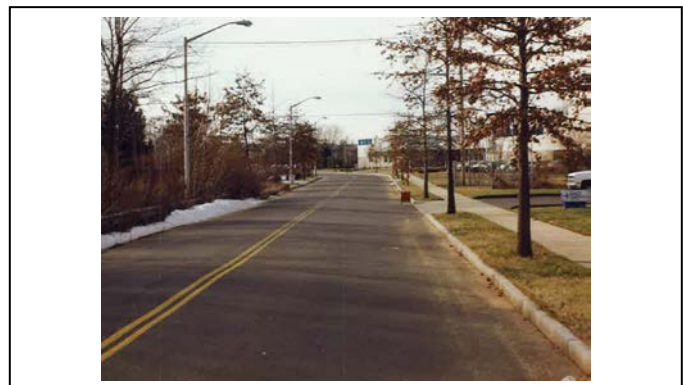
Elevation

Status Summary: Structure is in satisfactory condition. Scour holes were noted adjacent to the wing walls of the structure. Minor misalignment between units was noted, lack of distress on roadway indicates misalignment was due to construction error rather than settlement.

Suggested Work: Monitor vegetation growth within channel limits and for further scour conditions. Perform inspection biennially to ensure structure remains in satisfactory condition.

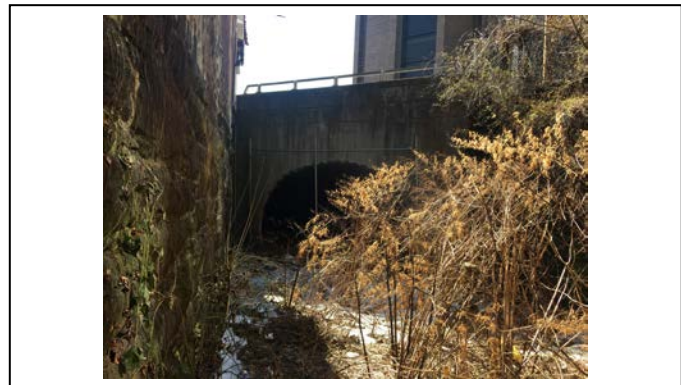
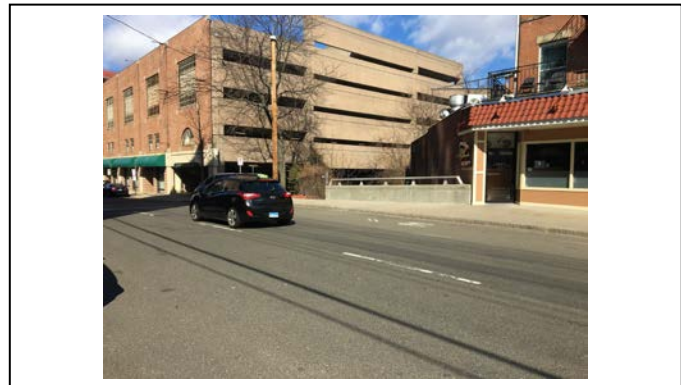
Elevation

Status Summary: No inspection reports or record data can be found for this structure. Parts of it were demolished during construction of the FUSCO/Federal building located at Orange & State.

Suggested Work: This structure should be fully inspected and if found to be in poor condition, load rated as well. A survey may be necessary.

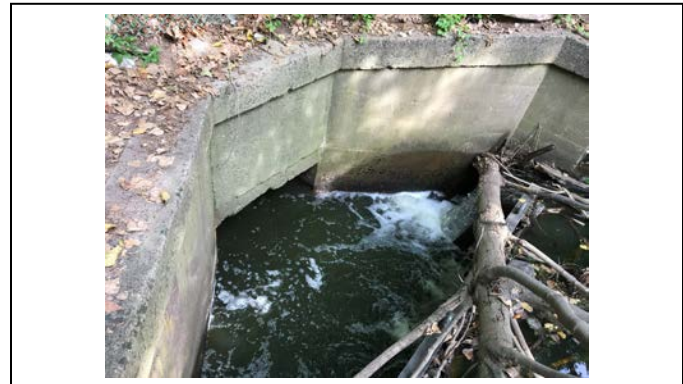
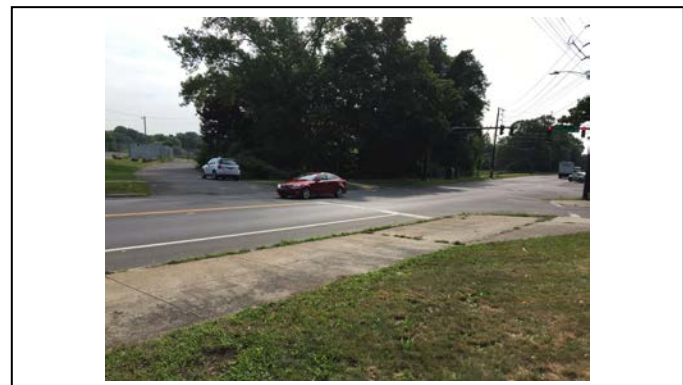
Elevation

Status Summary: No inspection records or reliable record data exists for this structure.

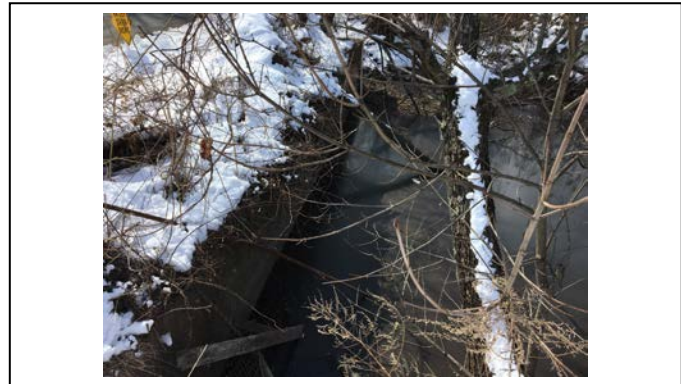
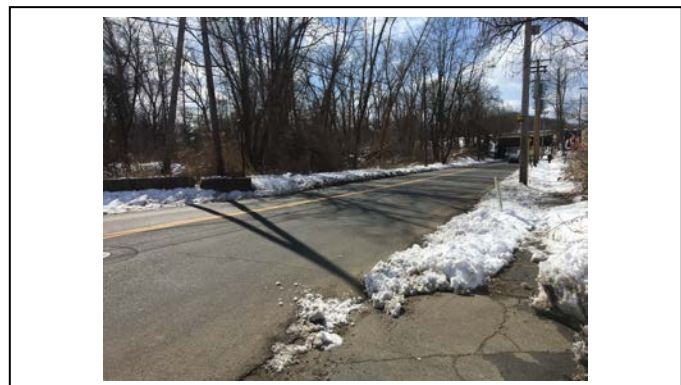
Elevation

Status Summary: At time of inspection only one 12" diameter outlet was above the water line. Headwalls on either side of the structure are in good condition. Water was still and additional piping, depth, and condition could not be determined. There is no barrier on the West side, the East side has 3 sections of 20' jersey barrier approx. 10' off the curb line. A significant amount of debris, trash, and vegetation were covering the Eastern (inlet) side of the culvert, pipes were not exposed and flow was restricted.

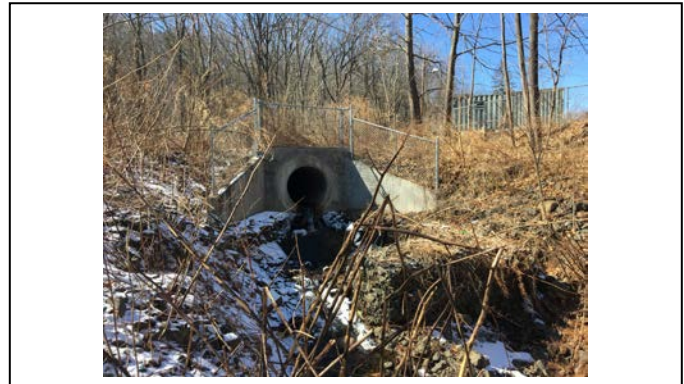
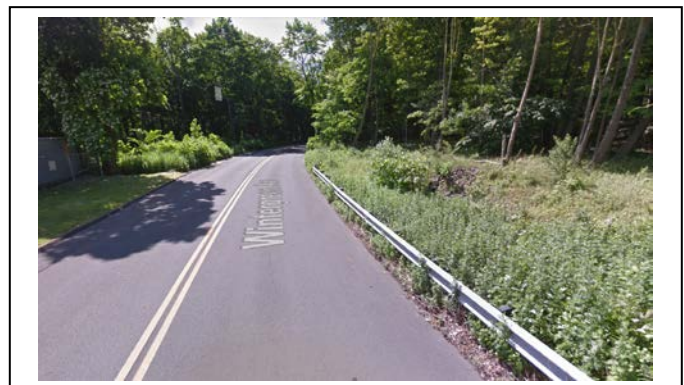
Elevation

Status Summary: This culvert is on Wintergreen Ave. approximately 1,100' south of Brookside. It is approximately 36" wide and in overall good condition. Erosion control devices have begun to fail and debris are interfering with flow at the inlet. There were no indications of distress at the headwalls, or within the body of the pipe.

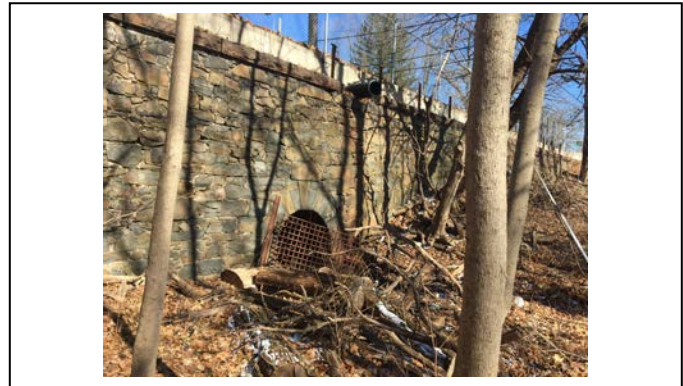
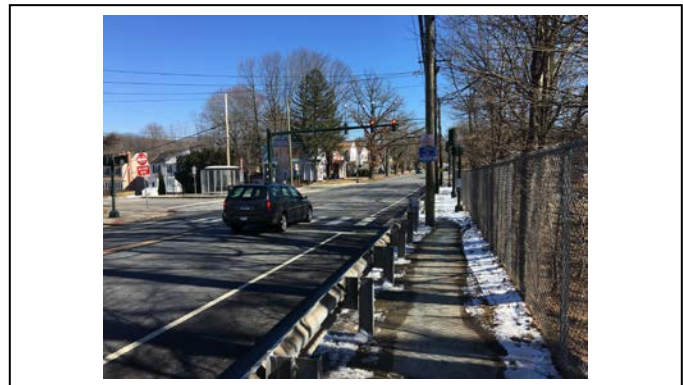
Elevation

Status Summary: Elliptical culvert under Fountain St. approximately 4'-11" wide and 5'-3" tall. Masonry retaining wall in good condition with minor vegetation overgrowth. Metal grating on inlet clasps have rusted off and is hanging loosely. Interior of structure appears in good condition from outside.

Suggested Work: Further inspection should be performed, record drawings located and flow should be observed during a rain event.

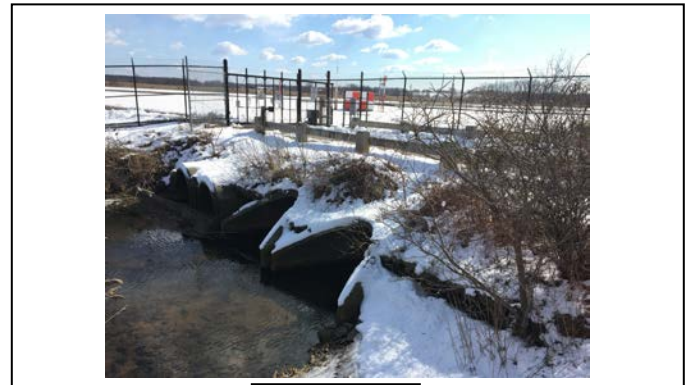
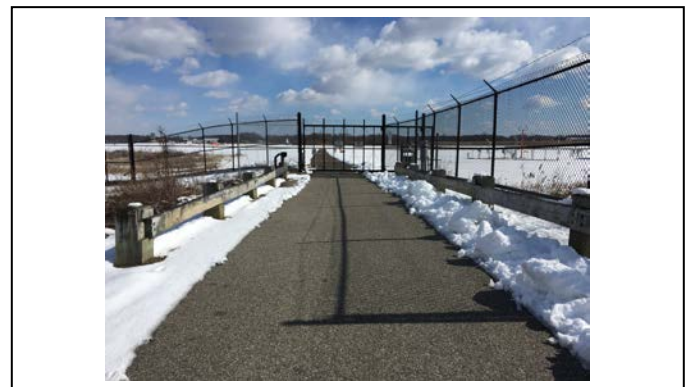
Elevation

Status Summary: This structure was installed to serve as an airport emergency access road from Morris Causeway to the Tweed runway. It conveys tidal water under the access road and consists of four buried 5' diameter RCPs approximately 28' long each. Flow was obstructed in two of the pipes and riprap at the SW slope has shifted at the time of inspection.

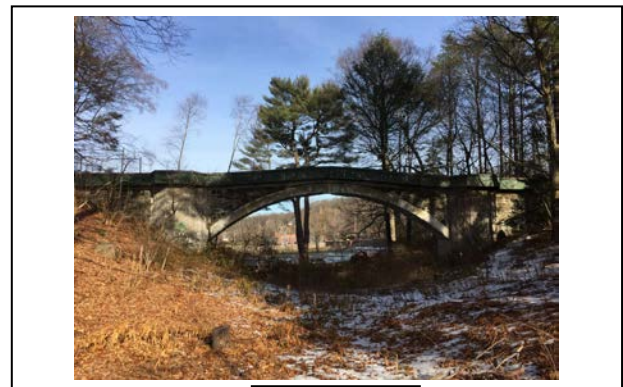
Elevation

Status Summary: This is a defunct structure that use to serve as an access road within Edgerton Park. The deck and approaches have fencing and plywood coverings to keep pedestrians off the bridge. The substructure appears to be in satisfactory condition. There is typical mortar loss within acceptable tolerances, and cracking on the underside of the deck.

Suggested Work: Temporarily uncover bridge for further inspections. Consider necking down bridge approach to only allow pedestrians access if conditions warrant reopening.

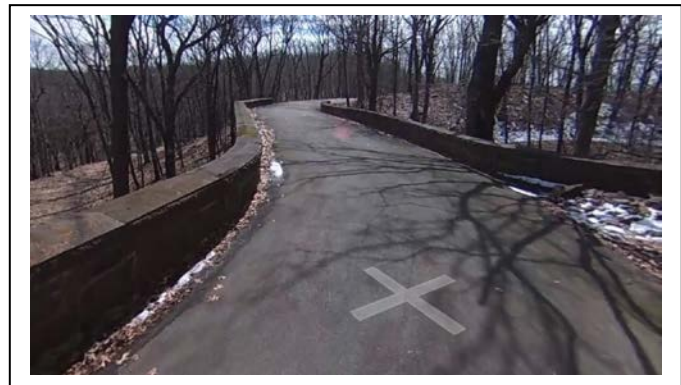
Elevation

Status Summary: Park's dept. access road bridge over East Rock Park trails.

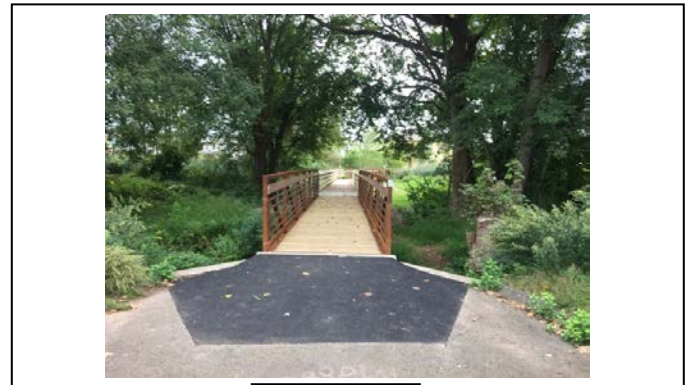
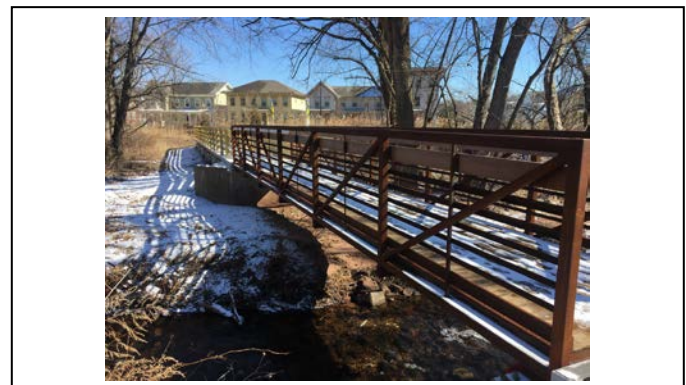
Elevation

Status Summary: This structure was installed as part of the Winslow Augustine Pedestrian Path project in 2018. It spans between Winslow Augustine Park and the Trail Path over Beldon Brook. It should have a minimum of 20 years maintenance free design life.

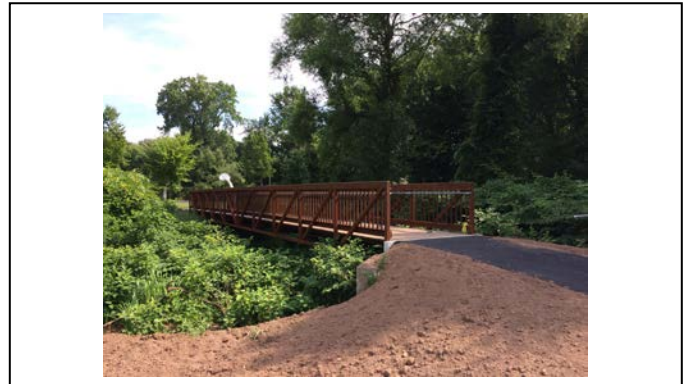
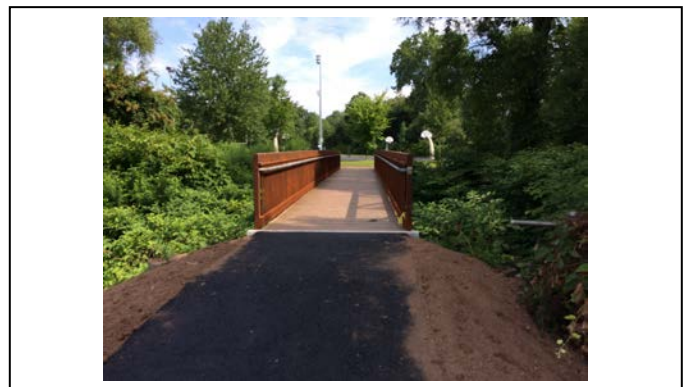
Elevation

Status Summary: This bridge was installed in 2017 and should have a typical maintenance free design life of 20 years minimum. It spans over Wintergreen brook between Winslow Augustine Park and the elementary school adjacent to Wilmot Rd.

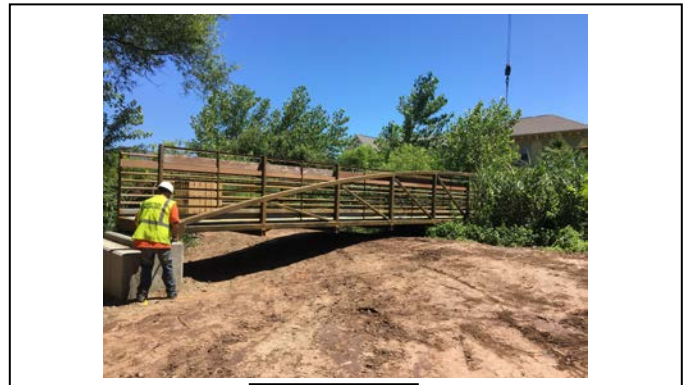
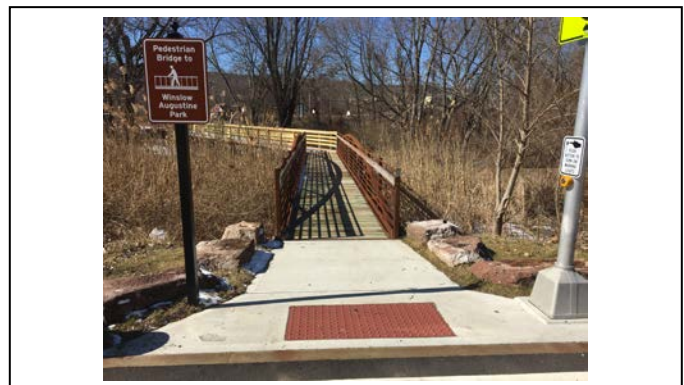
Elevation

Status Summary: This structure was installed in 2018 as part of the Winslow Augustine Pedestrian Path project. It spans between Augustine St. and the trail to Winslow Augustine Park over a detention basin and wetlands. It should have a minimum of 20 years maintenance free design life.

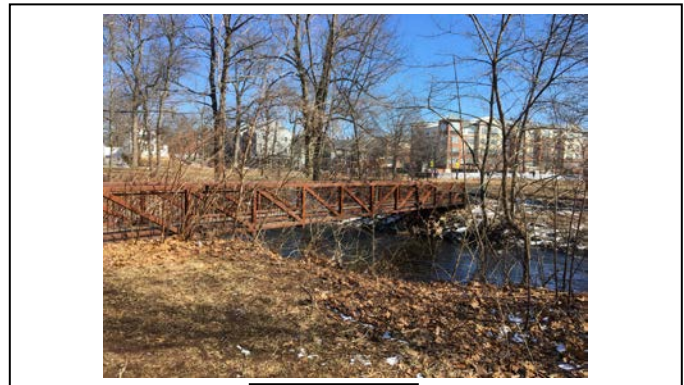
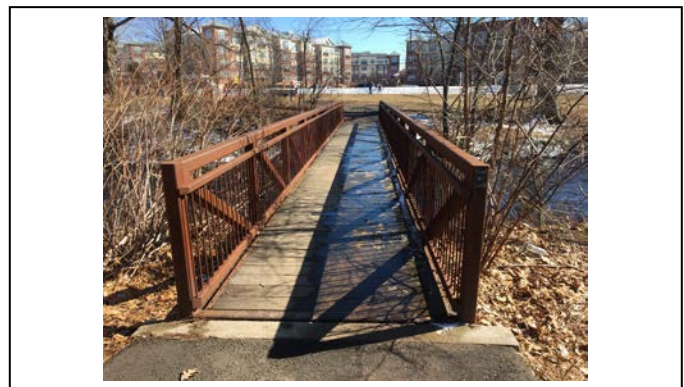
Elevation

Status Summary: This structure was installed in 2014. It spans over the West River between the playground adjacent to Blake St. and the parking lot off Valley St. It should have a minimum of 20 years maintenance free design life.

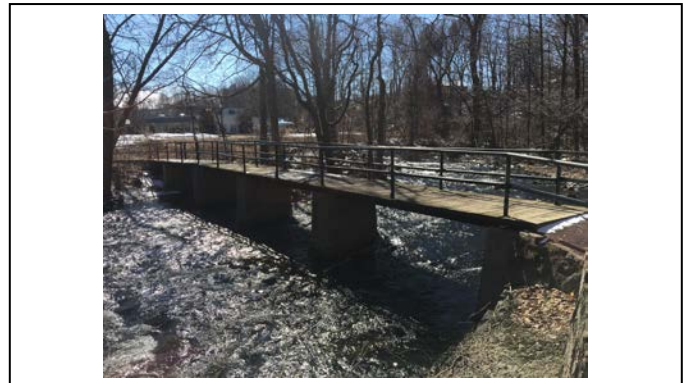
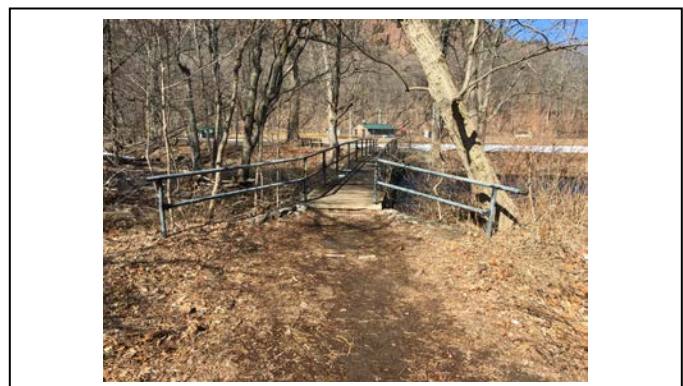
Approach

Status Summary: This structure spans over the West River from the parking lot adjacent to Valley St. to the West Rock Park baseball fields. There are no reliable record documents of when it was installed or the design of substructure units. There is a moderate shear crack in the Southern abutment, however the superstructure shows no indication of movement or distress. The decking is beginning to rot at connection points. Debris accumulation was typical against all the in-water piers.

Suggested Work: Clean decking of rot and treat with preservative. Periodically remove debris from piers to avoid negative impacts to channel flow.

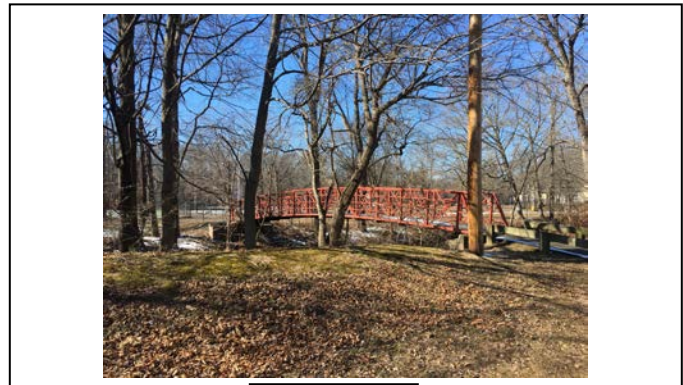
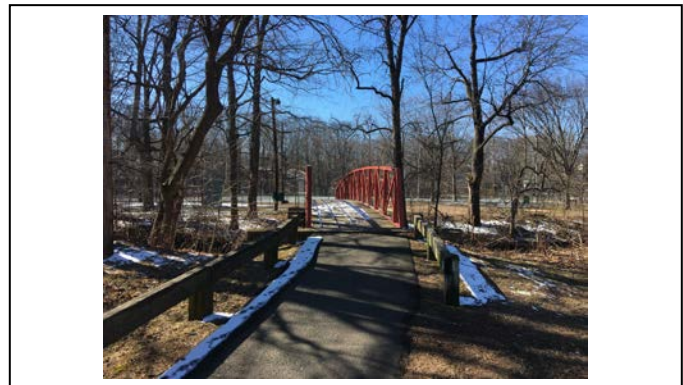
Elevation

Status Summary: This structure spans over the West River between the tennis courts and Coogan Pavilion within Edgewood Park. It is in overall good condition.

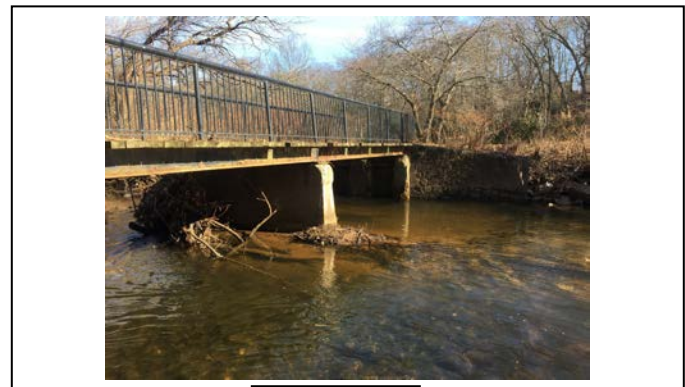
Elevation

Status Summary: This structure spans over the West River between a hiking path and the main access road within Edgewood Park. The decking on this structure is severely deteriorated and should be replaced. Several of the connections have failed due to corrosion and boards are loose. There is a significant amount of debris accumulating on the center pier causing channel flow problems. The masonry wingwalls have significant loss of mortar. The abutments have typical cracking and spalls but do not appear to be in distress.

Suggested Work: Replace bridge decking, clean and paint structural steel superstructure, repoint masonry and patch concrete abutments. An analysis should be performed to compare costs of rehabilitation to full replacement.

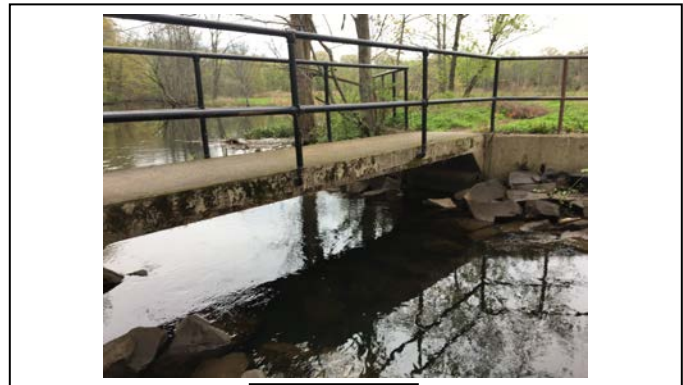
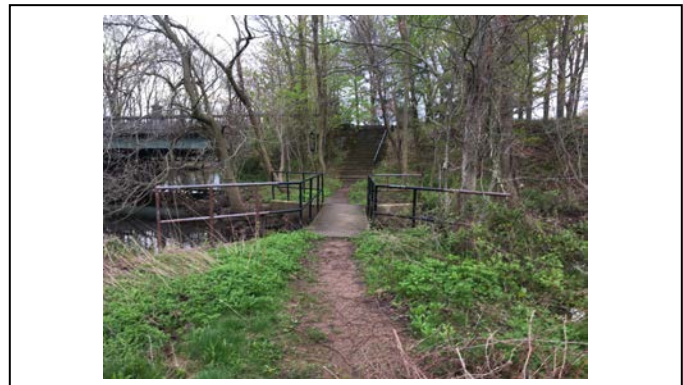
Elevation

Status Summary: This structure spans over the West River between a path from Edgewood ave to soccer fields within lower Edgewood Park. CIP concrete slab bridge is in overall good condition. The abutment was cast monolithic with the slab but there is a cold joint between the abutment and backwall/wingwalls that has begun to move laterally.

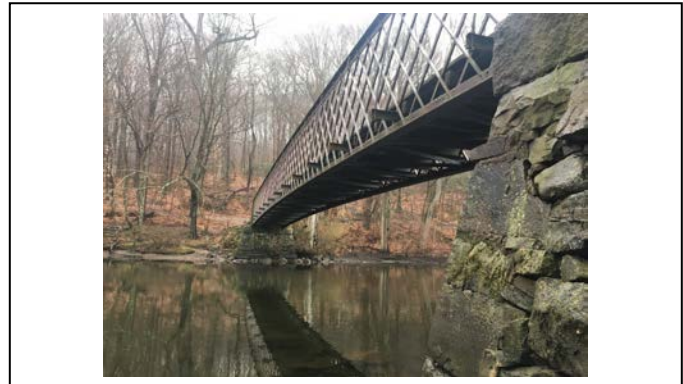
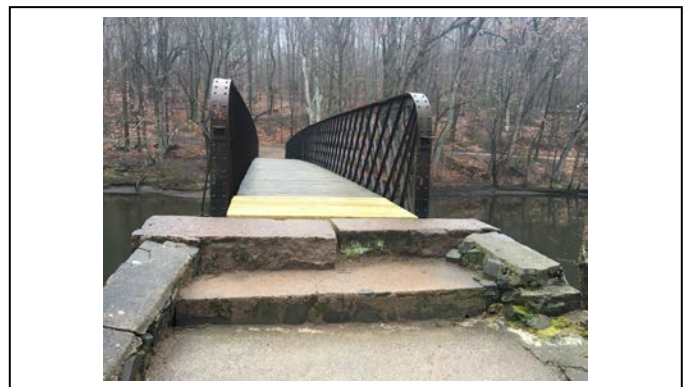
Elevation

Status Summary: This structure spans the Mill River in East Rock Park. It connects two hiking trails adjacent to English Drive and East Rock Park Drive. A void in the west wing wall due to scour and bulging of the wingwalls has begun. There is a 4" wide 12" deep void in the face of the eastern abutment.

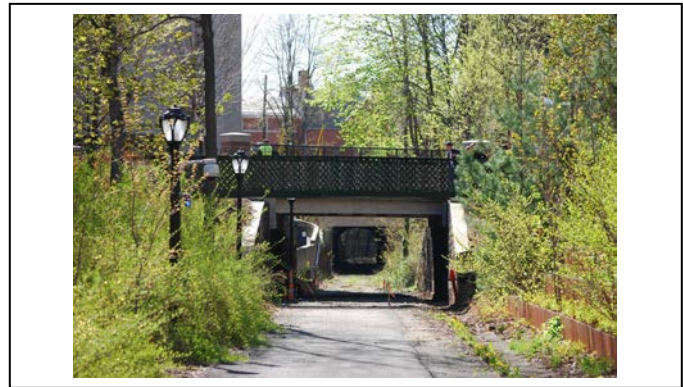
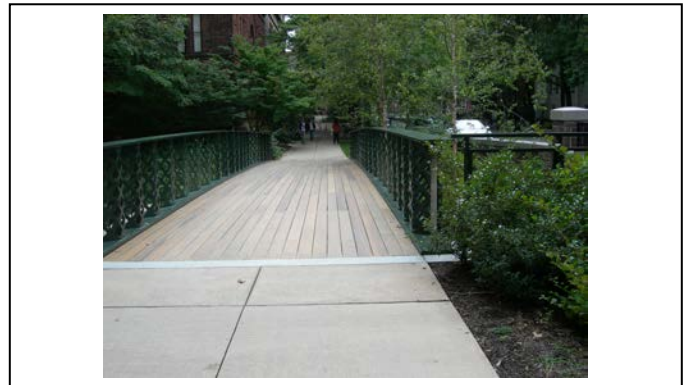
Elevation

Status Summary: This structure was installed in conjunction with the Hill House Ave Bridge Replacement project in 2009. It is one of twin pedestrian bridges installed on East and West sidewalks. The structure should have a minimum 20-year maintenance free design life.

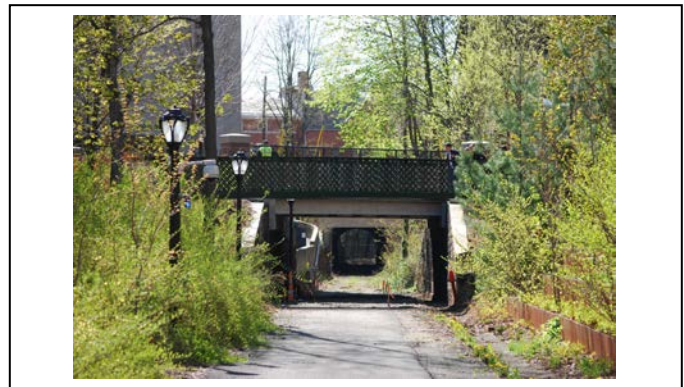
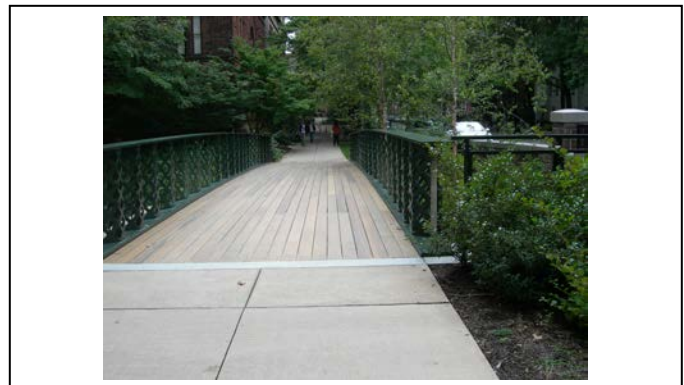
Elevation

Status Summary: Western twin pedestrian bridge over Farmington Canal. This bridge was installed in 2009 and should have a typical maintenance free design life of 20 years minimum.

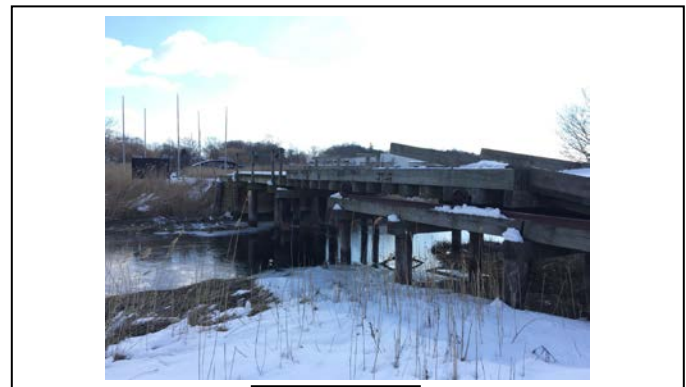
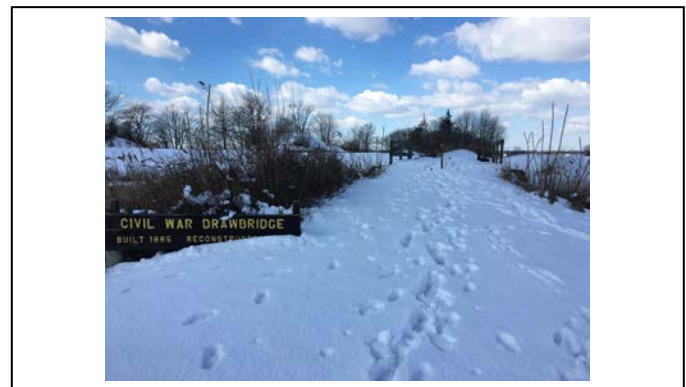
Elevation

Status Summary: Historic pull bridge within Fort Nathan Hale Park over tidal inlet. Pile supported bents without signs of deterioration. Signs of rot in toe-guard on deck of superstructure. Inlet is tidal, flow rate is insignificant, and no scour or erosion is anticipated.

Suggested Work: Further inspection of piles during low water and deck for rot should be conducted.

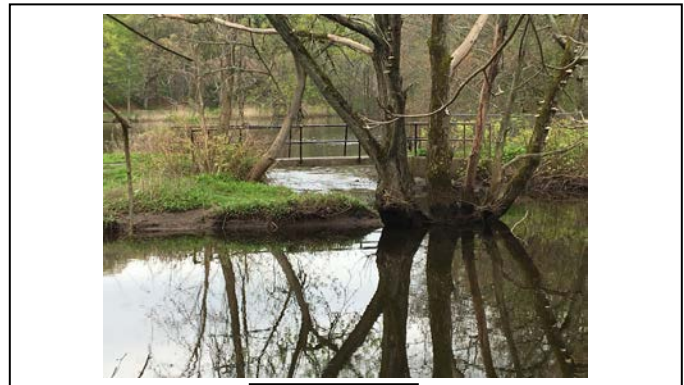
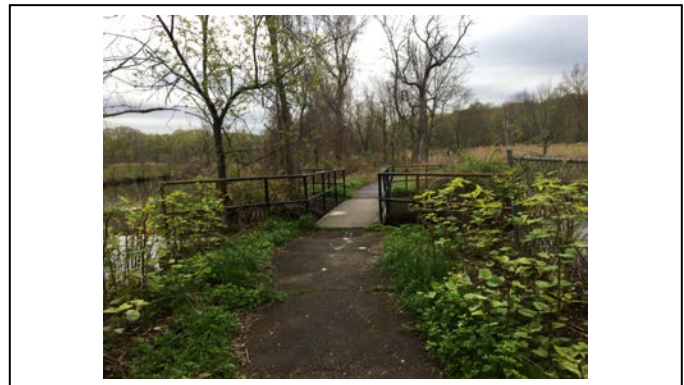
Elevation

Status Summary: Pedestrian bridge adjacent to Chapel St. on walking path through park over West River. One of two twin bridges at river. CIP concrete slab bridge is in overall good condition. The abutment was cast monolithic with the slab but there is a cold joint between the abutment and backwall/wingwalls that has begun to move laterally.

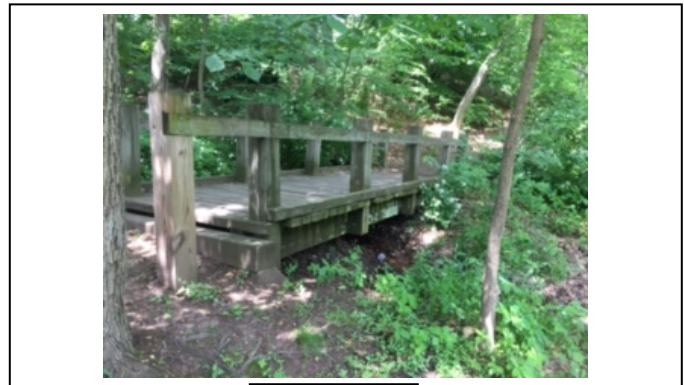
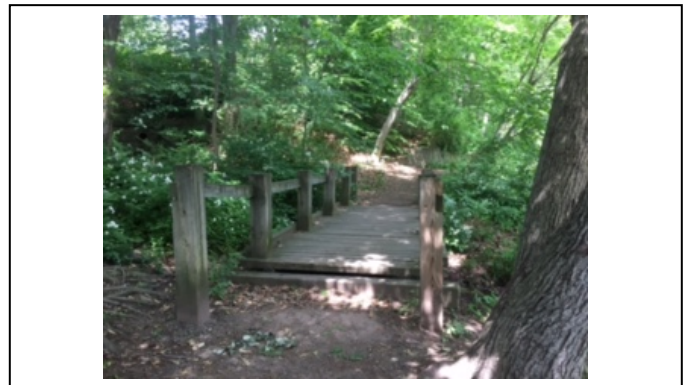
Elevation

Status Summary: Pedestrian bridge adjacent to Mill River on pedestrian trail in East Rock Park off Orange St. Timber superstructure on timber backwall. Brook invert to superstructure low member is approx. 2'.

Suggested Work: No significant work is anticipated to keep this bridge operational, bridge should be inspected after significant storm events for debris and aggradation, and substructure checked for rot every other year.

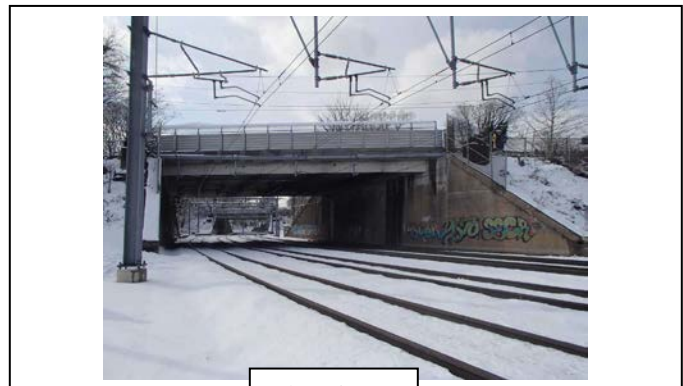
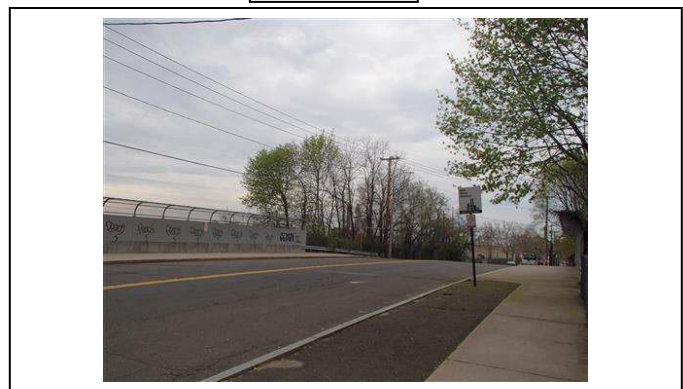
Elevation

Status Summary: This bridge is in fair condition, there is leakage and typical superficial deterioration of the superstructure. The overlay has map cracking, efflorescence between deck units indicates failure of the waterproofing membrane. The City is responsible for the wearing surface and maintenance.

Suggested Work: Seal the map cracking in the overlay during the next season.

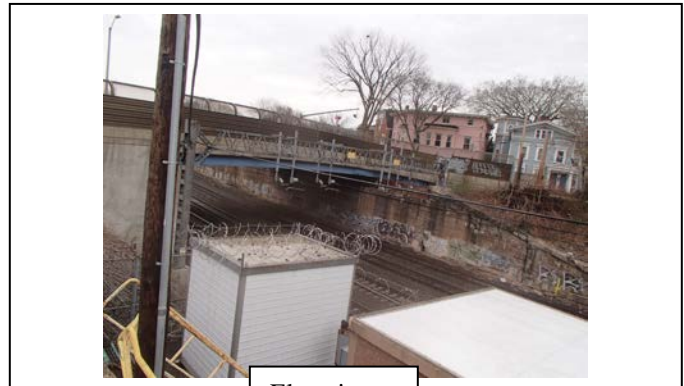
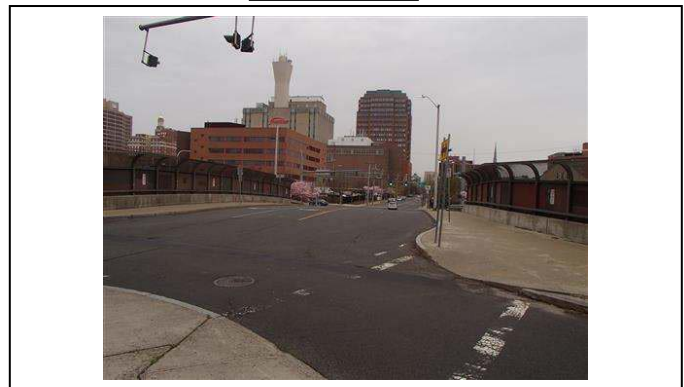
Elevation

Status Summary: This bridge is generally in good condition. There is some map cracking and light to moderate raveling of the overlay. The City is responsible for the wearing surface and maintenance.

Suggested Work: Seal cracks and monitor for mill and pavement replacement in 5-10 years.

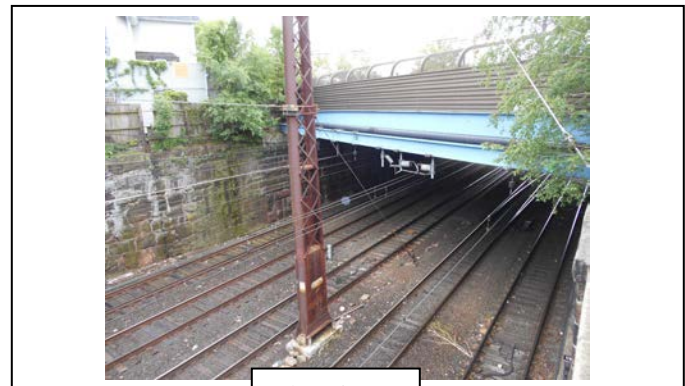
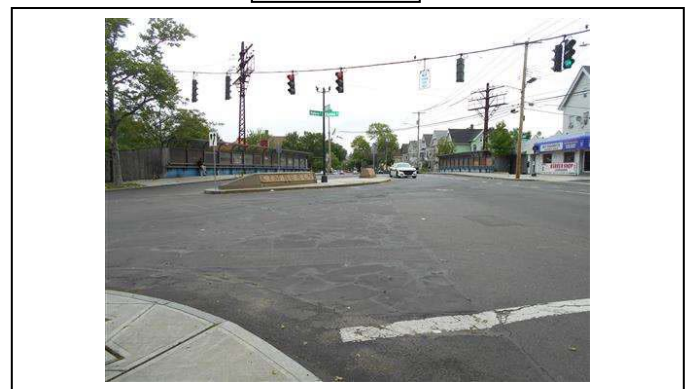
Elevation

Status Summary: This bridge is in satisfactory condition. Leaking at the abutments suggests penetrations in the overlay and waterproof membrane. The overlay has moderate wear and raveling at the curb line. The City is responsible for the wearing surface and maintenance.

Suggested Work: The overlay should be monitored for milling and pavement replacement within 5-10 years.

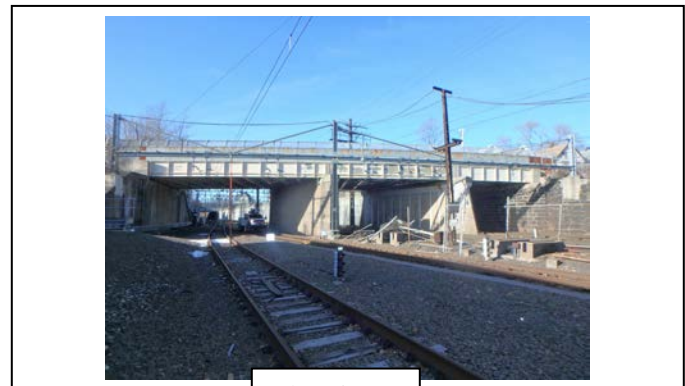
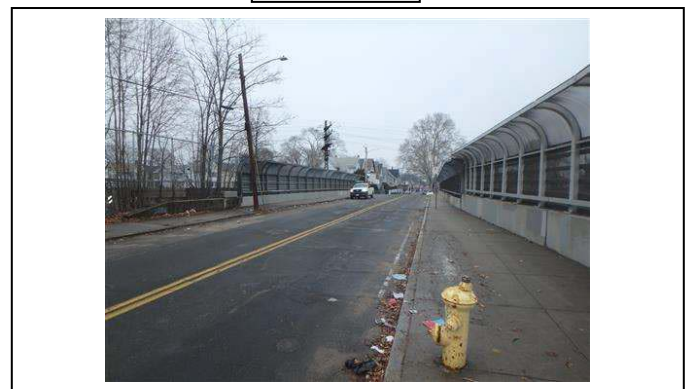
Elevation

Status Summary: This bridge is in satisfactory condition. The overlay exhibits extensive map cracking that has been sealed previously. The City is responsible for the wearing surface and maintenance.

Suggested Work: The overlay should be monitored for milling and pavement replacement within 5-10 years.

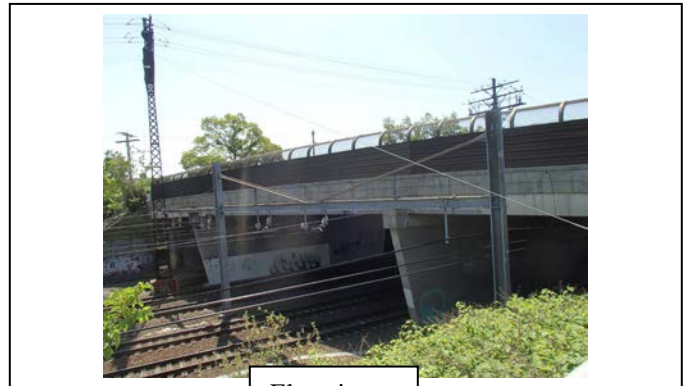
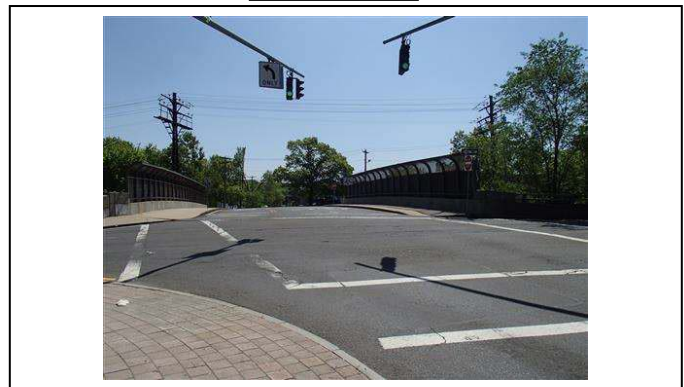
Elevation

Status Summary: This bridge is in generally good condition. There is light raveling throughout the overlay but no significant defects. The City is responsible for the wearing surface and maintenance.

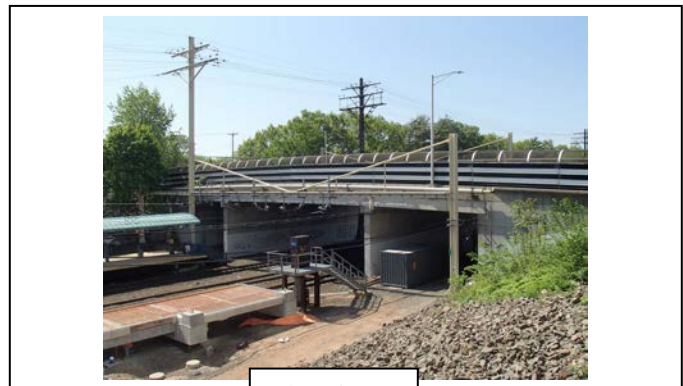
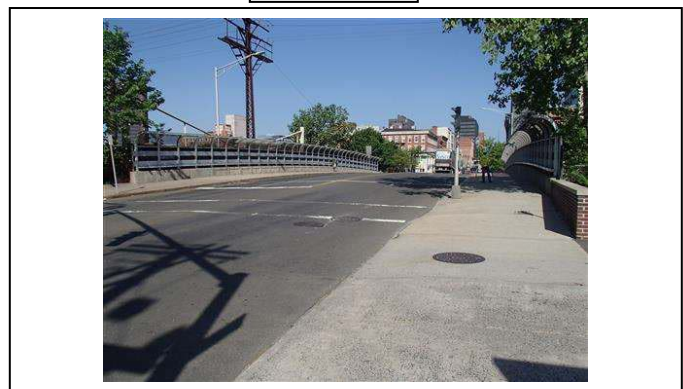
Elevation

Status Summary: This bridge is in satisfactory condition. The overlay, waterproofing membrane, and joint headers were replaced in 2018. The City is responsible for the wearing surface and maintenance.

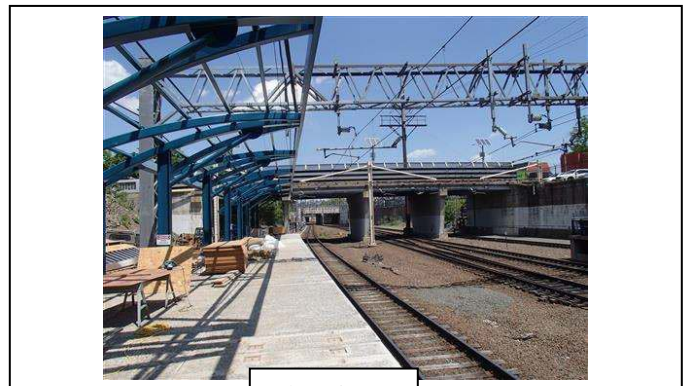
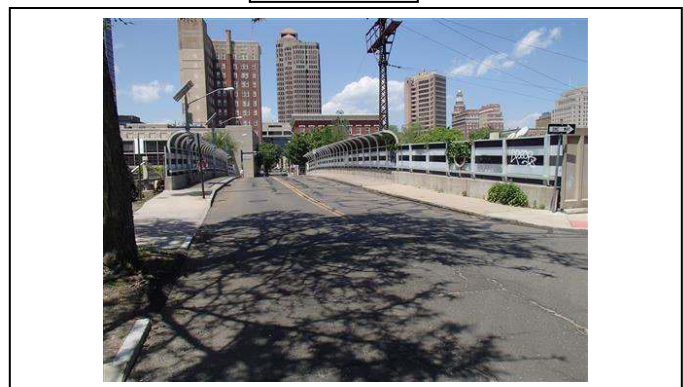
Status Summary: This bridge is generally in satisfactory condition. The City is responsible for the wearing surface and maintenance. There is map cracking which has been previously sealed, and light wear on the overlay.

Suggested Work: Seal cracks, mill and replace pavement within 5 years.

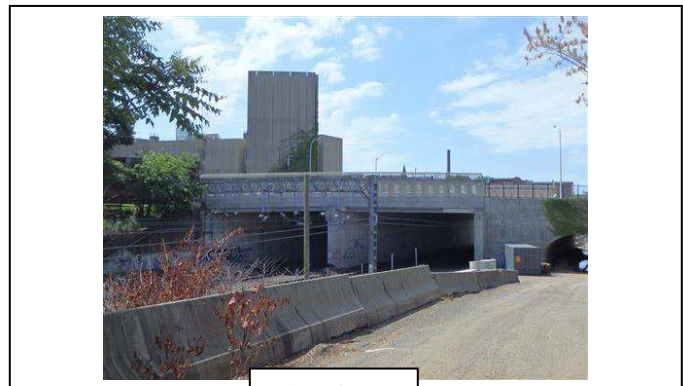
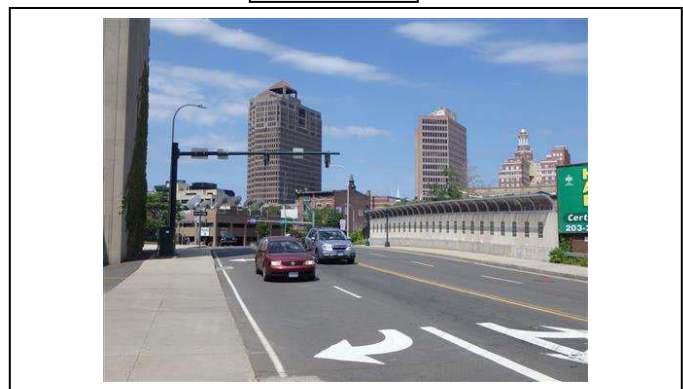
Status Summary: This bridge is generally in good condition. The City is responsible for the wearing surface and maintenance. There are random 1/2" wide cracks in the overlay and light wear.

Suggested Work: Seal cracks and continue to monitor for mill and pavement replacement within 5-10 years.

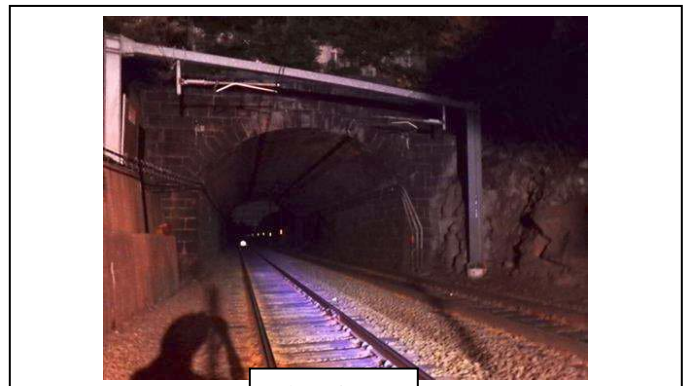
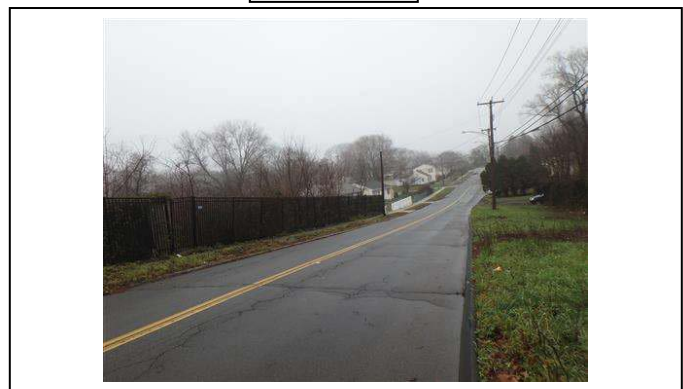
Status Summary: This bridge is currently in satisfactory condition. This bridge is now owned by Amtrak and will no longer be included in the State biennial inspection. The City is responsible for the wearing surface and maintenance. There are 1/2" cracks in the overlay.

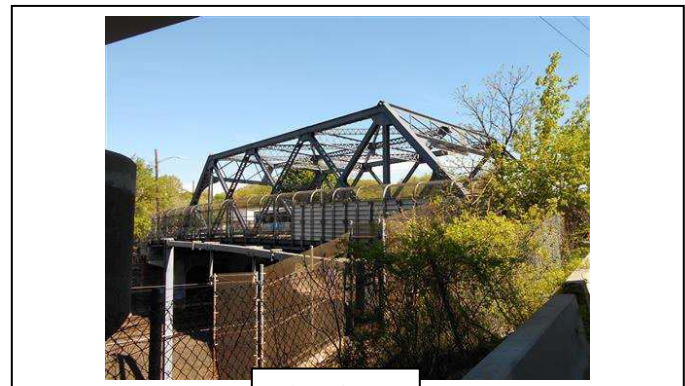
Status Summary: This bridge's superstructure is in poor condition. Stringers have section loss of 25% to 47% as well as pitting and rust build up. The City is responsible for the wearing surface and maintenance. A load rating request was submitted by the inspector to the State.

Suggested Work: The State is planning a rehabilitation project to replace the deck, wearing surface, approaches and perform limited concrete and steel repairs. The project is currently scheduled for the Fall through Spring of 2021 and will require a full road closure. The City is coordinating with the State to reduce the closure period and offer relief to anticipated congestion as much as possible.

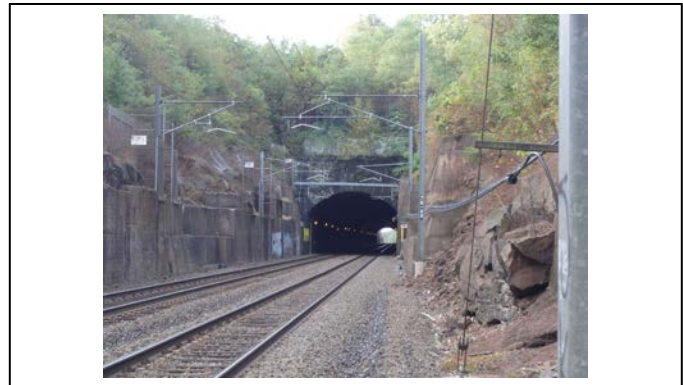
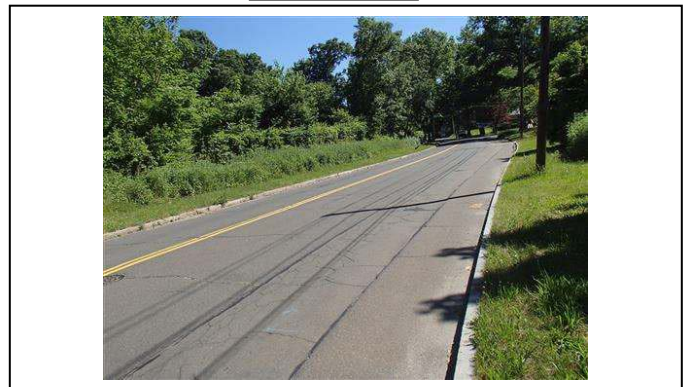
Status Summary: This structure is in poor condition. The superstructure is multi-course brick arch and at the 2016 inspection showed significant areas of efflorescence, mortar loss, and missing bricks. Load rating completed in 1991 by CTDOT using Concrete Judgement Rating found the bridge's inventory rating to be 36 Tons. The City is responsible for the wearing surface and maintenance. The overlay is in satisfactory condition.

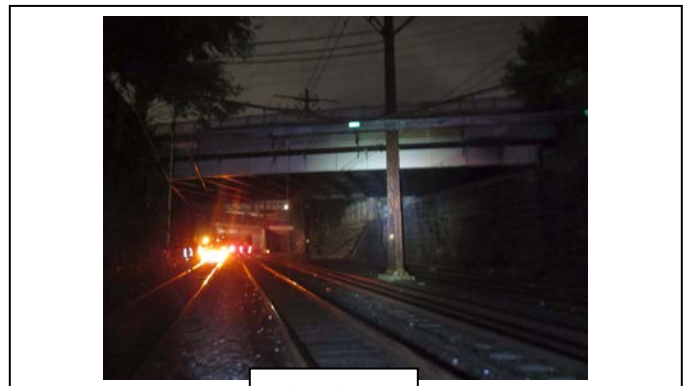
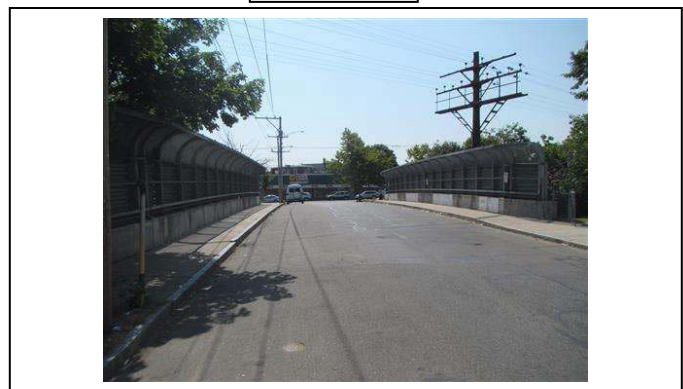
Status Summary: Bridge is generally in satisfactory condition. Random short cracks approx. 1/8" wide on overlay. The City is responsible for the wearing surface and maintenance.

Suggested Work: Seal cracks, monitor for mill and pavement replacement within 5-10 years.

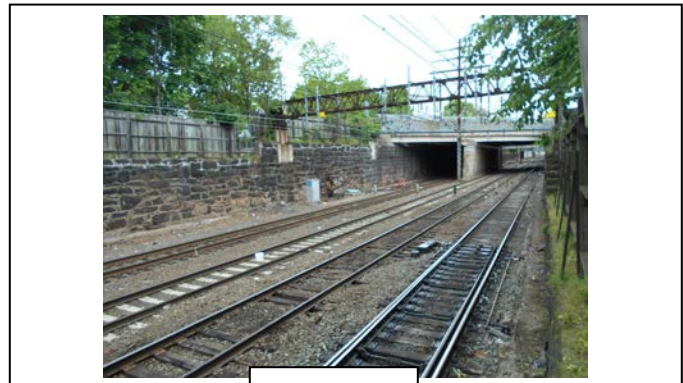
Status Summary: Bridge is in satisfactory condition. There are some 1/4" cracks previously sealed that have reopened. The City is responsible for the wearing surface and maintenance.

Suggested Work: Seal cracks, monitor for mill and pavement replacement within 5-10 years.

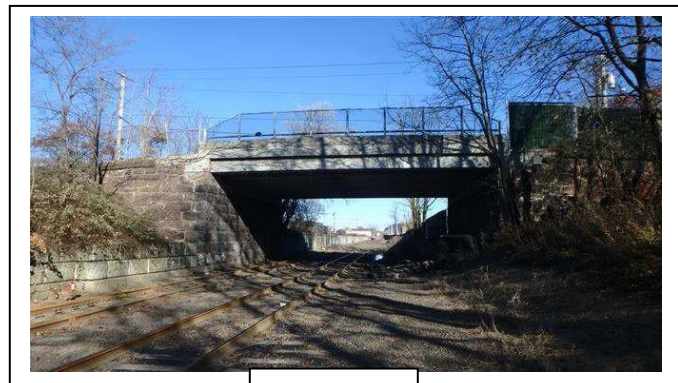
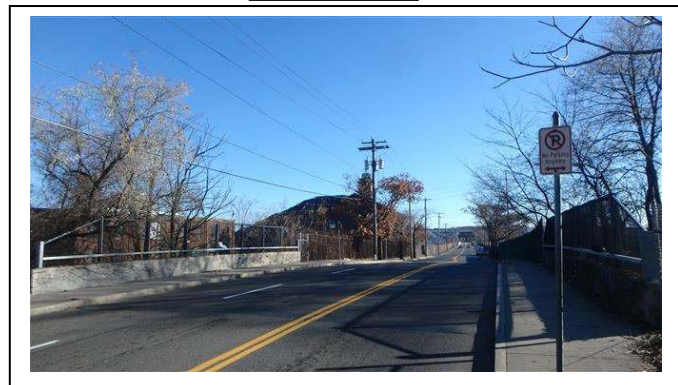
The bridge is in generally good condition. Overlay shows signs of light wear. The City is responsible for the wearing surface and maintenance.

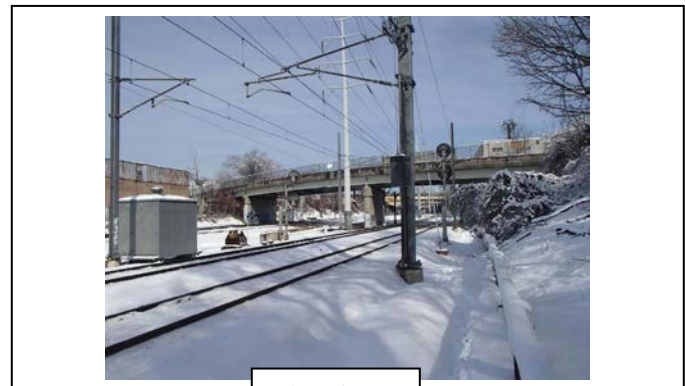
Status Summary: This bridge is in good condition. There is map cracking and raveling on the overlay. The deck show nominal efflorescence. The City is responsible for the wearing surface and maintenance. It should be noted in March 2017 adjacent construction of the UHAUL building caused undermining of the bridge abutment and a forced two-day closure of the bridge. Repair documents were created by Langan. The repair construction and coordination is the responsibility of the State.

Suggested Work: Cracks on the deck should be sealed next season.

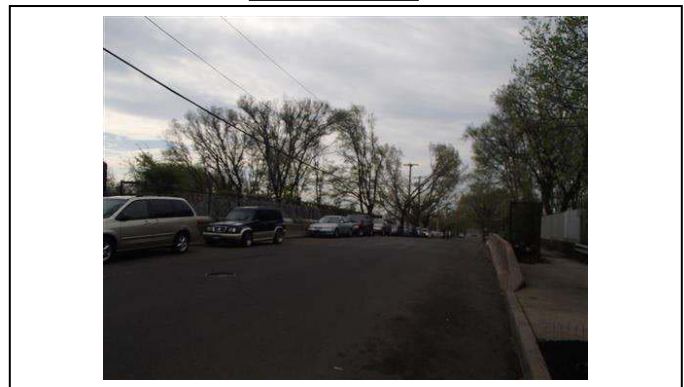
Status Summary: This bridge is generally in satisfactory condition. The cracks in the overlay have recently been sealed, and pot holes filled. The City is responsible for the wearing surface and maintenance.
