NEW HAVEN BRIDGE CONDITION REPORT

June 2019

**City Of New Haven
Engineering Department**

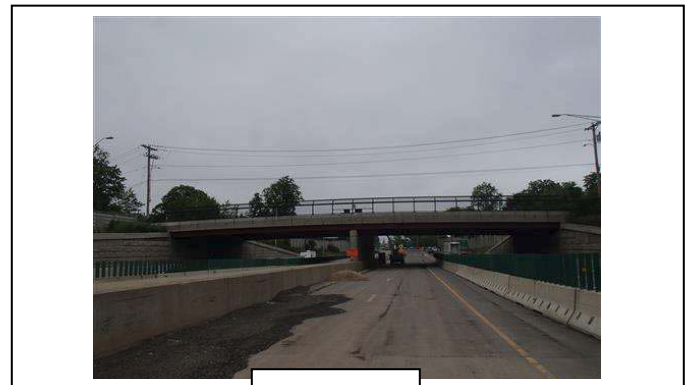
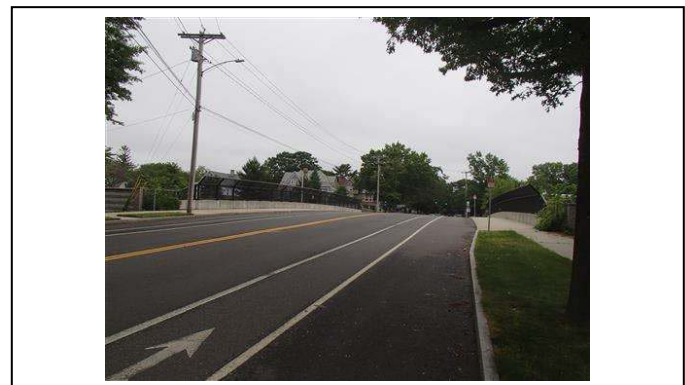
Status Summary: Bridge is in generally good condition. The City is responsible for the wearing surface and maintenance.

Overlay has some cracking and should be repaved within 5 years – at which time coordinate with the State for waterproofing membrane and joint replacement.

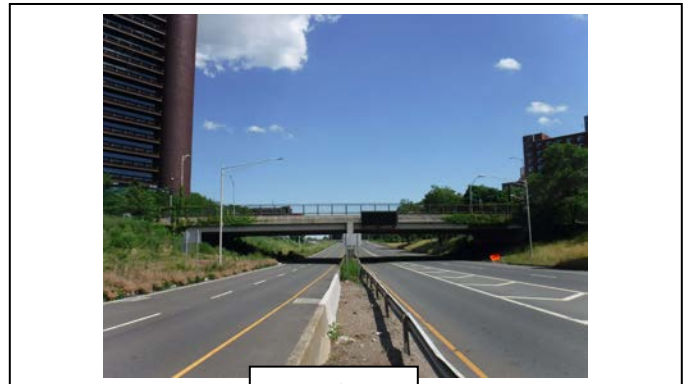
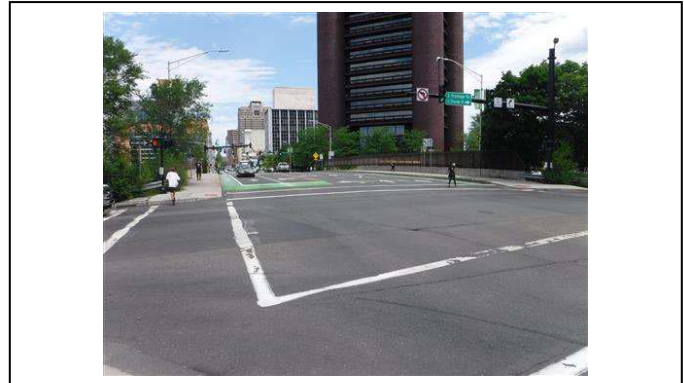
This bridge is in generally good condition. The City is responsible for the wearing surface and maintenance. Random ¼" cracks in the wearing surface, and moderate overall wear.

Seal cracks next season. Mill and pave within 5-10 years.

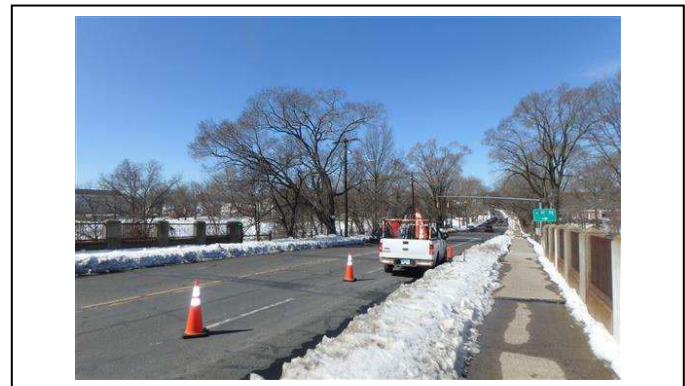
Bridge is in satisfactory condition. The City is responsible for the wearing surface and maintenance.

This bridge was milled and paved by the City in 2018. The State replaced the waterproofing membrane and joints.

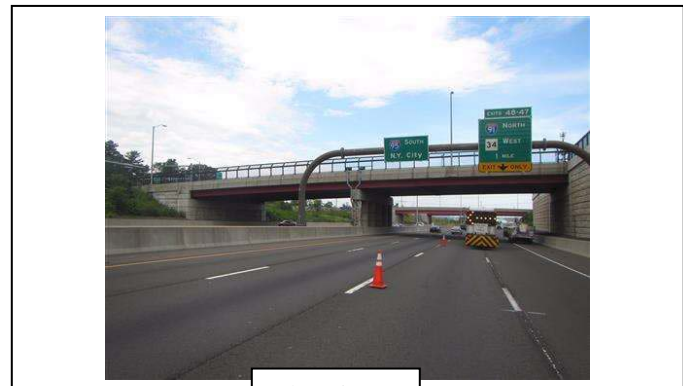
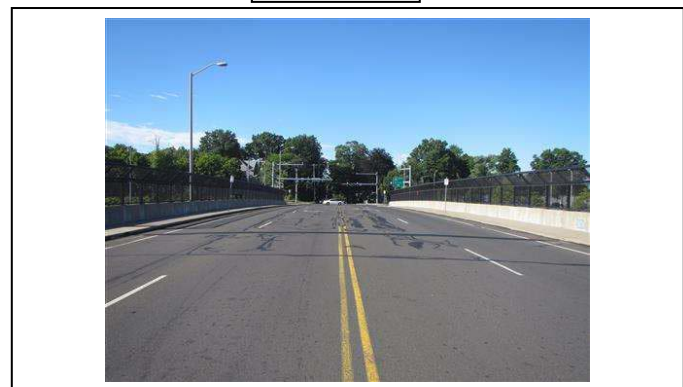
Bridge is in generally good condition. The City is responsible for the wearing surface and maintenance.

The overlay has very light cracking and should be inspected for milling/replacement within 10 years.

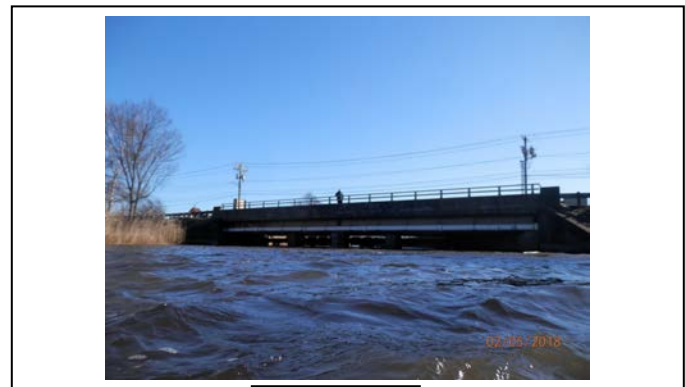
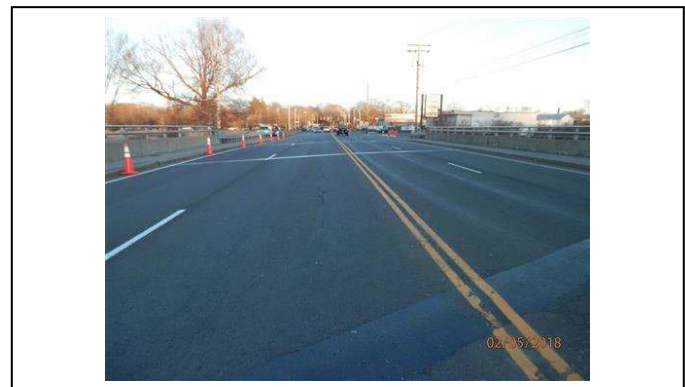
Status Summary: Route 1 (Columbus Ave.) over West River on New Haven/West Haven town line. Structure is in generally satisfactory condition. Bearing devices and girders have moderate rust and random areas of pitting. Substructure shows typical signs of wear but no distress. There are localized areas of scour at the substructure units.

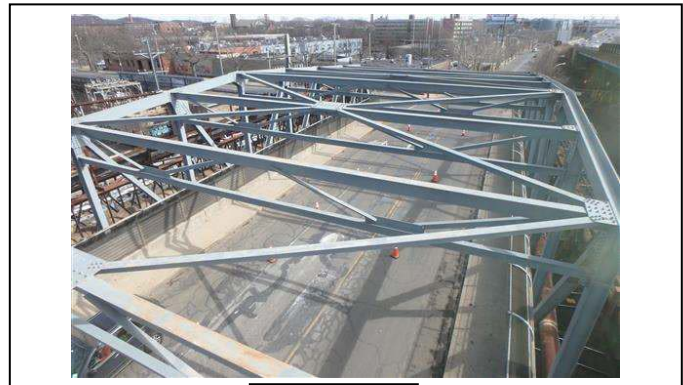
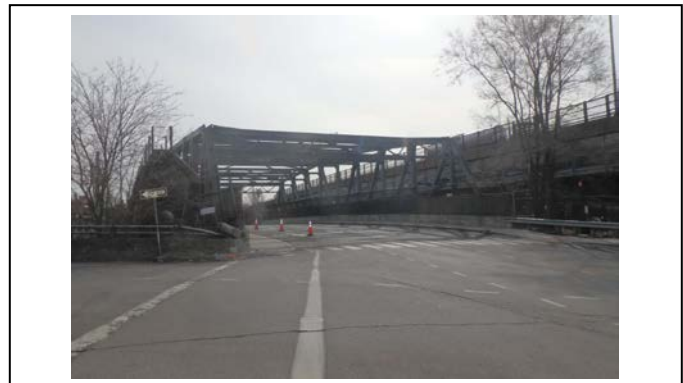
Status Summary: Water street bridge over Metro North Railroad. The superstructure is in satisfactory condition, some locations of debris accumulation and rusting has begun. Portions of the bracing and lateral frame sag up to 2", but no further distress is evident. The structure was load rated in 1999 and received an inventory rating of 56.5 TN. Significant collision damage to the parapet at the SW approach (shared parapet with State St. North bridge).

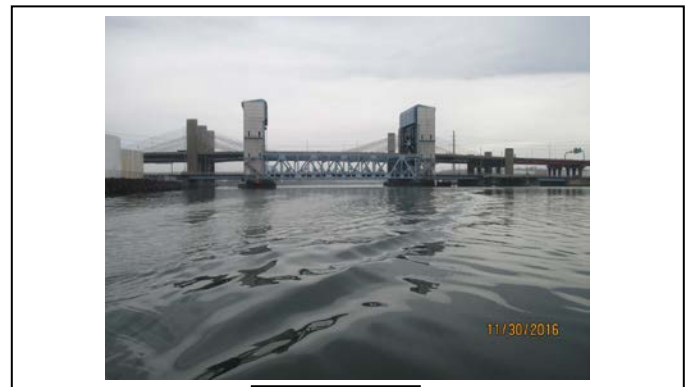
Status Summary: Tomlinson Lift Bridge (Forbes Ave.) over the Quinnipiac River. This structure was replaced in 2002 and is in overall good condition. There is typical wear on the overlay and hairline map cracking of the deck. The superstructure has minor rusting in some locations. The substructure has isolated vertical hairline cracks. Localized scour at pier 1w exposed the sheet pile around the footing, but no undermining was observed.

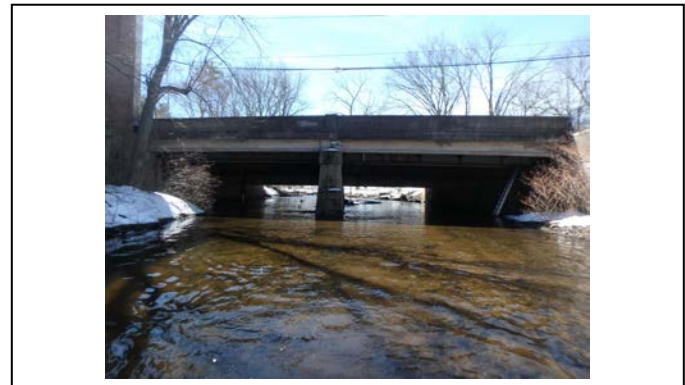
Status Summary: Route 63 (Whalley Ave.) over the West River. This structure is in fair condition. It was load rated in 2009 and received an inventory rating of 45.7 TN. The sidewalks have spalls up to 4" deep and pose trip risks to pedestrians, active leakage was observed through sections of sidewalk joints and spalls onto the superstructure below. The parapets have significant spalls with exposed rebar. The superstructure is made up of concrete encased steel girders. Cracks up to 1" wide, severe spalls at girder bearings, and section loss up to 25.2% was observed on the bottom flange of girders. The substructure has typical spalling and cracks up to 7/16" wide, several full height vertical cracks were noted on the abutments and pier. The footings have become exposed up to 21" in depth and areas of scour up to 30" deep along the abutments.

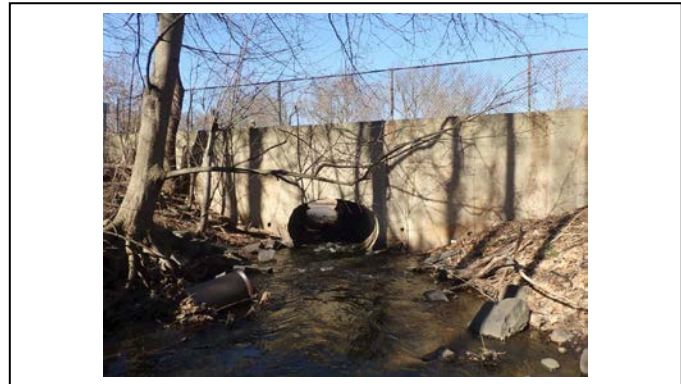
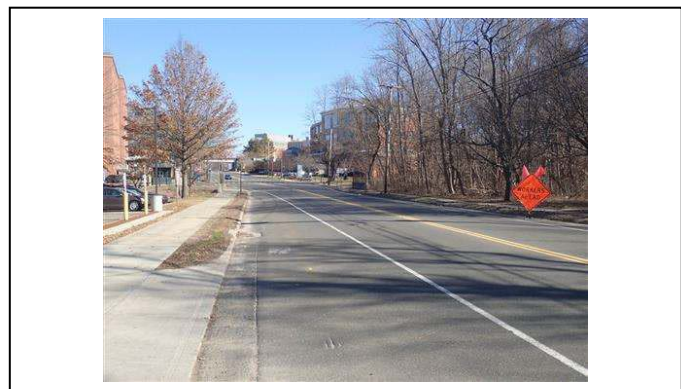
Status Summary: This structure is in overall satisfactory condition. It is the State's responsibility to maintain the road and structure. It was load rated in 2002 using a Judgement Rating method and found to have an inventory rating of 34 TN. Masonry within the culvert has some voids, cracked stones, and mortar loss. Concrete pipe extensions and headwall have minor spalling and typical cracking.

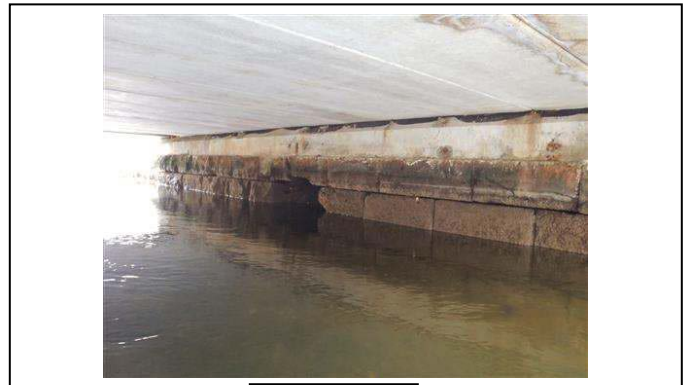
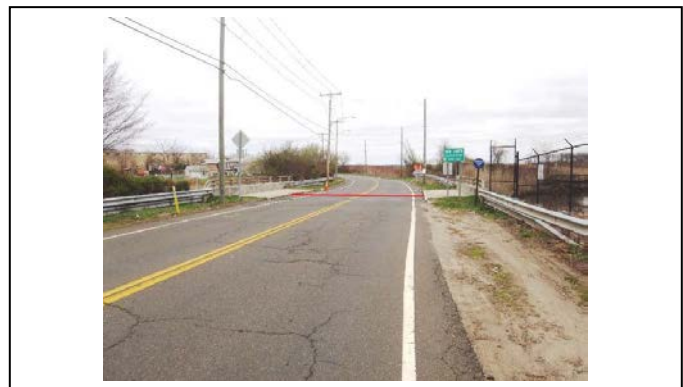
Status Summary: Route 337 (South End Rd.) over Morris Creek. This structure is owned and operated by the State at the boarder between New Haven and East Haven. It's substructure currently has a condition rating of '4' giving the structure an overall rating of poor. The superstructure is in overall good condition showing typical signs of wear. The abutments, made up of masonry brownstones, have lost enough mortar that stones have come loose and shifted. There are several voids, shear cracks, and heavy deterioration sections. The bridge was load rated in 2001 and given an inventory rating of 45.6 TN.

Suggested Work: Continued monitoring. This is a State bridge and as such they should be planning a rehabilitation project for it. At the moment the substructure conditions will not present a danger to the traveling public.

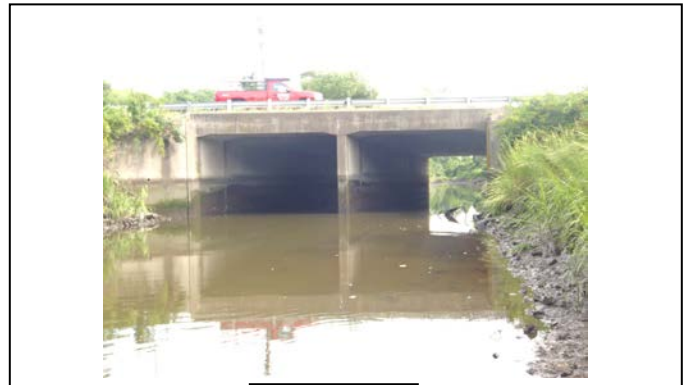
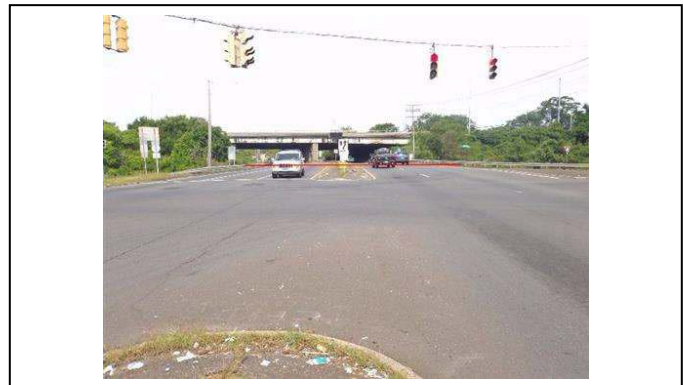
Status Summary: Route 17 (Foxon Blvd.) over little river at Middletown Ave. Structure is in overall satisfactory condition and was load rated in 2005 using the Concrete Judgement Rating method. Some sections of severe scale were found within the culvert at the water line and full depth in structure joints. The center pier (wall) has a section of void space approximately 1'x6". Efflorescence and hairline map cracking was typical throughout the interior of the structure.

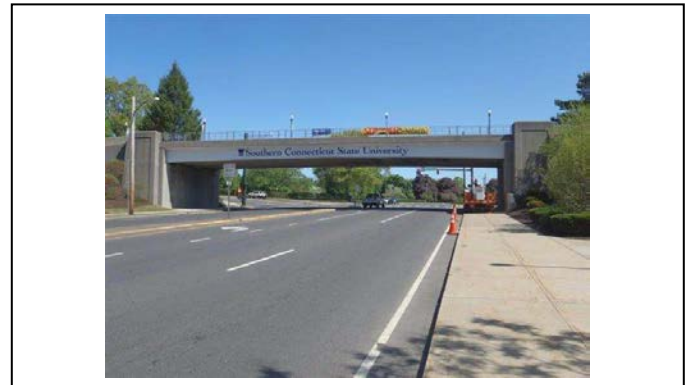
Status Summary: Pedestrian bridge over Route 10 (Fitch St.). Structure is in good condition. Minor spalling and vehicle impact damage is evident in the girders and CIP deck.

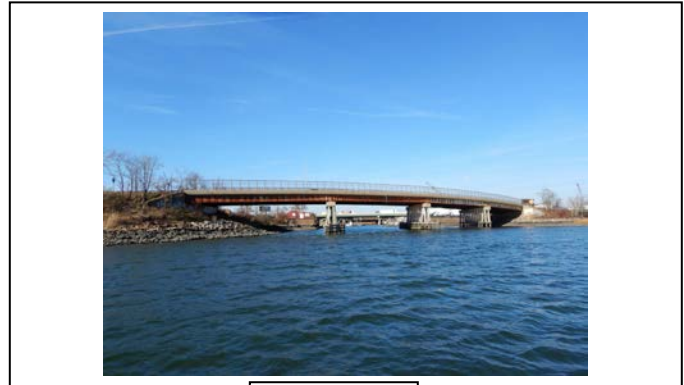
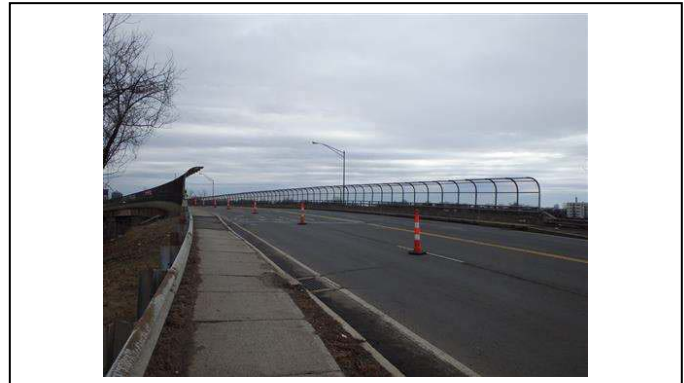
Status Summary: Route 745 (Kimberly Ave.) over the West River. This structure is State owned and maintained, on the boarder of New Haven/West Haven. The structure is in overall satisfactory condition.

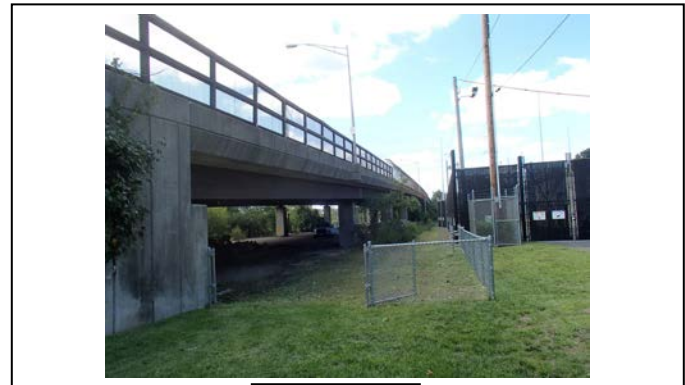
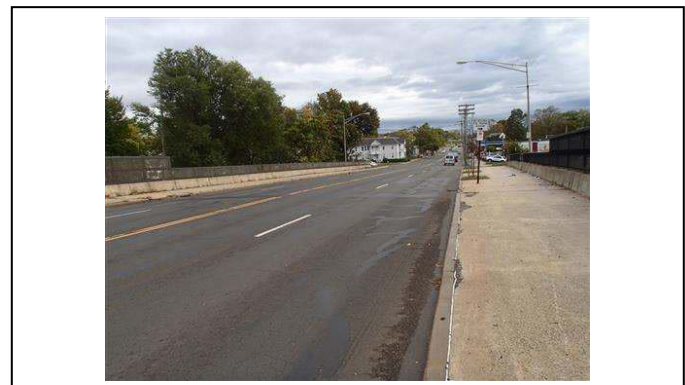
Status Summary: Route 10 (Ella Grasso Blvd) over Metro North RR This structure is in overall satisfactory condition. It was load rated in 2000 and given an inventory rating of 37.8 TN. The deck and wearing surface have slight map cracking within acceptable tolerances and deterioration was estimated at 1% of the total area. The bearings have accumulated pack rust and were found to be in 'fair' condition at the time of inspection. The superstructure was also given a rating of 'far' due to section loss in the web of several girders. Significant spalling has occurred at the bearing areas of intermediate columns.

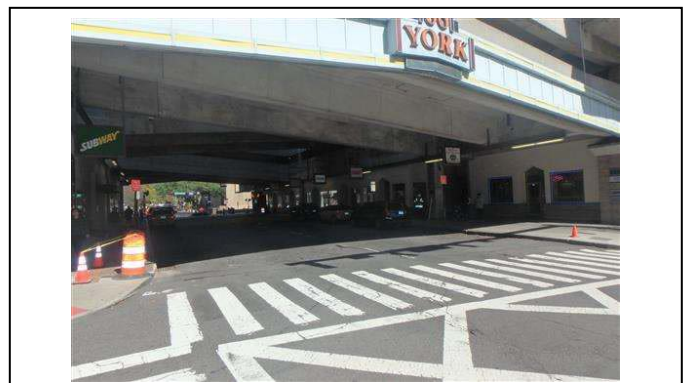
Approach

Status Summary: York St. over 'future route 34'. The structure is in overall satisfactory condition and was load rated in 2002. The overlay has typical wear, raveling and several potholes. Underside of the deck has spalls up to 1" deep, but no noticeable efflorescence. Minor concrete spalls, delamination and hollow areas were found on the abutments and piers.

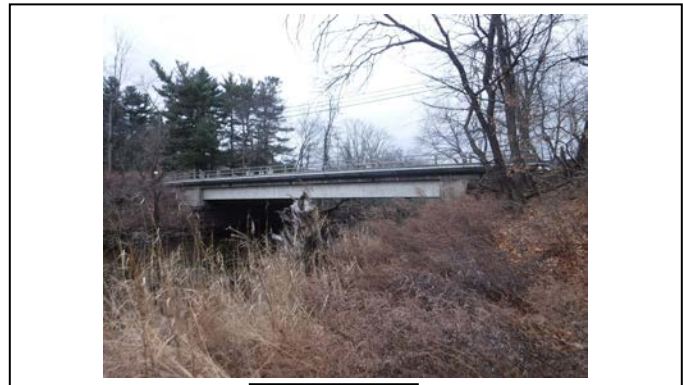
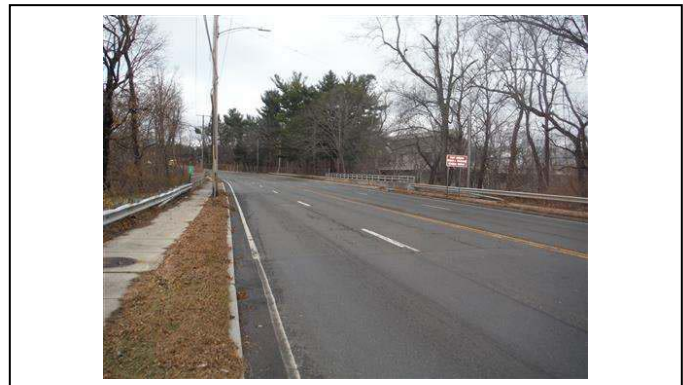
Status Summary: Route 34 (Derby Ave.) over West River. The structure is in overall satisfactory condition. It was load rated in 1999.

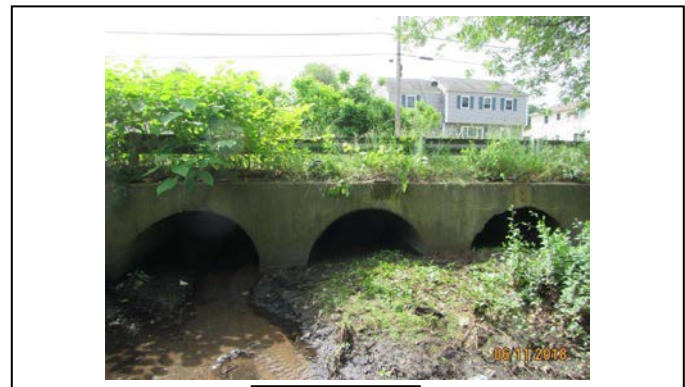
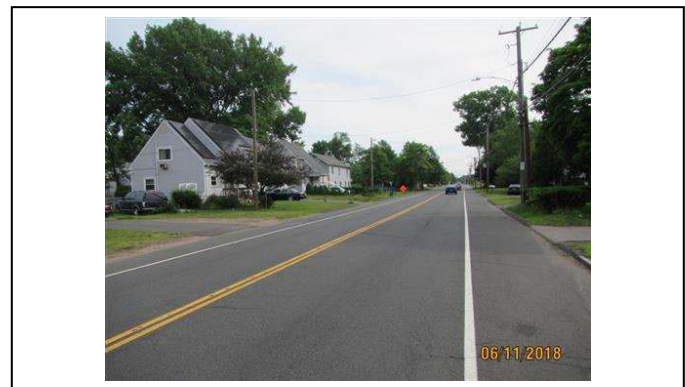
Status Summary: Route 17 (Middletown Ave.) over Brook at Gando Drive. The structure was load rated in 2010 and is in generally good condition. Wearing surface has some transverse cracking. Silt and marsh growth has effectively blocked two of the culvert pipes, the site should be monitored for over topping or pooling water during heavy rain events.

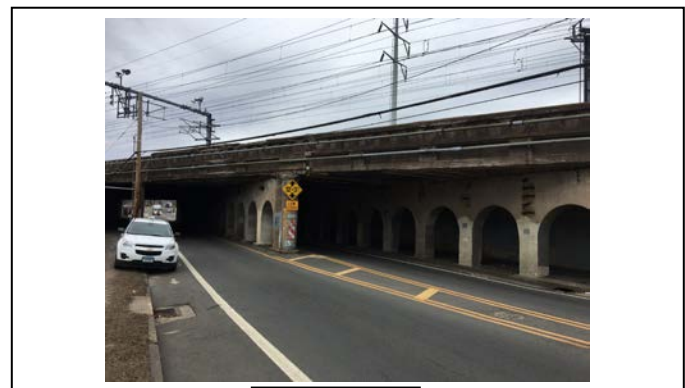
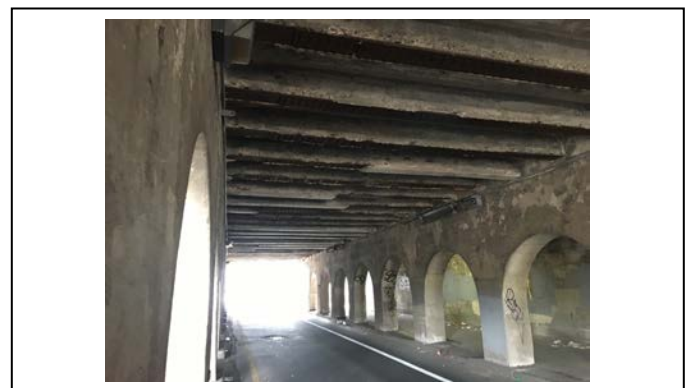
Status Summary: This structure is owned and operated by Amtrak. Spalling on the deck and girders is significant and wide spread. There is low clearance on both approaches and signage of 12'-3". Several lights are out over the sidewalk and street below the bridge. Utility cables (electric and communication) are suspended and drape 8.5' above the north sidewalk.

Suggested Work: This structure should be visited every few months to check for loose concrete or falling hazards from the road way below. The wires should be pinned to the wall or deck out of reach of pedestrians. Lights are the responsibility of the City and a project is currently in development to improve lighting beneath the structure.

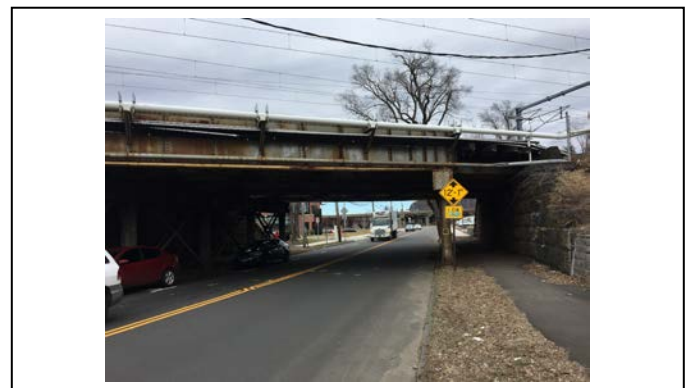
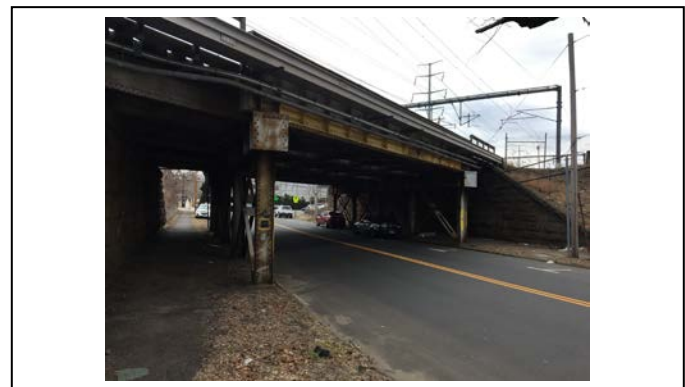
Status Summary: This structure is owned and maintained by Amtrak, it passes over James St. and carries train traffic. The deck is open with longitudinal girders, transverse stringers and transverse ties. Measurements of vertical clearance were taken as 12.66' at the sidewalk, 13.25' at the North curb line, and 12.75' at the center of road – both approaches are signed for low clearance of 12'-1". Utility wires are hung 7' off the Eastern sidewalk.

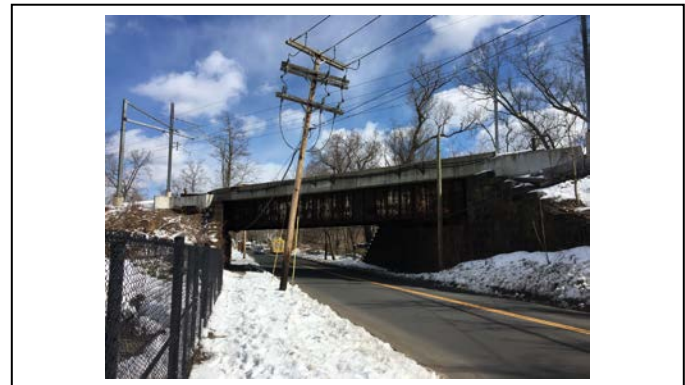
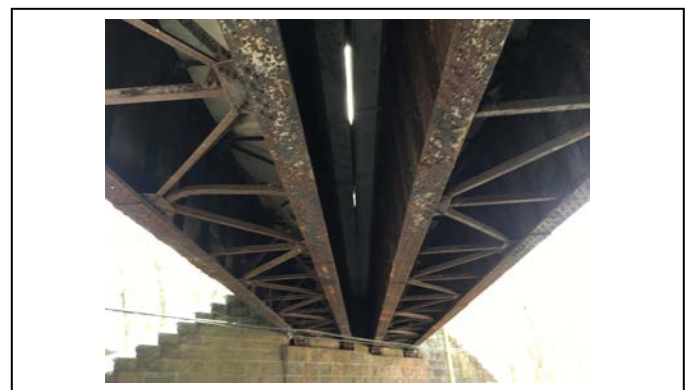
Status Summary: Amtrak railroad bridge over Quinniac Ave. The superstructure has significant corrosion accumulation, and lateral bracing showed deformation at gusset plate connections. No deflection of the superstructure was apparent. The substructure, masonry brownstone blocks, had full height 1.5" wide shear cracks in several locations with signs of a previous repair. Clearance was measured as 12'-11", SB is signed as '12'-11" Low Clearance'.

Suggested Work: Shear cracking in abutments should be measured again next year for comparison. If additional deformation, or deflection is noticed in the superstructure it should be brought to Amtrak's attention. Low clearance signage should be added to the NB approach.

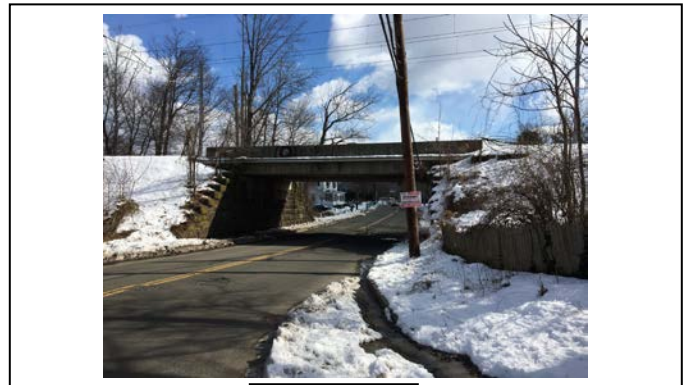
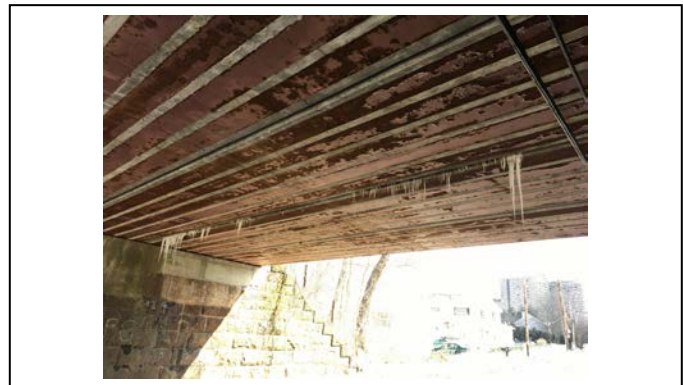
Status Summary: Amtrak railroad bridge over Hemingway Street. There was significant activage leakage from the longitudinal joint between girders 2 & 3. Joint was not large enough for debris to pose a risk, but ice may interfere with motorists. Clearance was measured as 12'-11". Two catch basins are in the road under the structure, both appeared to be fully clogged.

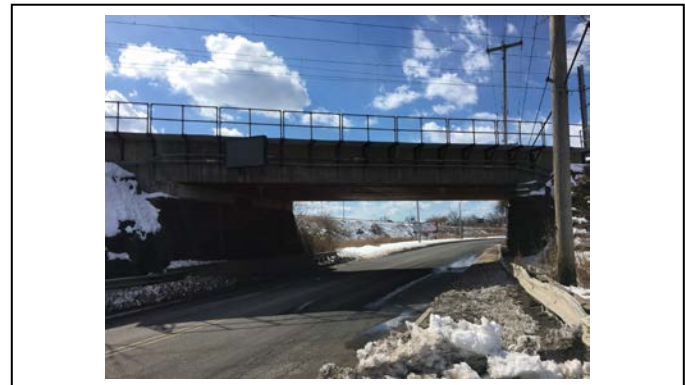
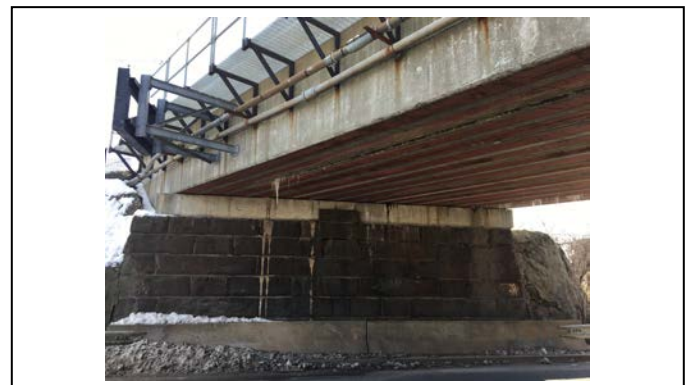
Status Summary: Railroad bridge over City ROW approximately 1,500' south of I-91 exit 8. Longitudinal joints in the superstructure are opened to approximately 2" and allow water, debris, and ice to fall onto the roadway below. Clearance to the superstructure was measured at 13'-3", the bridge is signed '13'-4" Low Clearance' in the SB lane. The substructure wingwalls are dry stacked masonry with shotcrete facing, masonry is exposed at edges. The abutments have moderate mortar loss between stacked brownstones, as well as shifted blocks. It appears the Eastern abutment was repointed at some point but has since lost a significant amount of mortar.

Suggested Work: The NB lane should be signed '13'-3" Low Clearance'. Biennial inspections should verify condition of the abutments and wingwalls to ensure they do not pose additional risk to vehicles on the adjacent road. If motorists complain about icicles, or they are observed as posing a danger the RR should be alerted.

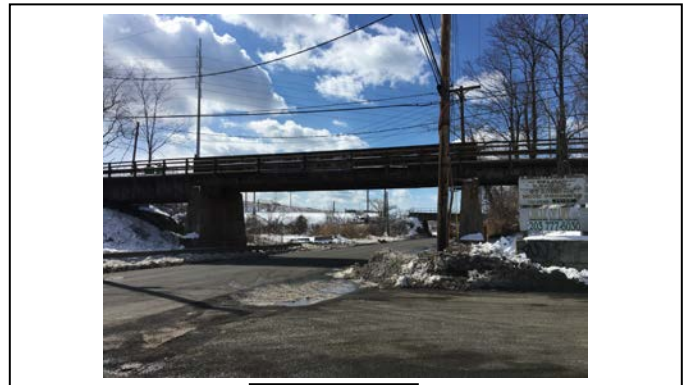
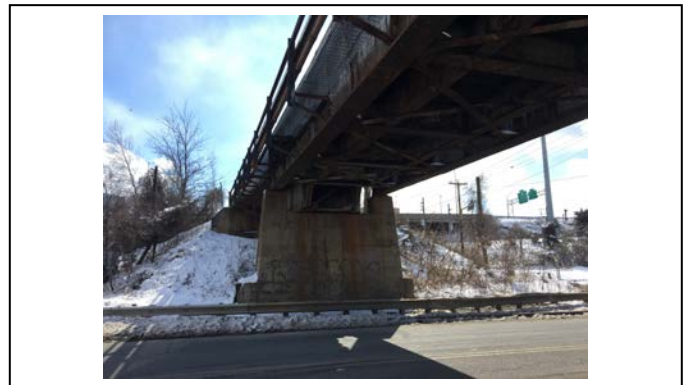
Status Summary: Railroad bridge over City ROW approximately 650' south of I-91 exit 8. Clearance measured as 14'-6". Superstructure is open deck with transverse RR ties. Substructure is in satisfactory condition. This structure poses no apparent nuisance or risk to traveling public.

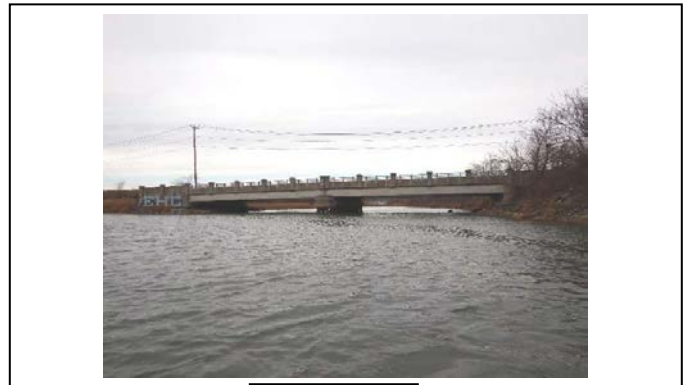
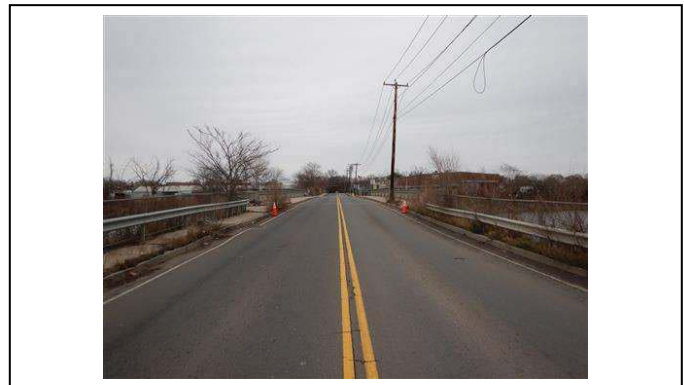
Status Summary: Washington Ave. over West River. This structure is at the town line between New Haven and West Haven. The structure is in overall satisfactory condition.

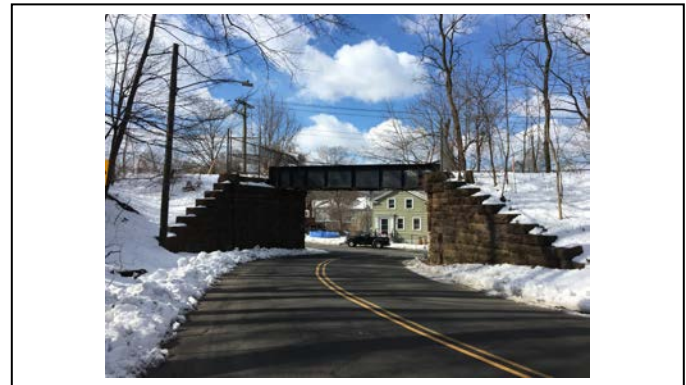
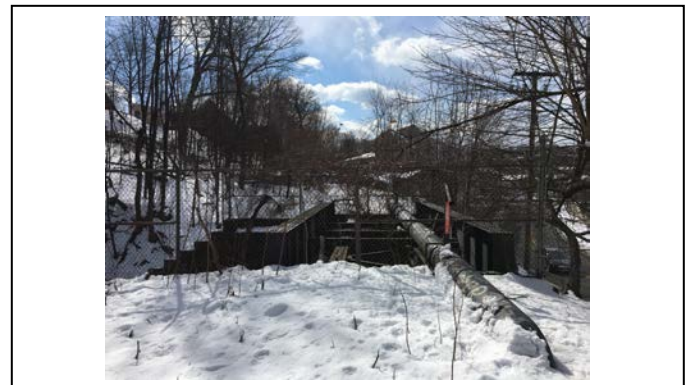
Status Summary: This is a private utility bridge over Lenox St. carrying Buckeye Pipe Line Company's utility line. There is low clearance and signage of 12' clear on both approaches. There is no deck on the bridge and the approach was blocked by chain link fence which has been partially removed.

Suggested Work: This is a private structure and currently poses no hazard to traveling public. It should be inspected every two years for damage and potential risk to the street traffic below.
