Facility Assessment

Sacred Heart Church,
New Haven, Connecticut
June 24, 2008

Prepared by:
Timothy J. Callahan AIA
Herbert S. Newman and Partners P.C.

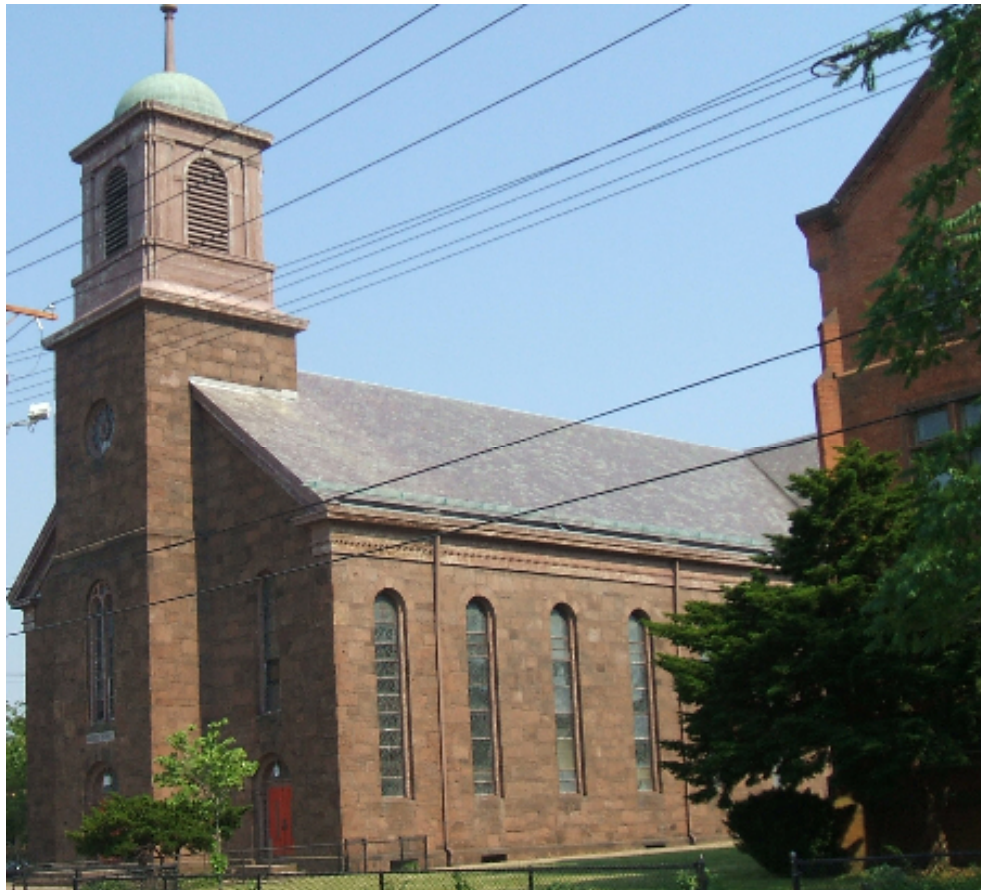
The exterior wall appears to be solid, load bearing brownstone. The windows, doors, and trim are wood. The roof is slate with metal flashing at the edge. The gutters are integrated into the roof and drainage is through exterior roof drains.

The exterior wall is a bearing wall of solid masonry construction. The stone is rough cut brownstone with concrete mortar at the joints. The condition of the stone is excellent. It appears the building was re-pointed from the transept joint to the front façade. The transept and the back altar wall have visible gaps and cracks at the mortar joints
